Neversink River East Branch

MANAGEMENT UNIT 11

EAST BRANCH MANAGEMENT UNIT 11
BETWEEN STATION 42200 AND STATION 40110

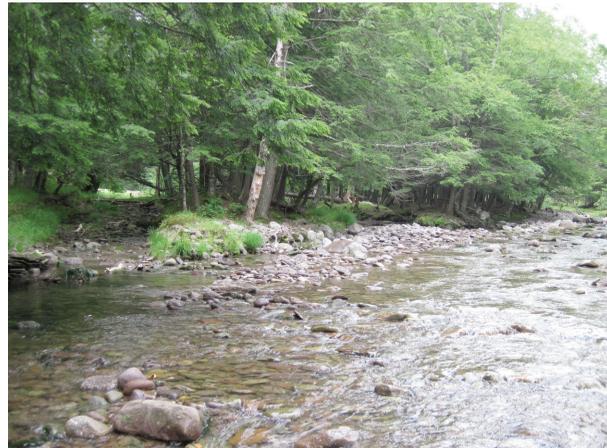
EBMU11 begins at Station 42200, where Riley Brook enters through the right floodplain. (*A147*) Riley Brook is a perennial tributary which crosses under Denning Road approximately 80-feet prior to its confluence with the East Branch of the Neversink River, making it a potential source for contaminants from road runoff. It is likely that this tributary contributes chlorides (salt) and petroleum by-products from road runoff to the Neversink.

Riley Brook entering through right floodplain (A147)

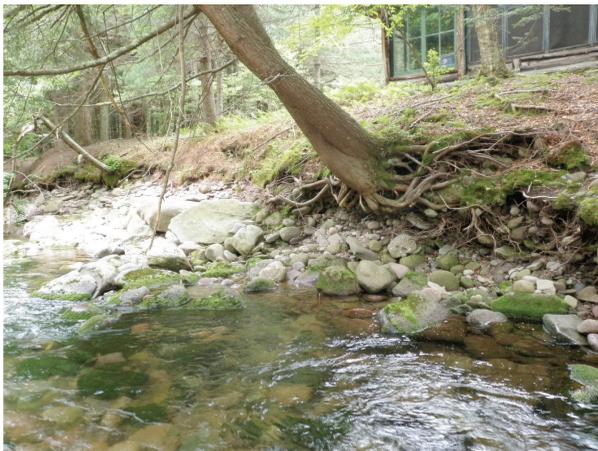
Erosion along the right bank begins just downstream of the tributary confluence at Station 42170, continuing approximately 184-feet before ending at Station 41990 (BEMS NEB11_41800). The toe of the bank is being actively undercut exposing the alluvial cobble sized bank materials. Several mature coniferous trees have had their root structure scoured out and are now leaning towards the stream. (B78) There is a log home standing only 20-feet from this eroding bank that is being threatened under higher flows. Due to the proximity of this structure to the bank erosion, assisted restoration is recommended at this site. Bioengineering practices could be used to stabilize the toe of the bank and prevent further undercutting. Large mature trees that are severely leaning toward the stream can be cut at the trunk and removed, leaving the root wads in place to help stabilize the bank materials.

Scour on right bank endangering log home (B78)

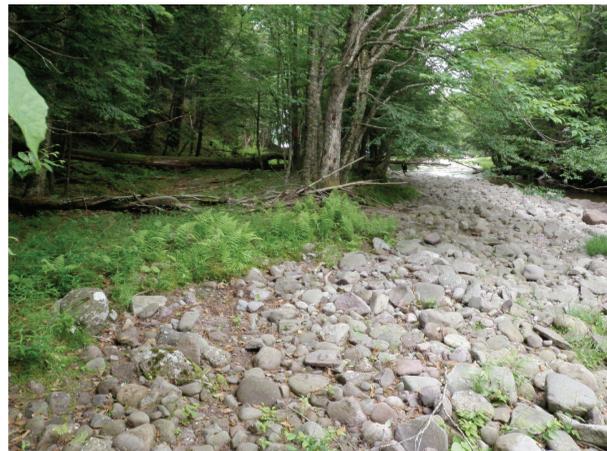
A side bar has formed along the left bank directly across from the erosion at Station 42020. This depositional area consists of primarily cobble sized materials and is approximately 50-feet in length. (B76) An abandoned side channel diverges into the left floodplain near the upstream end of the bar. This relict channel is overgrown with herbaceous vegetation and is littered with leaf debris from the previous Fall, suggesting that it has not received significant flow in any recent events.

Cobble side bar on left bank (B76)

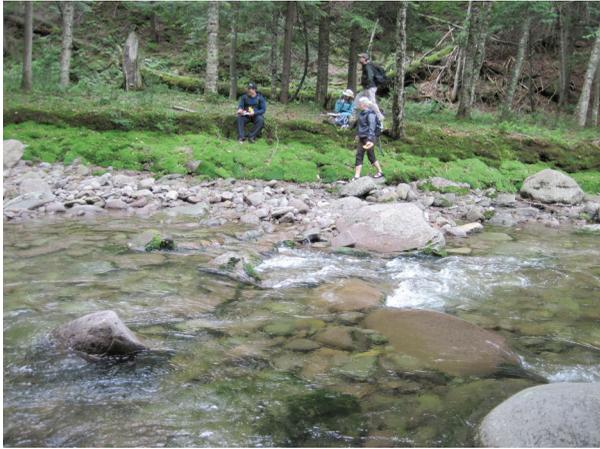
Continuing downstream, a rock vein runs across the stream creating elevation grade control at Station 41840. (A153) It is unclear whether this rock structure is naturally occurring or intentionally placed. A scour pool has formed directly below because the water faces an abrupt vertical drop as it flows over the vein, creating a localized readjustment of channel slope and sediment movement.

Rock vein running across stream (A153)

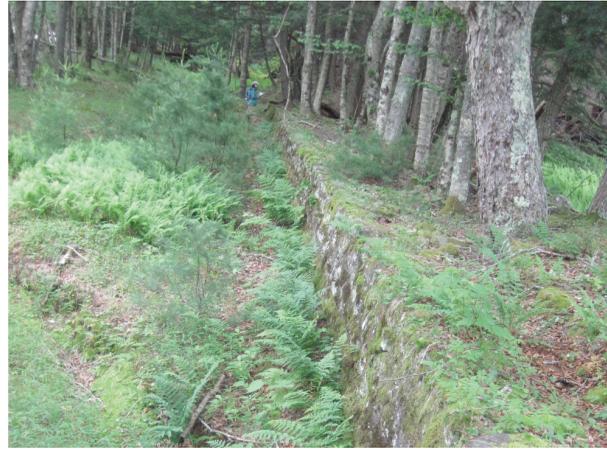
Mortar and stone berm on left bank (A154)

At Station 41720 an old mortar and stone berm begins on the left bank, continuing approximately 126-feet to Station 41600. (A154) This berm is set back from the stream by 15-feet and averages 3-feet in width. A relict sluice gate is incorporated into the upstream end of the berm and still stands in solid structural condition. This gate was once used to divert water from the stream into a millrace that runs into the left floodplain. (A155) According to Kudish and the 1875 Beers Maps, this millrace was once used by a sawmill built before 1849 by John W. Smith. At the time when beers plotted his maps in 1875, the mill was run by the Johnson brothers in the hamlet of Denning.

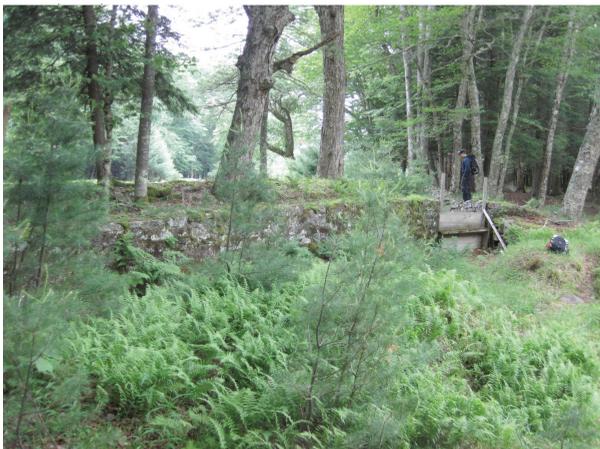
Relict sluice gate (A155)

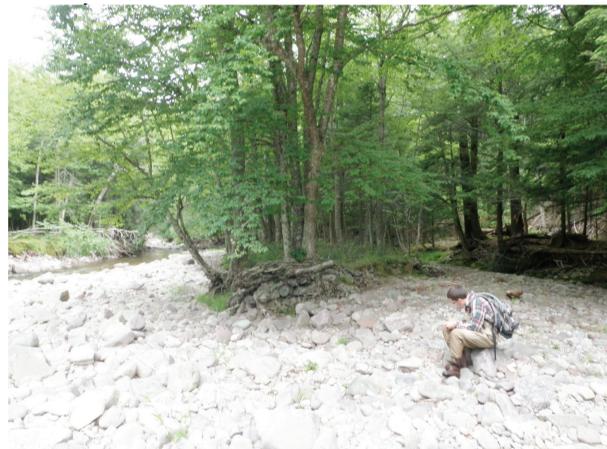
Cobble side bar on right bank (B82)

Across from the berm, a cobble side bar begins at Station 41780 and continues 195-feet to Station 41450. (B82) This bar has been cleared of any leaf debris and has minimal vegetative growth on it, indicating that it is at a low enough elevation that it becomes inundated under significant flow events. A small side channel diverts to the right side of the bar at Station 41600 and converges back with the main channel at Station 41400. (B84) This channel was dry at the time that this stream feature inventory was conducted.

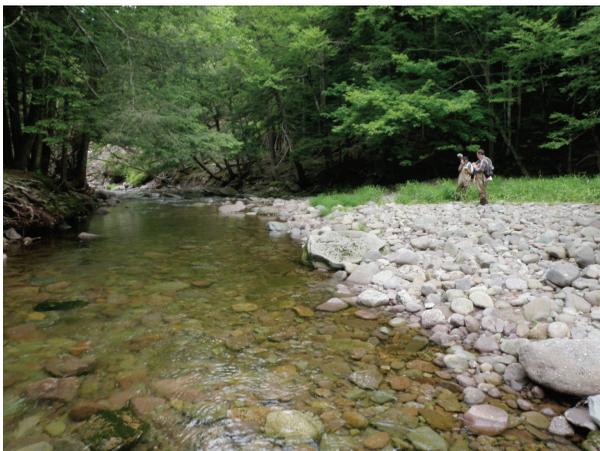
Looking downstream of main channel at converge with small side channel (B84)

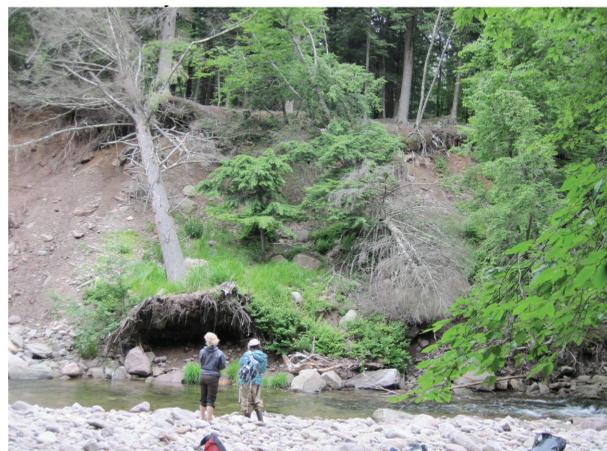
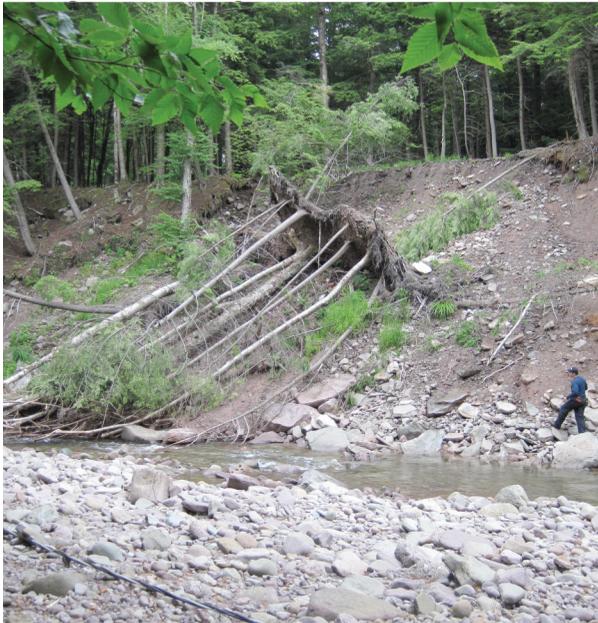
Large failure on right bank (A165)

The main channel takes a sharp turn to the left at Station 41420 and continues in a relatively straight alignment for the remainder of EBMU11. A large failure on the right bank begins at Station 41280, continuing downstream over 100-feet downstream until Station 41170 (BEMS NEB11_41100). (A165, A166) The cause of this mass failure is a combination of processes, including hydraulic erosion at the toe of the bank and rotational slumping near the top. As the bank has become less stable, large sod mats with trees still rooted in

Large failure on right bank (A166)

Station 41990. Assisted restoration is recommended for this site. The second bank erosion site is a mass failure that is a potential source of fine sediment along the right stream bank between Station 42180 and 41170. Full restoration is recommended for this site in order to alleviate hydraulic pressure on the bank and establish stability.

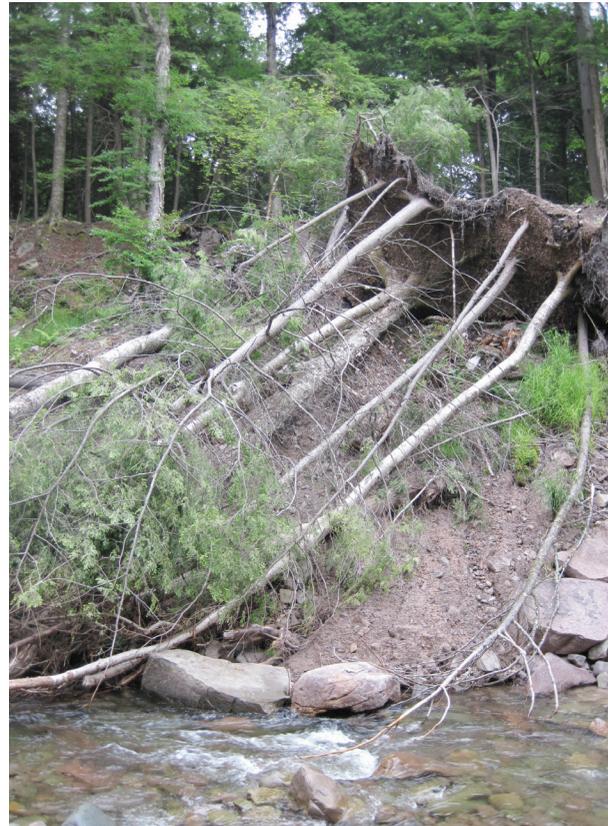
Uprooted trees sliding into stream (A162)

them have slid or fallen from the top of the 50-foot high bank down to the toe, which in some instances has caused obstructions to stream flow. (A162) The exposed glacial till in this bank is a potential source of fine sediment and turbidity when entrained under higher flows. (A161) Although some large boulders have begun to accumulate at the toe of the bank it does not appear that this failure has reached an angle of repose, suggesting that it will continue to erode and fail during significant flood events. Therefore, assisted restoration is recommended for this site in order to alleviate hydraulic pressure on the bank and establish stability.

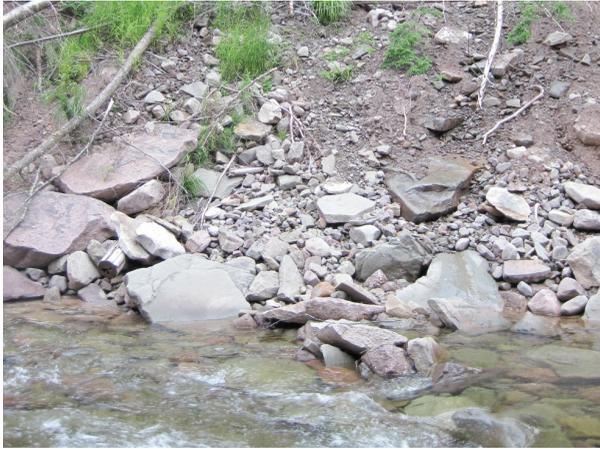
Exposed glacial till (A161)

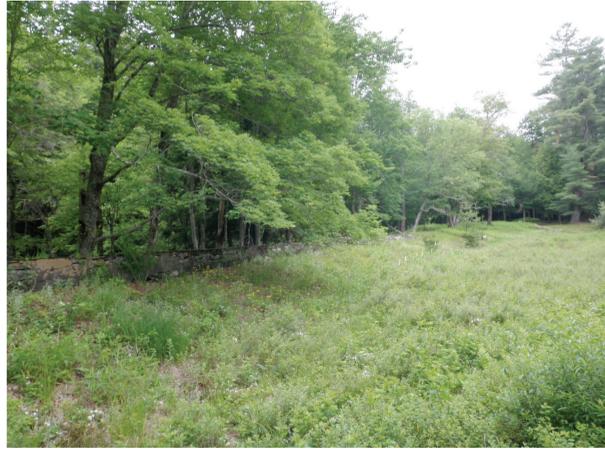
Mortared rock wall revetment on left floodplain (B88)

As we continue downstream the channel begins to come in close contact with infrastructure on the left bank and floodplain owned by Frost Valley YMCA. Due to flood threats to buildings and access roads, a mortared rock wall revetment has been constructed beginning at Station 40900, continuing downstream until Station 40730. (B88) This revetment is set back from the stream approximately 30-feet and runs adjacent to a retention pond. The area between the wall and the stream consists of primarily herbaceous vegetation which does not provide adequate stability to the stream bank under high flows. (B87) A riparian buffer including woody vegetation could be established here using planting techniques, which could strengthen the stream bank and slow erosive forces of higher flows during flood events.

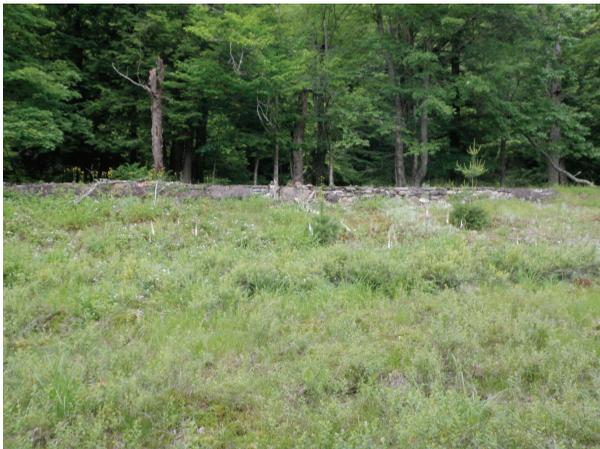
Herbaceous vegetation not providing adequate stabilization (B87)

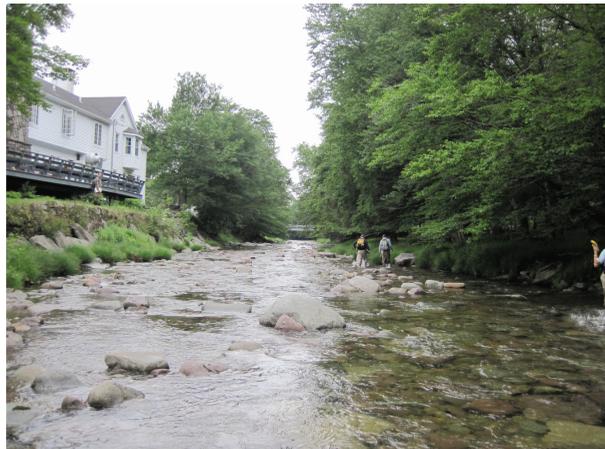
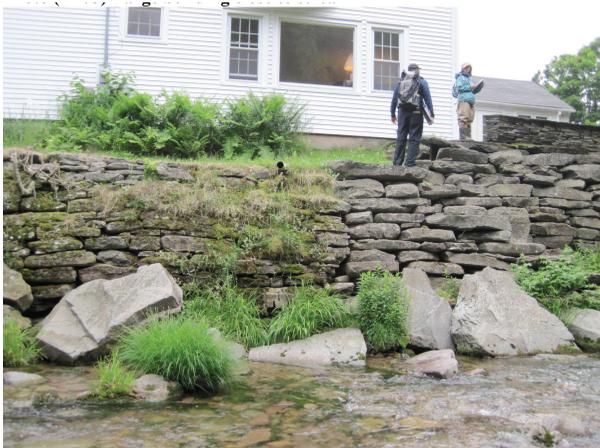
Large building close to stream (A175)

Stacked rock revetment protecting building on left bank (A178)

A second revetment has been placed directly downstream along the left bank between Station 40650 and Station 40400 in an attempt to protect a large building that is situated less than 15-feet from the edge of the bank. (A175, A178) This stacked rock wall is an attempt to alleviate the high risk of hydraulic erosion and failure under significant flows. Although this revetment appears to be in relatively fair condition, under increased flood magnitudes and frequency it will do little to mitigate flood risk to this structure.

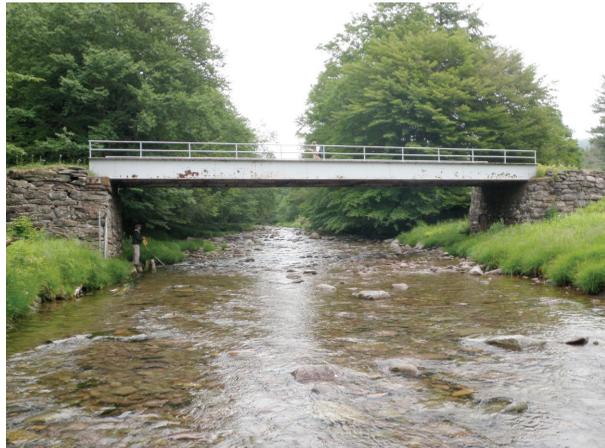
Looking downstream at Frost Valley owned bridge (B92)

EBMU11 ends at Station 40080, just downstream of where a private bridge owned by Frost Valley YMCA crosses the stream channel (B92). This bridge is in good functional and structural condition, however the stacked rock abutments encroach on the bankfull channel on both sides of the stream which may contribute to difficulties in conveying flow and sediment during larger flood events. Both the right and left banks on the downstream end of the bridge consist of primarily herbaceous vegetation and should be considered for riparian buffer improvement using planting techniques. (B94)

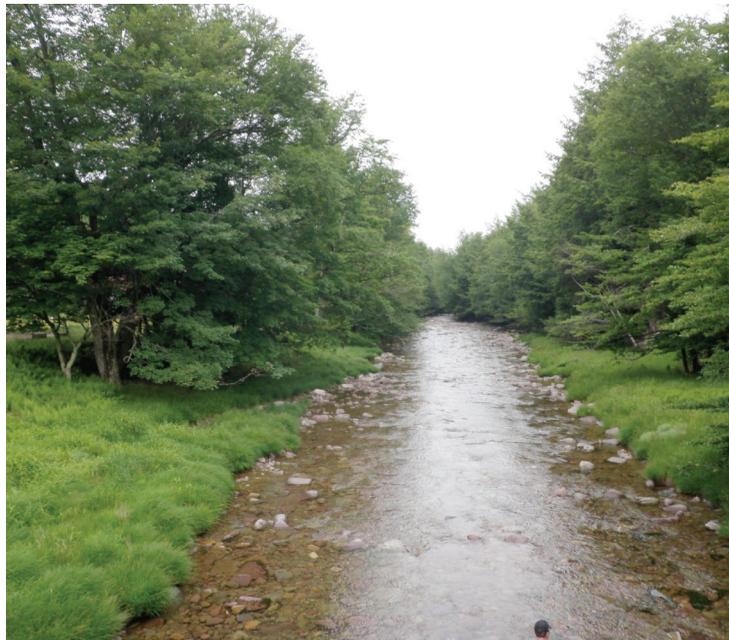
Herbaceous vegetation on right and left banks downstream of bridge (B94)
