# Neversink River East Branch

## MANAGEMENT UNIT 12

### Summary of Post-Flood Recommendations

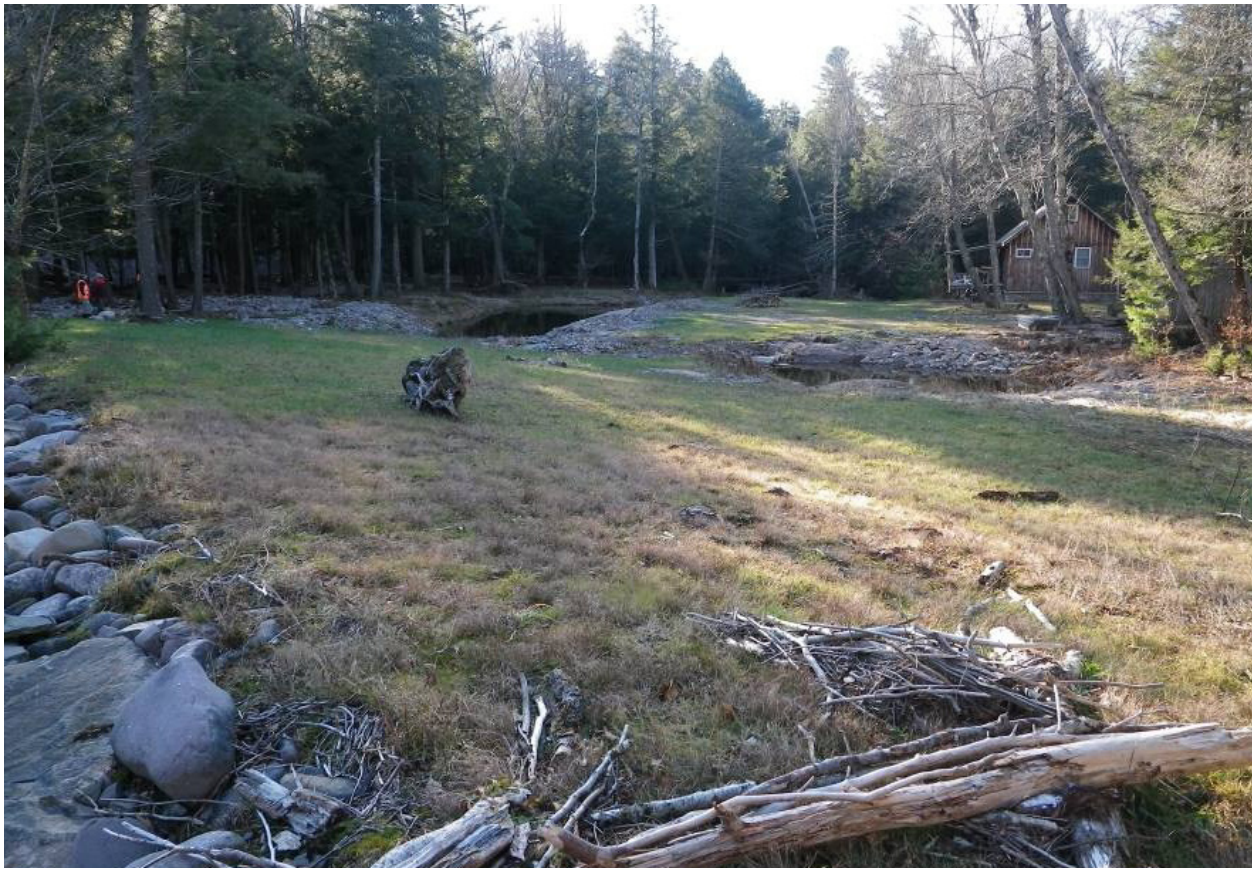
A cobble berm begins on the right bank at Station 42290, continuing 195 feet to Station 43095. A stacked boulder revetment was documented on the right bank beginning at Station 42980 continuing for 248-feet to Station 42720. Although the berm and revetment remain in good structural and functional condition since the high flow events, significant flood chutes were observed in the floodplain between the stream bank stabilization and Denning Road.

*Constructed pools in right floodplain- note lack of riparian buffer. (IMGP1544).*

Recommendations for this site include both potential re-routing of the flood chute and improved grading of the constructed pools on the property to prevent risk to the nearby residence during future high flow events. Furthermore, the right stream bank does not have a vegetated riparian buffer and is primarily mowed grasses and other herbaceous vegetation. A vegetated riparian buffer can naturally slow the flow velocity thus slowing erosive forces along stream banks during flood events on the bank, and strengthen the stream bank.

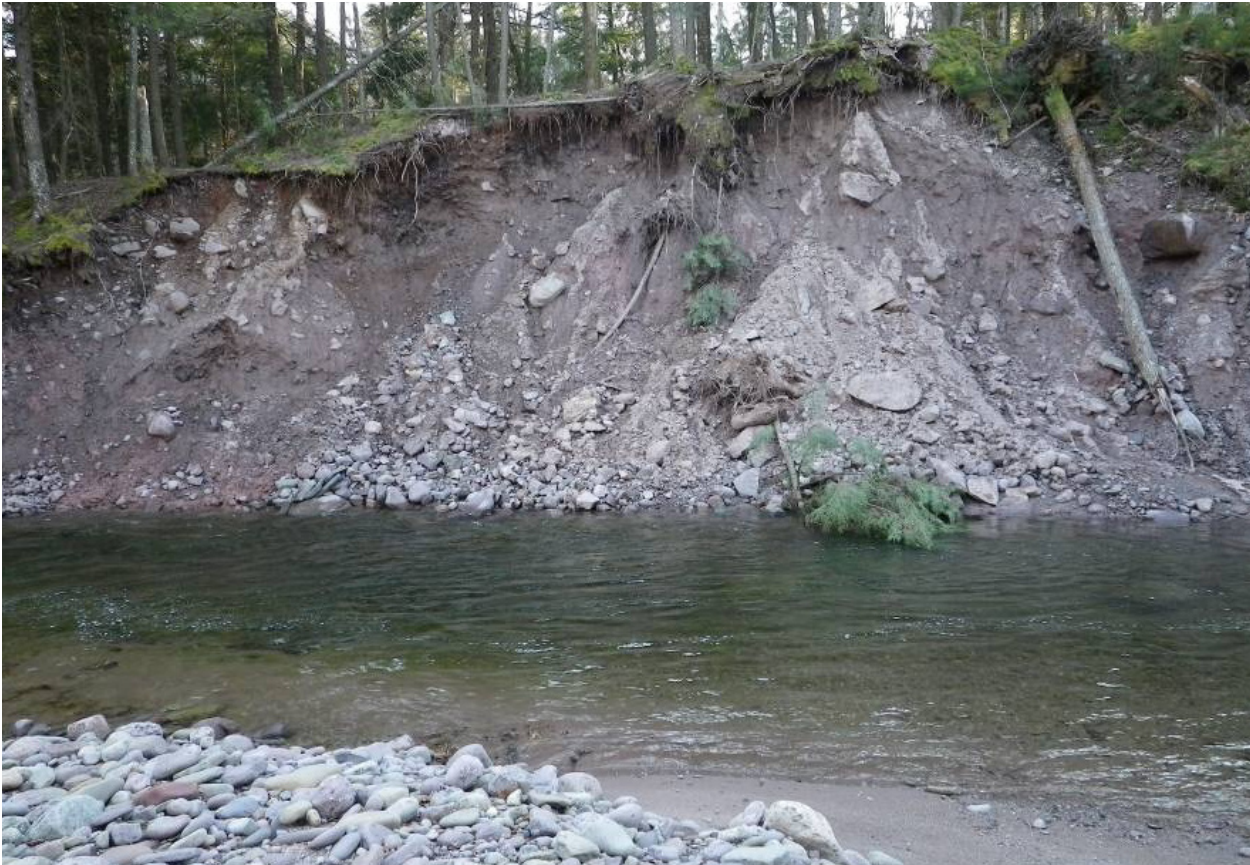
A mass failure of the left stream bank begins at Station 42440, continuing downstream until Station 42360 (BEMS NEB12\_42300). This bank is 27-feet in high to the top of the bank and consists mostly of glacial till material with some recently exposed lacustrine clay which is a new source of fine sediment that could be entrained during high flows and lead to water quality degradation. Elevated turbidity has been observed in the river since the TS Irene flood event due to clay exposures like this one.

*Slope failure on left bank. Exposed lacustrine clay visible at the upstream end. (IMG1548)*

During the survey conducted in the summer of 2010 it was determined that this bank could stabilize without treatment (passive restoration). However, since the recent high flow events, the bank is no longer projected to self-stabilize. Instead full restoration is recommended for this site. This restoration could include installation of a bankfull stage bench at the toe of the slope, an increased radius of curvature, and establishing a riparian buffer including woody vegetation to strengthen the stream bank and decrease erosive forces on the bank during future flood events.
