Neversink River East Branch

MANAGEMENT UNIT 13

EAST BRANCH MANAGEMENT UNIT 13
BETWEEN STATION 46900 AND STATION 50100

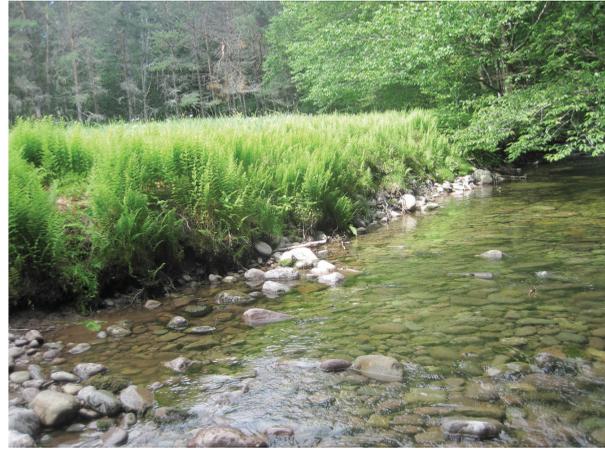
erosion at this site is the result of the grass and herbaceous vegetation not providing adequate stability to the stream bank under high flows. (A71). A riparian buffer including woody vegetation can strengthen the stream bank and slow erosive forces of higher flows during flood events. Recommendations for this bank erosion site minimally include assisted restoration with riparian planting techniques to restore the forest connectivity and stabilize the bank.

Grass and herbaceous vegetation not providing adequate riparian buffer (A71)

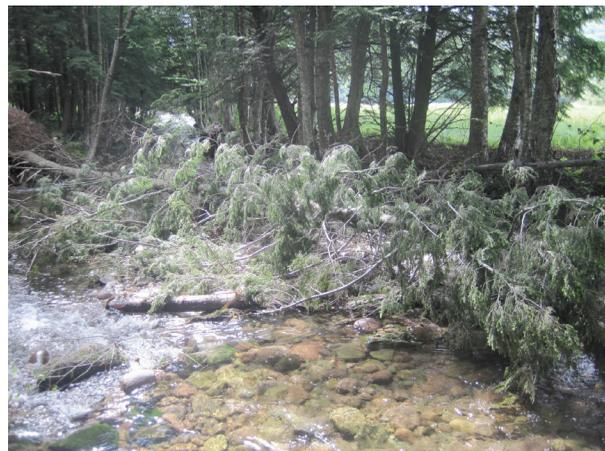
Directly downstream of the erosion on the right bank is a significant accumulation of woody debris at Station 46850 that is causing a channel wide obstruction and instability. (A64). Scour is occurring directly downstream of the obstruction because the water faces an abrupt vertical drop as it flows over the debris. This continuous scour is resulting in a headcut which is actively migrating upstream, and will continue to do so until it meets a substrate that is not erodible. (A73). The obstruction decreases the channel's ability to move sediment through this reach, resulting in the formation of a cobble side bar along the right bank at Station 46790. (A67). The debris obstruction is also causing a portion of the flow to re-route

Obstruction causing erosion on right bank (A64)

to the left, resulting in erosion along approximately 40 feet of the left bank between Station 46790 and Station 46750 (BEMS NEB13_46700). Recommendations for this site would include assisted restoration for the removal of the woody debris obstruction. Since the obstruction is causing the redirection of flow against the left bank, removing it will take stress off of the eroding bank by allowing the flow to take an unobstructed route through the channel.

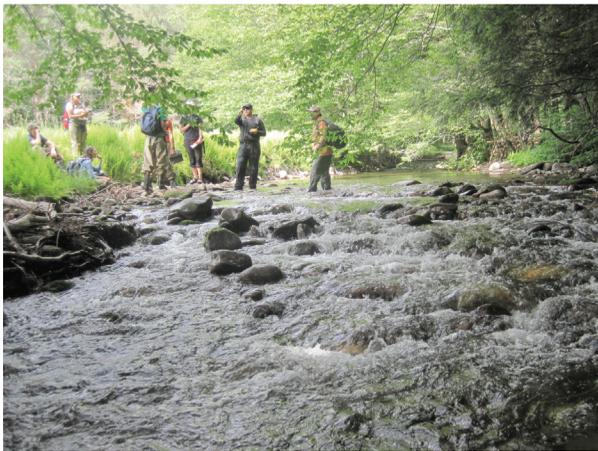
Headcut migrating upstream (A73)

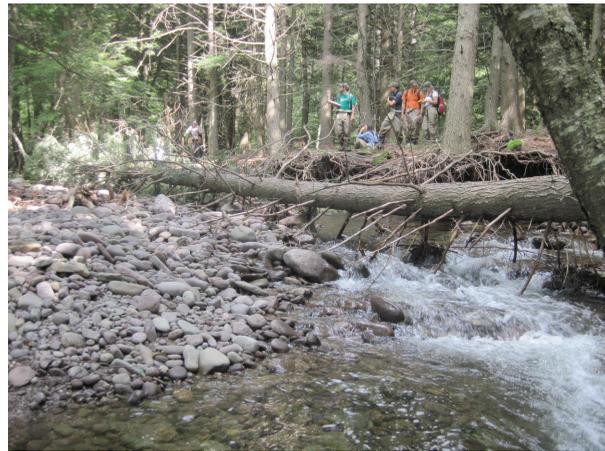
Cobble side bar on right bank forming because of obstruction (A67)

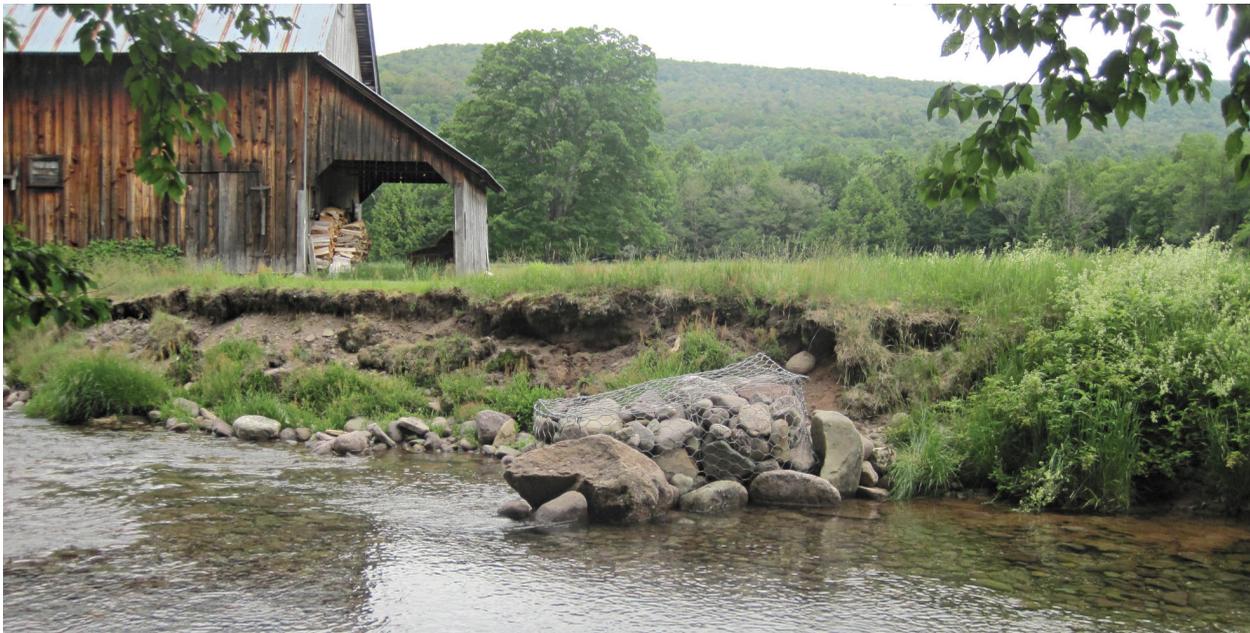
Continuing downstream, significant bank erosion begins on the right bank on the outside of a meander bend at Station 46500. (A83) This hydraulic erosion continues downstream for approximately 188-feet to Station 46310 (BEMS NEB13_46300), a portion of which is a source of fine sediment in the form of lacustrine clay. (A78) The only vegetation established on the top of this eroding bank is mowed grass which provides

Erosion on right bank (A83)

Recommendations for this site include *assisted restoration* with riparian planting techniques to restore the forest connectivity and stabilize the bank. A riparian buffer including woody vegetation can strengthen the stream bank and slow erosive forces of higher flows during flood events. The gabion baskets along this bank should be replaced with bioengineering techniques to expedite bank stabilization.

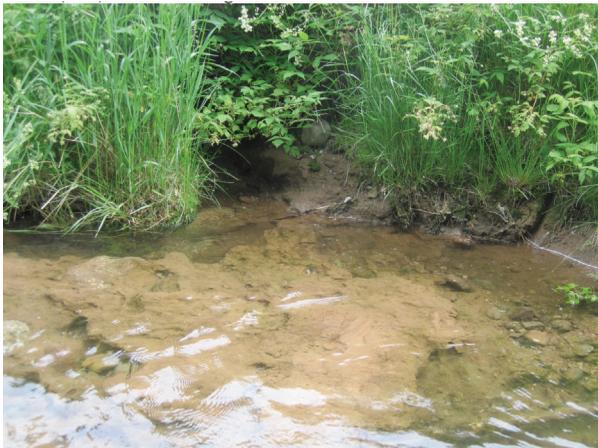
Lacustrine clay (A78)

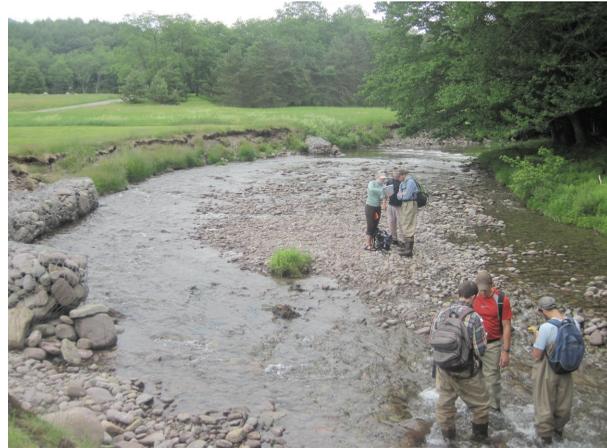
Mowed grass field not providing bank stabilization (A84)

virtually no sediment stabilization or resistance to fluvial erosion. (A84) There is a barn approximately 50-feet from the edge of the stream bank that will be in danger if this erosion continues. In order to protect this barn, Gabion baskets have been placed relatively recently along the 105-feet of the eroding right bank that is directly adjacent. (B27) Gabion baskets are very susceptible to failure during high flows, as larger rocks moved by the stream can continuously hit the cage and cause structural weaknesses. The combination of stresses caused by stream flow and sediment movement can cause tearing of the basket and release of the rock inside, resulting in the structure no longer functioning for its intended purpose.

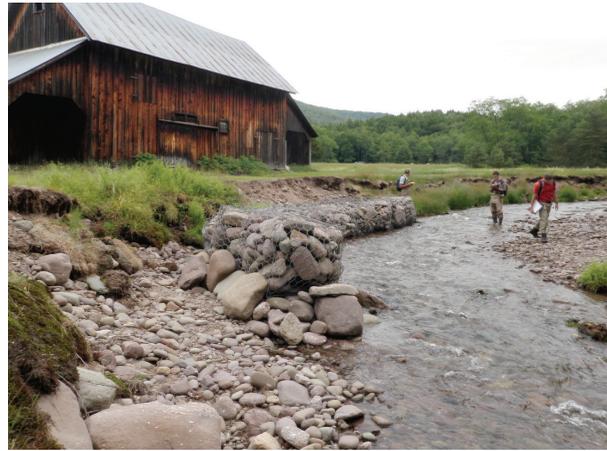
Gabion baskets placed on right bank to protect barn (B27)

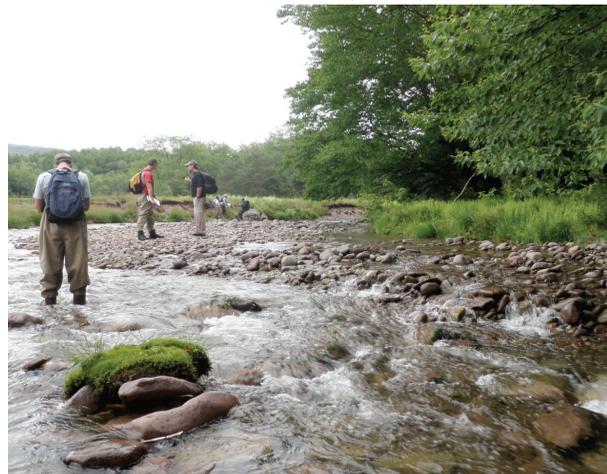
The next 200-feet of stream length in this management unit is characterized by headcuts, most notably occurring at Station 46330 (B30) and Station 46230 (B32). The headcuts are actively migrating upstream, and will continue to do so until they meet a substrate that is not erodible. At Station 46130 the main channel converges with the side channel from the left that diverged in EBMU14 at Station 47025. (A90) This side channel is a 700-foot aggradational reach with a 400-foot long center bar that is caused by multiple large woody debris obstructions near the downstream end. (A100) At the time of this walkover, flows were exclusive to the channel on the right of the bar. However, there

Headcut migrating upstream (B30)

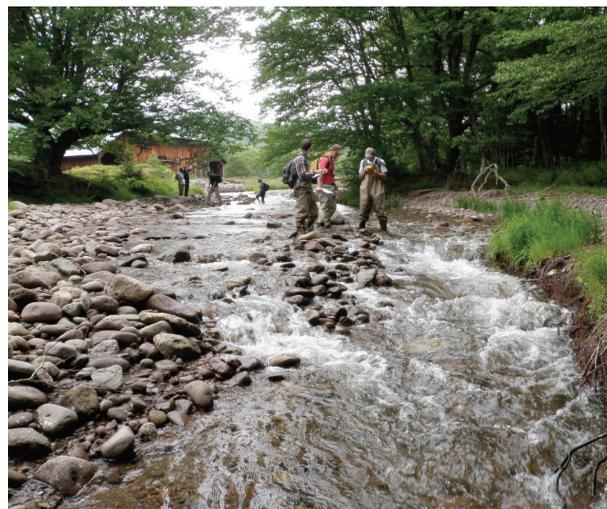
Headcut migrating upstream (B32)

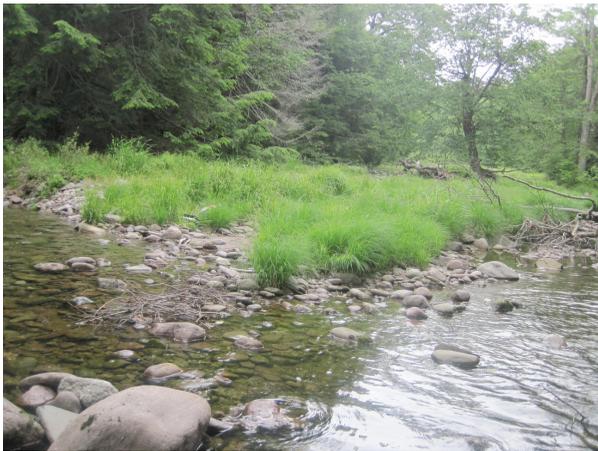
Looking upstream at main and side channel convergence (A90)

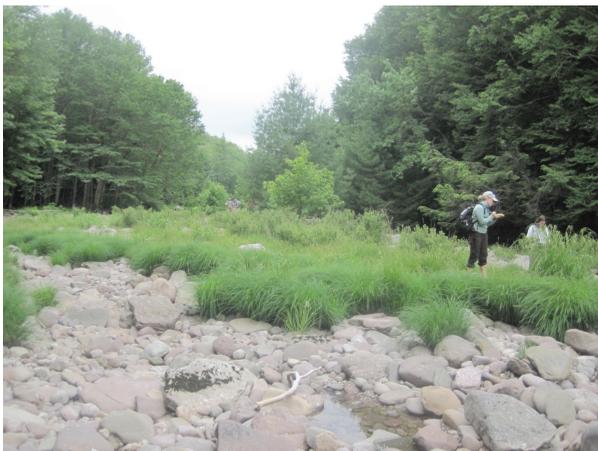
Center bar caused by multiple obstructions downstream (A100)

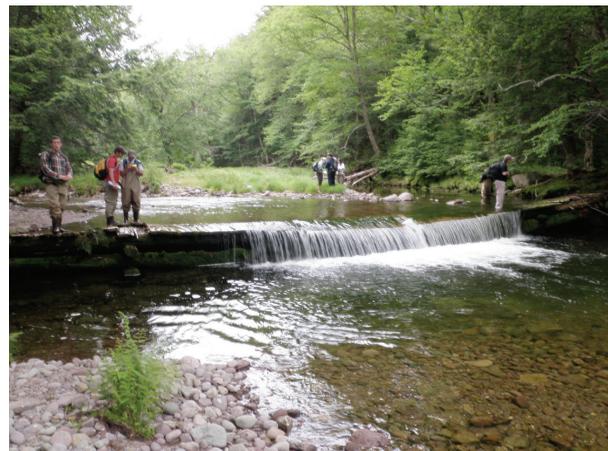
Downstream of the convergence there are two wooden dams that have been installed at Station 46110 (B34) and Station 45760. (B46) These dams measure 88-feet and 105-feet across, respectively, and are both in fair structural condition. They were most likely installed in order to improve trout habitat, as they add diversity to what would otherwise be a relatively uniform flow regime. Both of the dams create a 2-foot drop in stream elevation which results in a deep scour pool below.

Looking upstream at wooden dam at station 46,110 (B34)

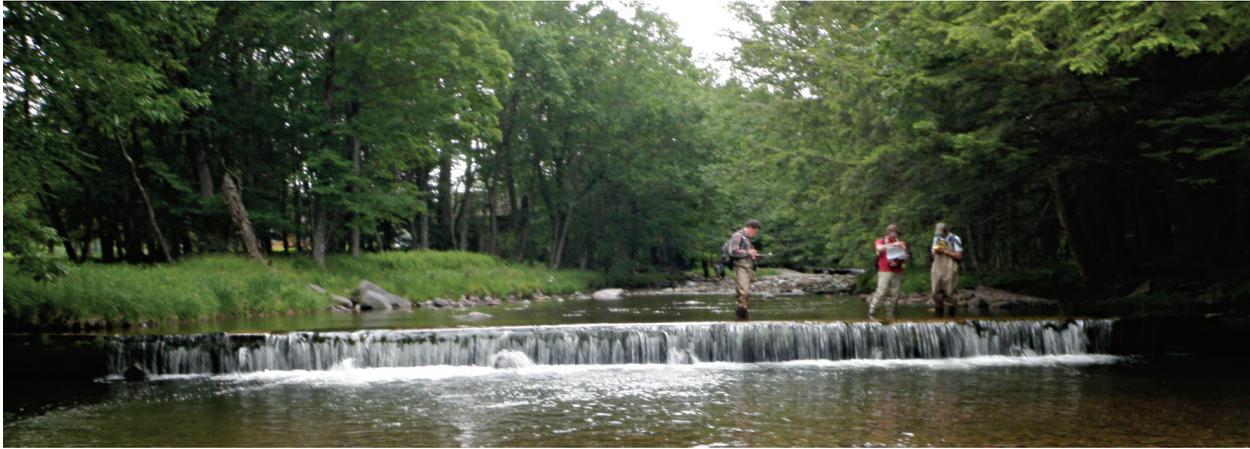
Looking upstream at wooden dam at station 45,760 (B46)

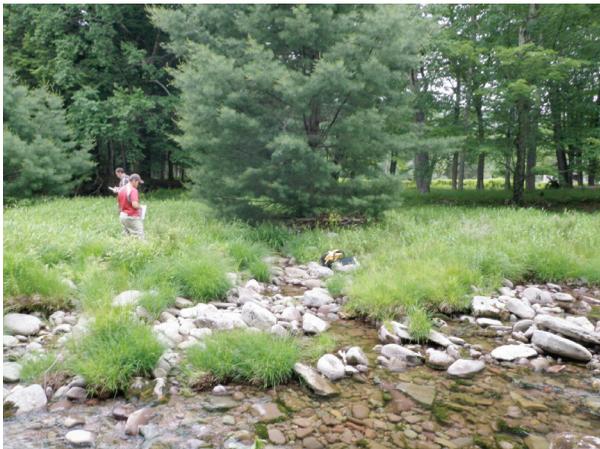
A small tributary flows into the main channel through the right floodplain at Station 45600. This tributary was flowing subsurface during the time of this walkover. (B49). The channel maintains good connectivity with the right floodplain through the remainder of this management unit. Large tree trunks were deposited on the right floodplain at Station 45520, suggesting that this area is inundated enough under high flows

Small tributary with subsurface flow (B49)

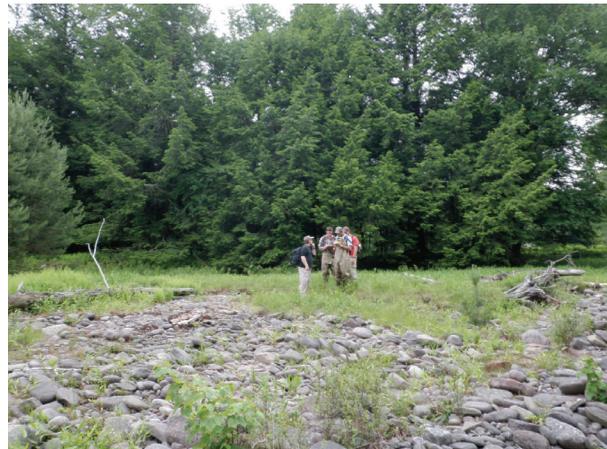
that the transportation of large woody materials is possible. (B50) Significant flood chutes are evident beginning at Station 45300 and continue through the right floodplain for the remainder of EBMU13. (B52) Leaf litter had been washed from these flood chutes prior to the 2010 walkover, indicating that they are active under high flows.

Large tree material deposited on right flood plain (B50)

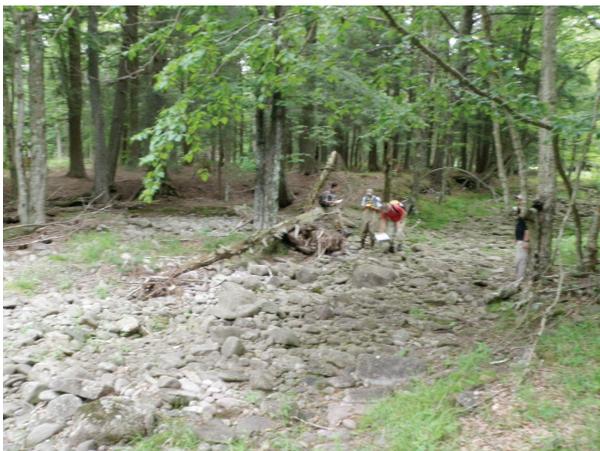
Flood chute on right flood plain (B52)

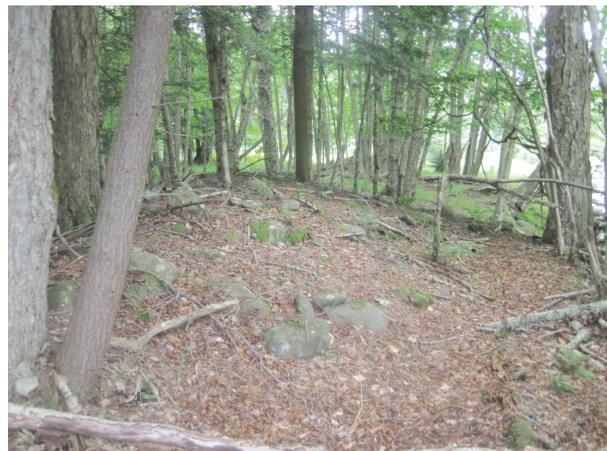
An old stone berm begins on the right bank at Station 45300 and continues until 45100, averaging 6-feet in width. (A112) It was most likely intended to prevent higher flows from leaving the main channel. This berm is overgrown with mature trees

Stone berm on right bank (A112)

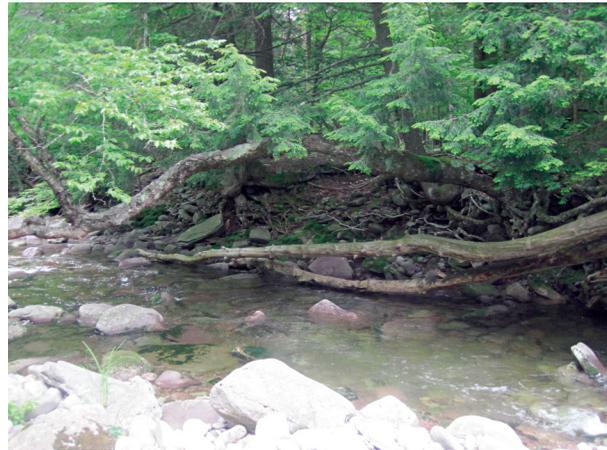
At Station 45560 fallen trees on the right bank have formed an obstruction to higher flows (A122). These obstructions redirect stream flow into the right bank, resulting in 55-feet of erosion and undercutting of the bank from Station 44630 to Station 44590 (BEMS NEB13_44500). (A117) Large rocks are beginning to deposit at the toe of this eroding bank, though it is possible for this bank to stabilize without treatment (passive restoration). However, it is recommended that this site be monitored for changes in condition.

Fallen trees on right (A122)

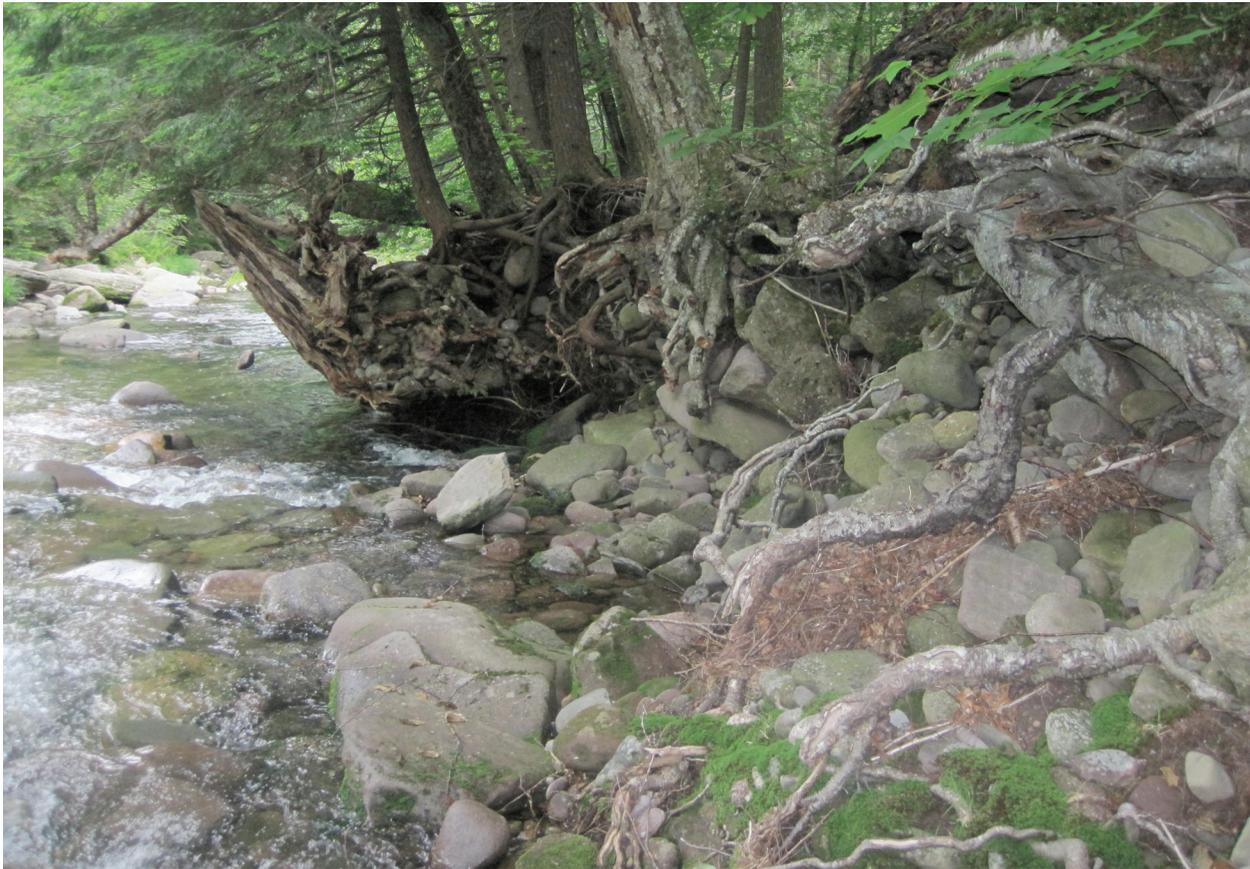
Large rocks depositing at toe of eroding bank (A117)
