Neversink River East Branch

MANAGEMENT UNIT 14

Summary of Post-Flood Recommendations

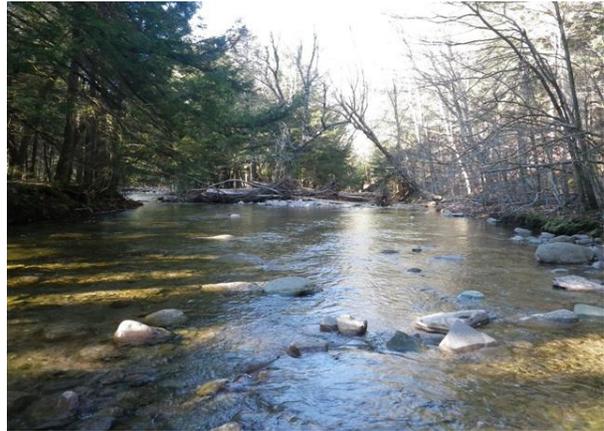
During the 2010 survey, accumulation of woody debris in this management unit was first evident at Station 50100, where a log jam obstruction across the main channel had caused a portion of the flow to divert into a secondary side channel. (See photo A13 on page 5 for pre-flood condition). Remarkably, there was no significant change observed at this location during the post-flood survey. The main channel at this divergence remained stable through the flood. This stream reach could be considered for use as a *reference reach* providing a blueprint of stream morphology for future restoration projects in this section of the Neversink River. (See photo A2 on page 5 for pre-flood condition) The channel consists of a long and shallow riffle system that is confined by the valley wall on the right bank, resulting in scour and undercutting of some of the trees along this bank.

Log jam in main channel post-flood (Dec, 2011). (IMG1477)

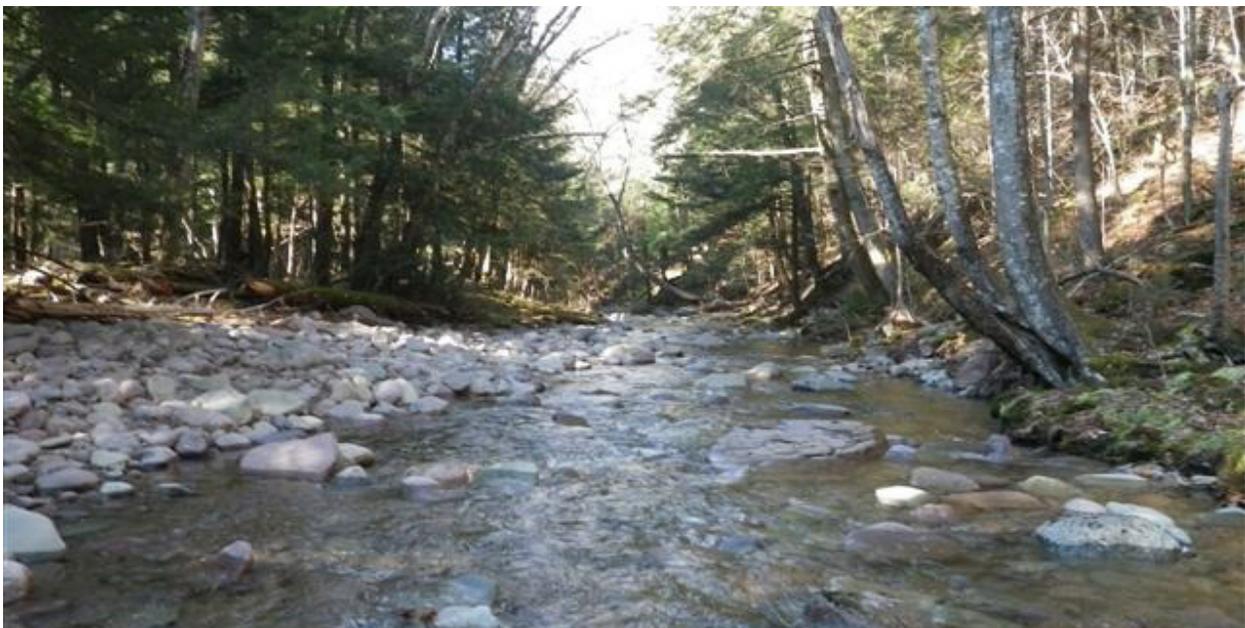
Channel along right valley wall post-flood (Dec, 2011). (IMG1480)

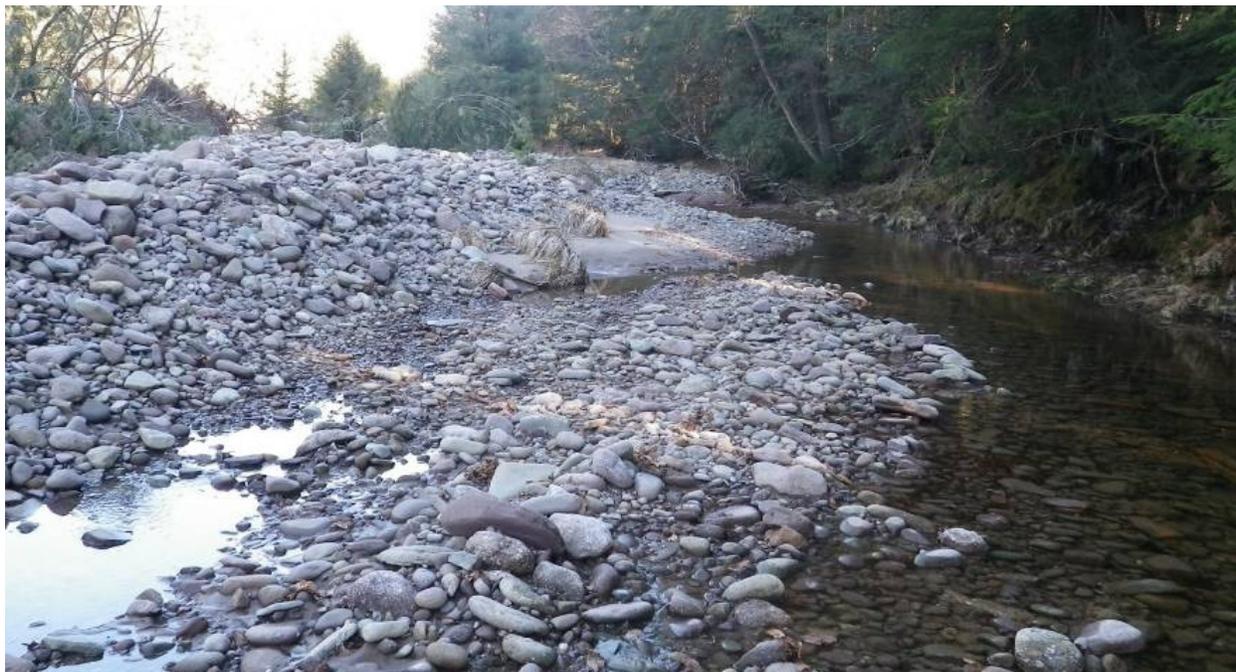
Side channel along left valley wall (facing upstream). (IMG1490)

This side channel is at a lower elevation than the main channel, which will likely lead to accelerated *aggradation* through this section and formation of a center bar. Prior to the formation of this significant side channel, a 120-foot long segment of erosion on the right bank had formed on the outside of the meander bend (BEMS NEB14_47700). This bank segment is currently experiencing less erosive pressure due to the change in channel planform alignment through this stream reach (see photo A43 on Page 7 for pre-flood condition).

Recommendations for this 300-foot long stream reach include blocking of the side channel with secured woody debris / root wad revetment to encourage pooling, slow water velocity, and promote sediment deposition. This could improve the alignment and dimensions of the main channel in this section, helping to restore sediment transport through this stream reach. The eroding bank segment on the right bank may stabilize without treatment (*passive restoration*), but minimally it should be monitored for changes in condition.

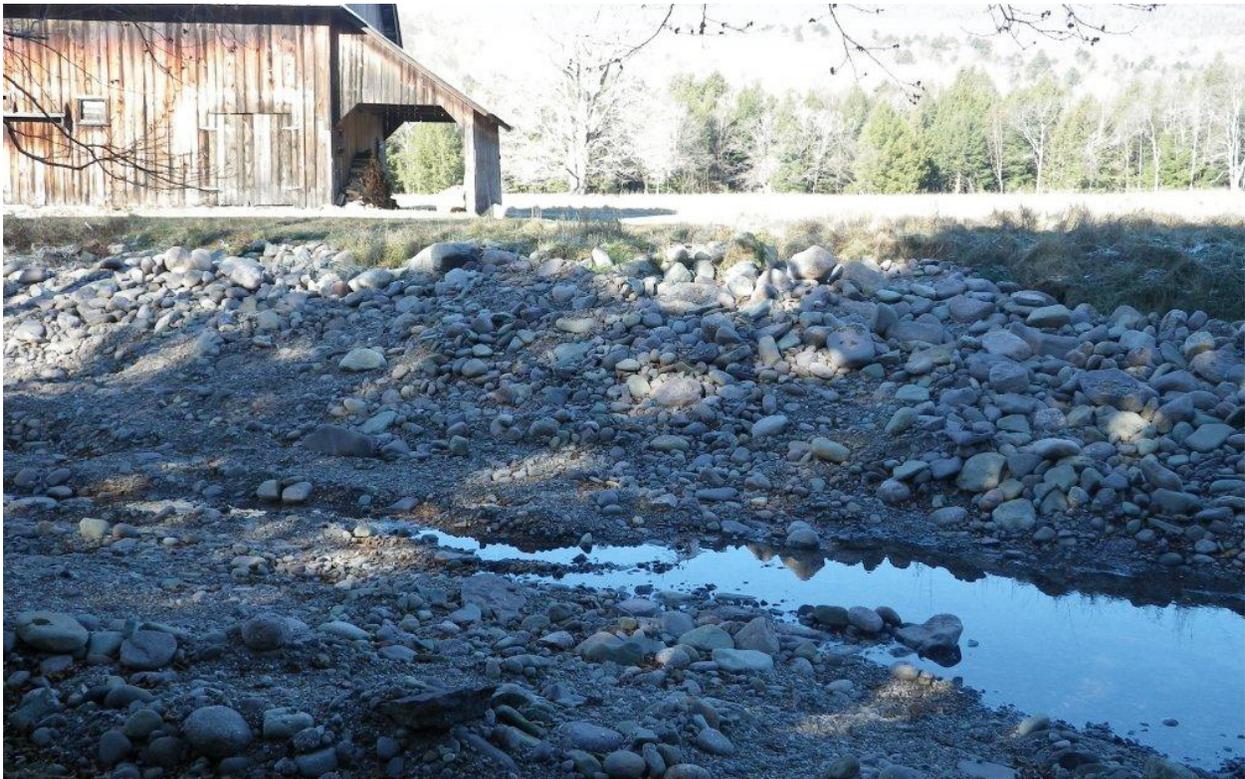
The downstream end of this management unit is an area characterized by channel divergences and braiding caused by the accumulation of large woody debris. While the debris jams shifted during flood events, the braided character of the floodplain remains intact. However, the sidecast berm now blocks flow to several channels, including the furthest right channel. This channel, which extends into Management Unit 13, is adjacent to open mowed fields on the right bank at Station 46930 in the mowed and maintained Alexander Tison Preserve.

*Mowed and maintained fields at Tison Preserve.
(IMGP1510)*

During the 2010 survey, hydraulic erosion was documented beginning at Station 46930 due to a lack of woody vegetation to provide adequate root structure and stability to the stream bank under high flows (BEMS NEB14_46900). While this bank erosion has been partially covered with cobbles since the flood events, a riparian buffer would improve stability of this bank during future high flow events. Recommendations for this bank erosion site minimally include *assisted restoration* with riparian planting techniques to restore the forest connectivity and stabilize the bank. This riparian buffer restoration could occur in conjunction with the *full restoration* recommended above.

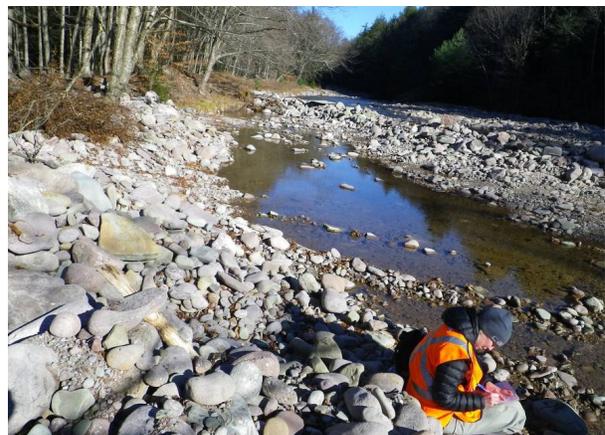
*Side channel along left valley wall (facing upstream).
(IMGP1490)*

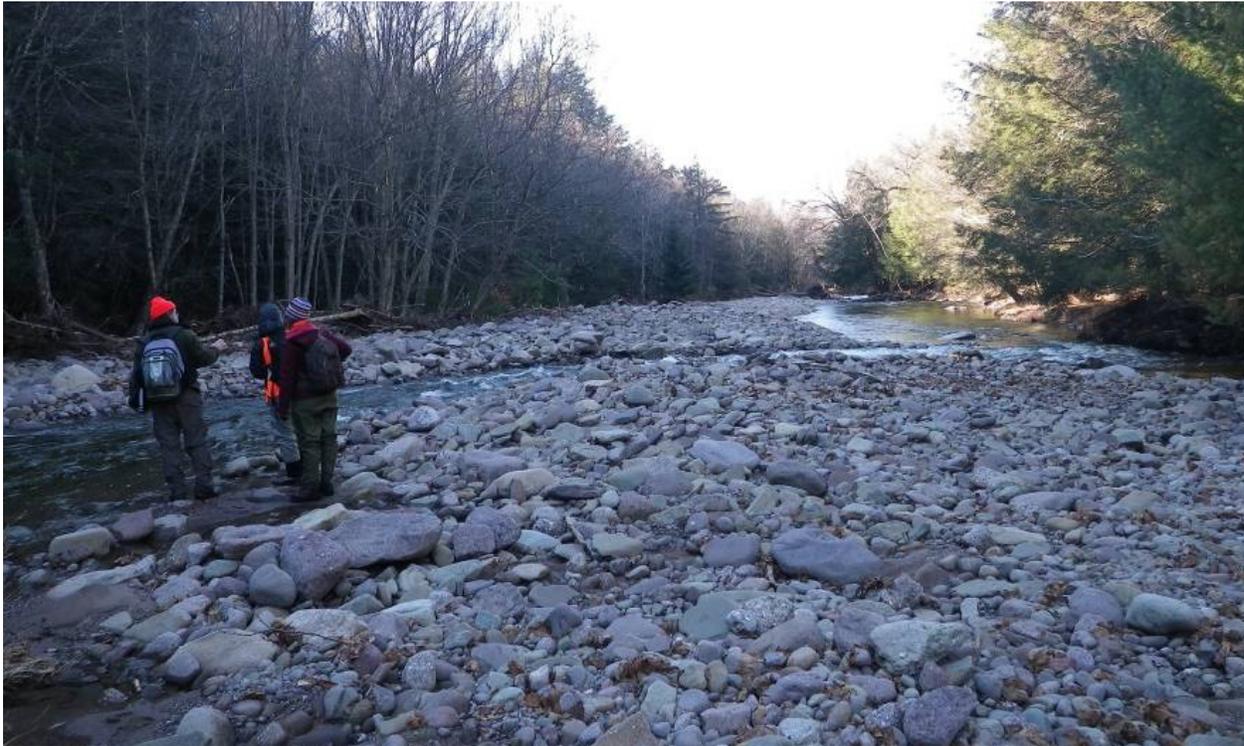
Continuing downstream on the main channel, an undersized excavated channel conveys flow through an area of sediment deposition from Station 47700 to Station 47450.

Undersized excavated channel through depositional area. (IMGP1503)

Full restoration is recommended for this site including removal of the berms and reconnection of the main channel, side channels and floodplain through Station 46200 in Management Unit 13. As constructed, the berms will not sustain successive high flows. They are instead likely to fail, creating unpredictable flooding and resetting of the channel planform alignment, thwarting the objectives of the emergency stream work, and re-establishing the threat to infrastructure downstream. The restoration effort could also include re-shaping of the channel downstream to establish a channel planform, longitudinal profile, and channel dimensions that will enable the stream to transport sediment effectively in future flood events. Post-September 18, 2012 update: Work was performed on this reach following TS Irene through the Emergency Watershed Protection program.
