# Neversink River East Branch

## MANAGEMENT UNIT 1

### Summary of Post-Flood Recommendations

### Stream Channel and Floodplain Current Conditions

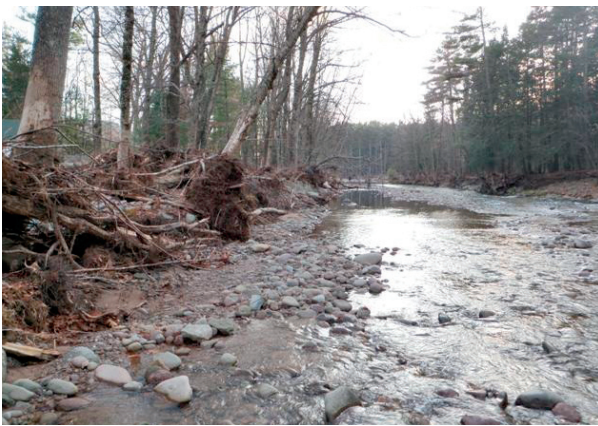
At Station 850 there was a v-shaped timber dam that spanned the entire width of the stream channel that was destroyed in flooding since 2010. The dam was forcing a portion of the flow into a side channel in the left floodplain which is now blocked by woody debris conveyed downstream and lodged on the floodplain during recent high flow events.

*Woody debris and sidecast blocking the left floodplain.  
(P1010105)*

It is recommended that this entire MU be included in a comprehensive Local Flood Hazard Mitigation Analysis to investigate hydraulics and sediment transport in the stream corridor, from Station 10500 through the Halls Mills covered bridge on the mainstem of the Neversink River. The purpose of the analysis would be to develop options for reducing flooding threats to this relatively dense population center of the Neversink Valley.
