Neversink River East Branch

MANAGEMENT UNIT 2

Summary of Post-Flood Recommendations

Stream Channel and Floodplain Current Conditions

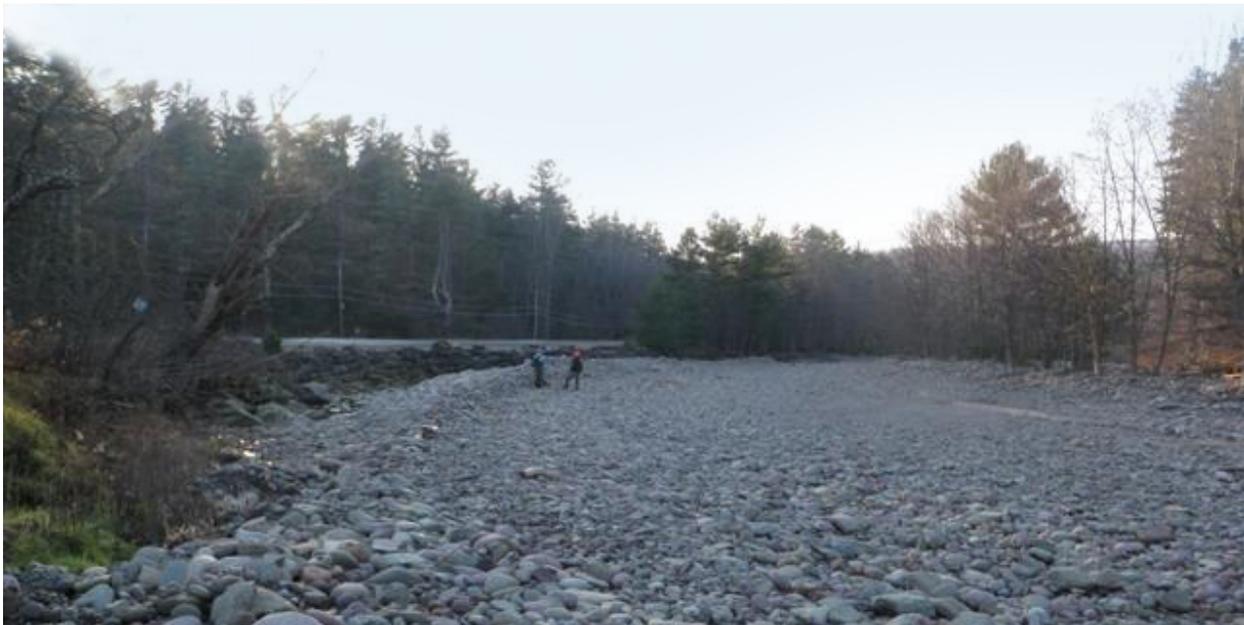
Immediately following TS Irene, the majority of the flow in the channel was diverted to the side channel through Station 3200 to facilitate emergency repair work to the rock wall. Repair was completed by Sullivan County DPW during spring 2012. The channel was in the process of being restored when the September 18 flow (~40-yr return probability) occurred, which again eroded the toe of the rock wall and undermined the placement. The wall was repaired in October 2012. While revetment is once again in good structural condition, inappropriate channel dimensions and ineffective sediment transport will continue to present both inundation and flood erosion hazard risk at this location. The installation of flow deflection structures at the rock wall, are recommended for this reach.

Stacked boulder revetment along left bank protecting road. (P1010081)

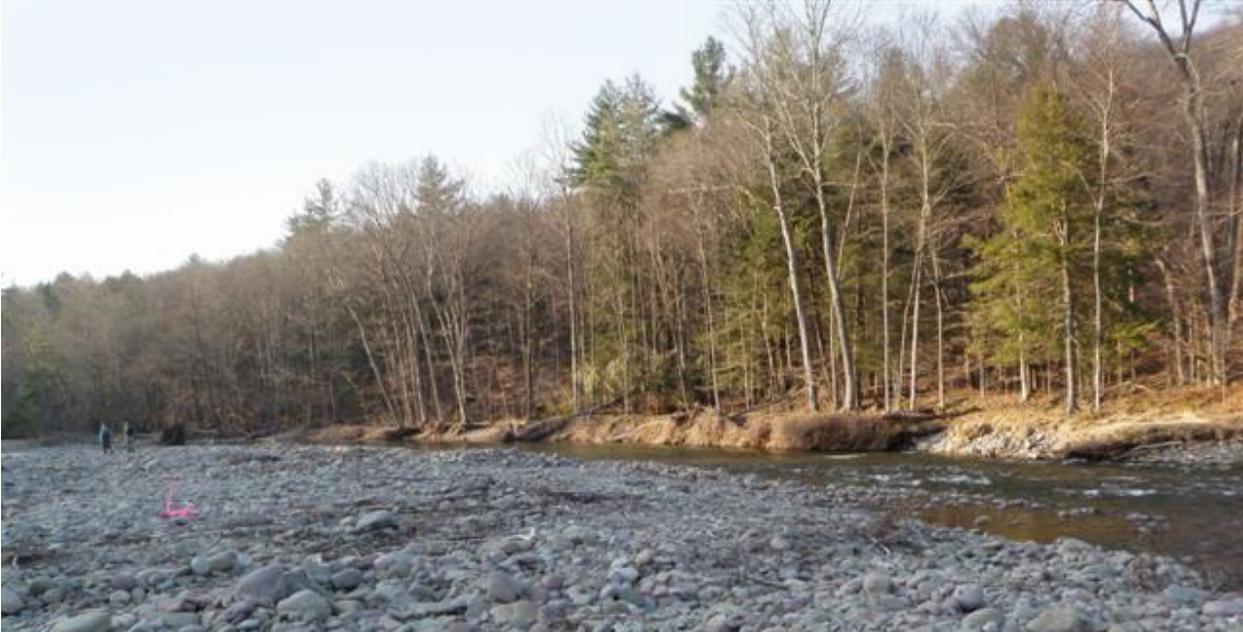
Downstream of the stacked rock wall, an eroding bank segment on the right bank extends 430-feet from Station 3150 to Station 2720 (BEMS ID # NEB2_2700). (See picture A476 on Page 9 for pre-flood condition) An over-widened channel and excessive floodplain connectivity on the left bank create ineffective sediment transport dynamics here, leading to significant deposition and an unstable channel pattern. This in turn is contributing to erosion at the toe of the right bank, which is exposing cobble sized alluvial material. The *full restoration* of the main channel through this stream reach could include use of *bioengineering* techniques to stabilize this slope.

Eroding bank segment on the right bank on the outside of a meander bend. (P1010090)

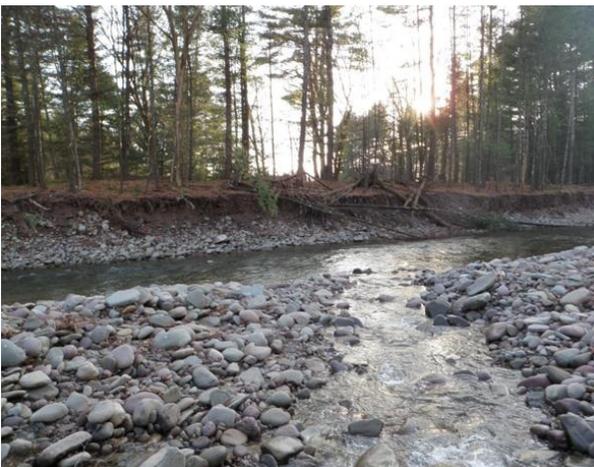
Continuing downstream, the channel again meanders slightly to the right and the resulting hydraulic pressure put on the left bank has caused erosion that was documented in both 2010 and after the flood events in December, 2011. This erosion site begins at Station 2600, continuing approximately 90-feet to Station 2510 (BEMS ID # NEB2_2500). (See picture B378 on Page 9 for additional detail) *Bioengineering techniques* to stabilize this bank should be incorporated into the restoration planning for this management unit.

Erosion along left bank. (P1010096)
