# Neversink River East Branch

## MANAGEMENT UNIT 4

### Summary of Post-Flood Recommendations

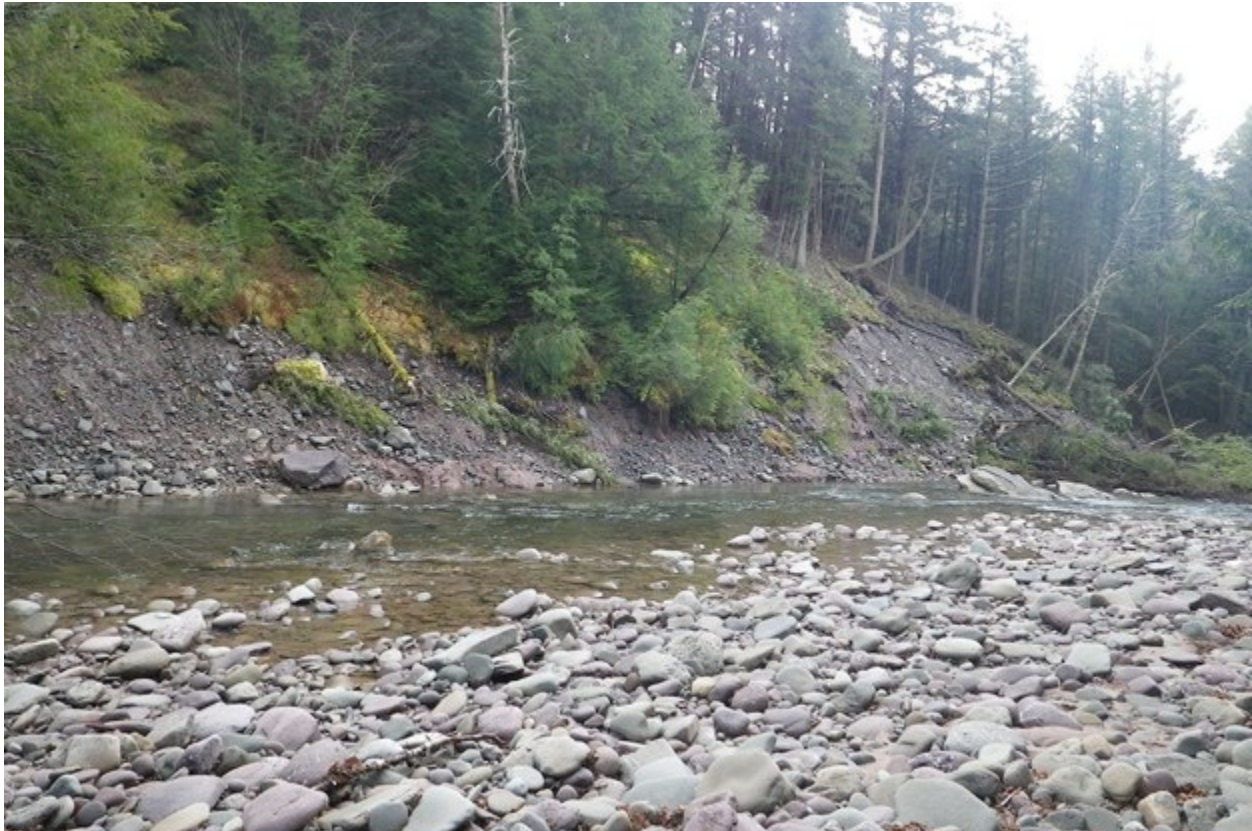
*Eroding bank segment on the left bank. (IMG1715)*

Prior to recent flooding, large boulders and sedges had accumulated at the toe of this slope so it was anticipated that this site would remain stable. However, hydraulic erosion due to high near-bank velocities during recent flood events has extended this eroding bank segment and led to slumping from high elevations on the slope. Therefore, *assisted restoration* is recommended for this site including installation of a bankfull stage bench at the toe of the slope and use of bioengineering techniques to stabilize the slope.
