# Neversink River East Branch

## MANAGEMENT UNIT 8

### Summary of Post-Flood Recommendations

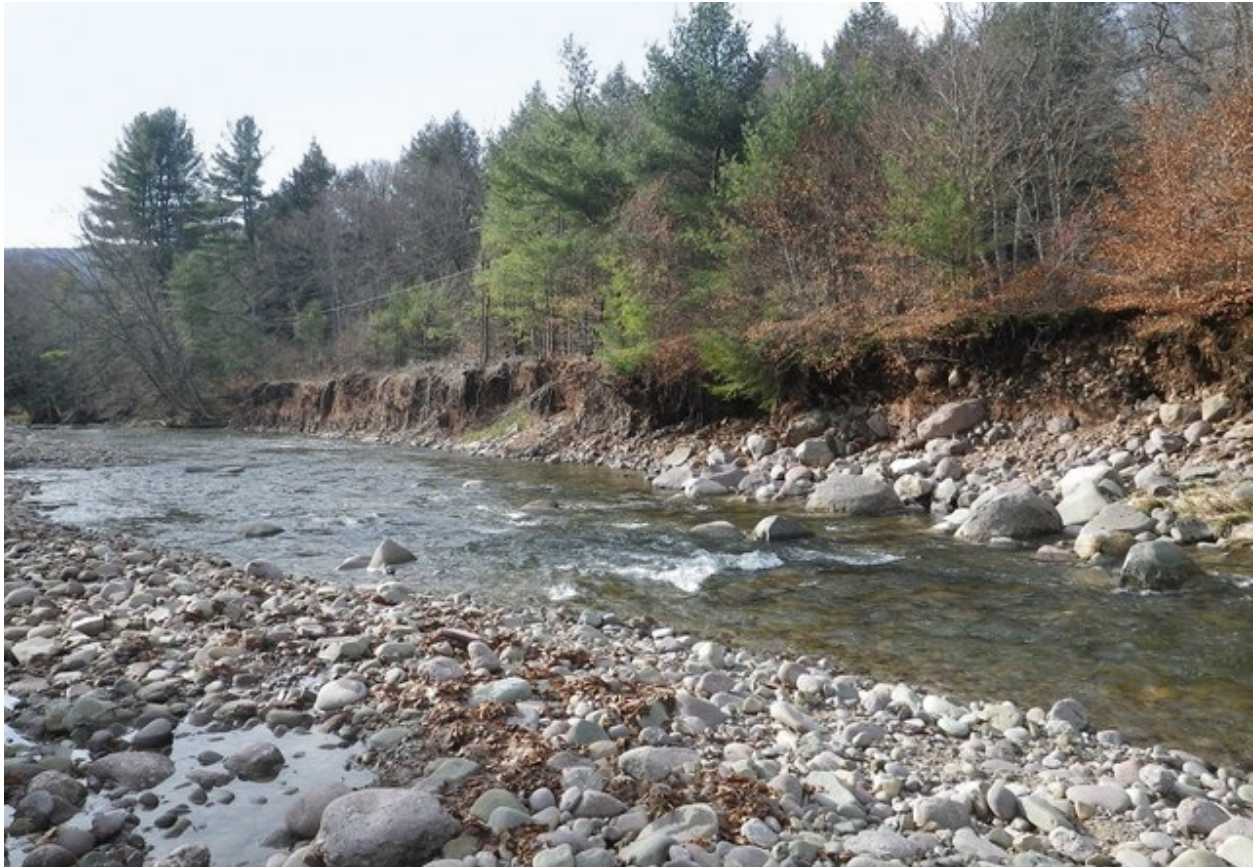
EBMU8 begins downstream of a convergence with a retention pond drainage channel. As the stream continues through the upstream end of this management unit, it meanders slightly to the right and flows up against the embankment of Denning Road on the right. The narrow riparian buffer between the road and the stream does not provide enough deeply rooted vegetation to adequately stabilize the stream bank under higher flows. As a result, hydraulic pressure during large events is causing approximately 167 feet of erosion on the right bank between Station 30700 and Station 30530 (BEMS NEB8\_30500). Since the recent high flow events this eroding bank segment has become more severely undercut, with fewer signs

*Eroding bank segment adjacent to Denning Road. (IMG1615)*

of self-stabilization. Due to the close proximity of Denning Road, assisted restoration is recommended for this site including using of bioengineering techniques and establishment of a riparian buffer to reduce near-bank velocities and shear stresses during future high flow events. A potential source of root wads for use in this restoration effort was document between Station 3200 and Station 30800 in Management Unit 9 upstream.
