Neversink River Main Branch

MANAGEMENT UNIT 10

MAIN BRANCH MANAGEMENT UNIT 10
BETWEEN STATION 1100 AND STATION 100

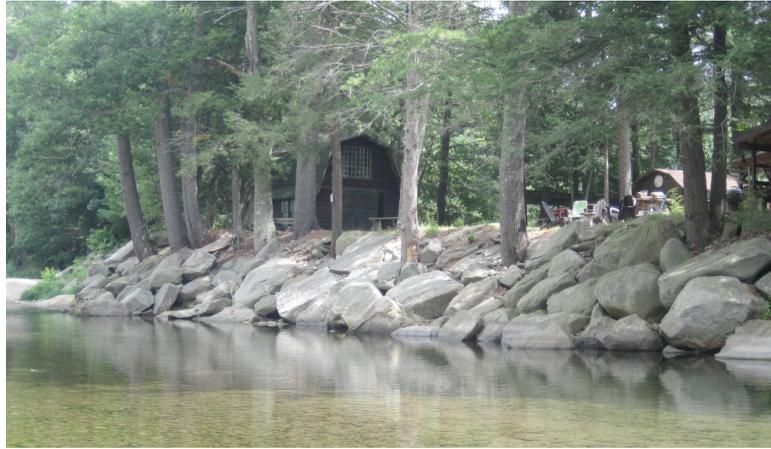
flood event. Depositional bars on both the right and left banks from Station 29800 to Station 29550 are variously sorted with sand, gravel and cobble. The bars feature scattered grass, sedge and shrub growth. Within this reach the right bank is a low vegetated terrace below the *bankfull* elevation. Several woody debris piles scattered throughout this terrace indicate that it is regularly flooded. The left bank is at a slightly higher elevation, and is developed with residential structures close to the edge of the bank, including four structures at least partially within the FEMA-mapped 100-year floodplain. The bank along these structures is revetted with large dumped or stacked rip-rap at the upstream end from Station 28900 to Station 28020 and is eroding at the unprotected downstream end. (B394, B400).

Looking upstream, large stacked revetment on left bank (B394)

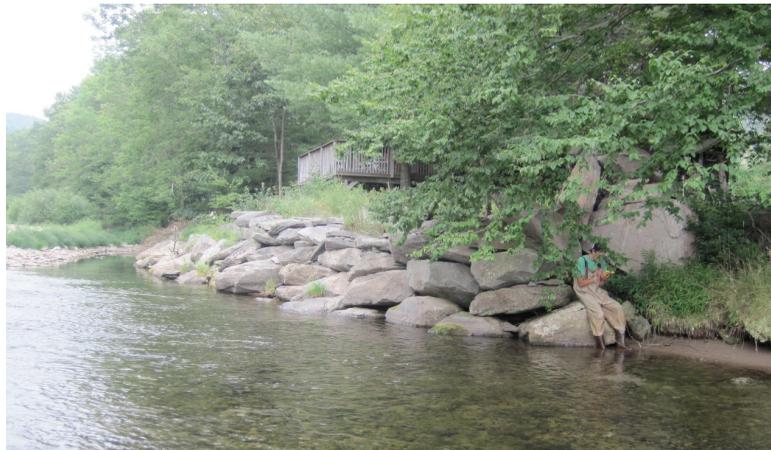
Erosion at downstream end of large revetment on left bank (B400)

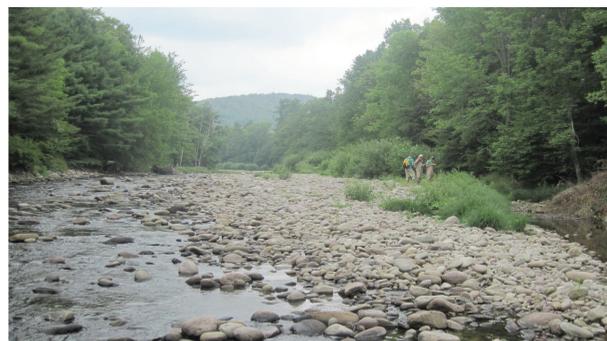
At the divergence a cobble center bar has formed in the main channel from Station 29300 to Station 29100 (B398). This *aggradation* is due to the loss of sediment transport capacity caused by the divergence of flows.

Looking downstream at large cobble center bar (B398)

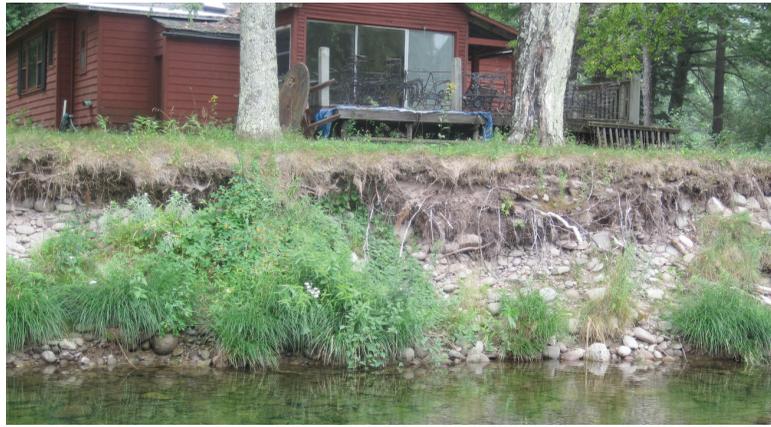
Proceeding downstream, the main channel bends to the right along a long point bar, with 254 ft. of erosion along the left bank, from Station 28080 to Station 28020. (B406) until it rejoins the right channel thread at the valley wall. At Station 27700, the right channel thread reconverges with the main channel, with significant deposition of sand, gravel and cobble. (A076, A080).

Erosion on left bank (B406)

BANK EROSION Due to a number of conditions in MBMU10, the stream banks within the management unit are at a relatively high risk of erosion. Two areas of erosion were documented during the stream feature inventory. The first, running 254 ft. along the left bank from Station 28080 to Station 28020, is the result of hydraulic erosion of the toe of the bank. *Assisted restoration* practices are recommended for this site. The second, 449 feet along the right bank from Station 27220 to Station 26680, is also caused by fluvial erosion of the toe; this bank was identified as a source of fine sediment. There is some evidence of reestablishment of sedges at the toe. *Passive restoration* is recommended for this site.

Recommendations for this reach of the Neversink River include assisted restoration of eroding and revetted bank as appropriate, and improvement of the riparian buffer. However, this reach is likely to require ongoing management due to the confluence at the upstream end and the divergence at the downstream end.

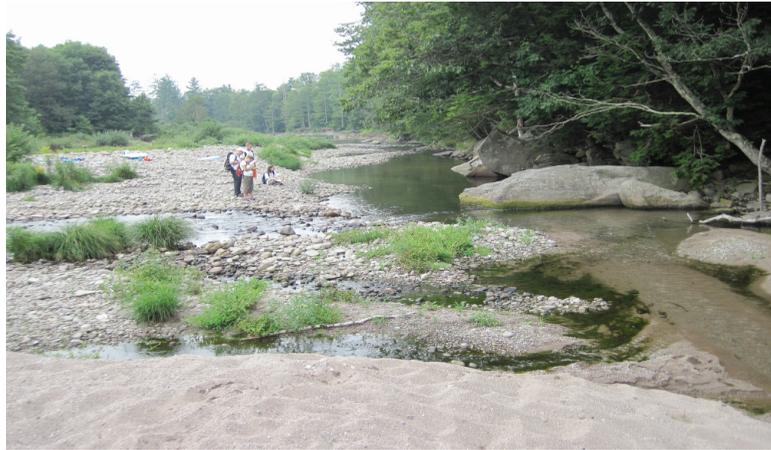
Downstream view of convergence (A076)

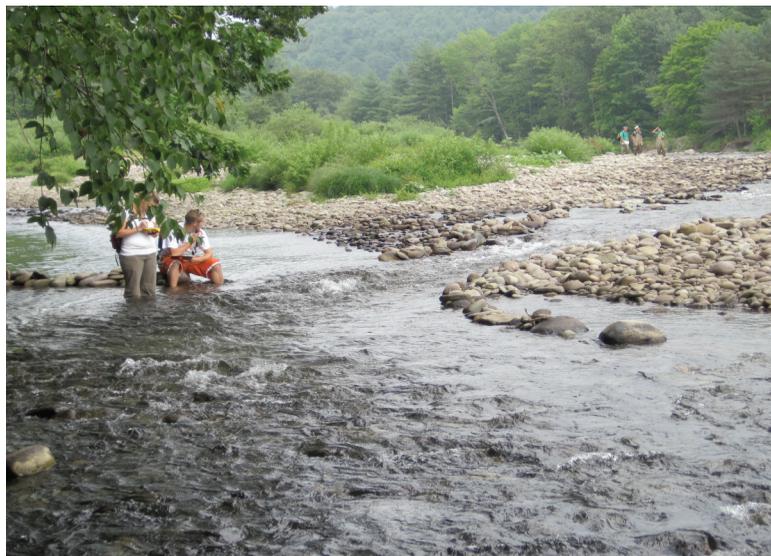
Looking upstream at convergence and cobble center bar (A080)

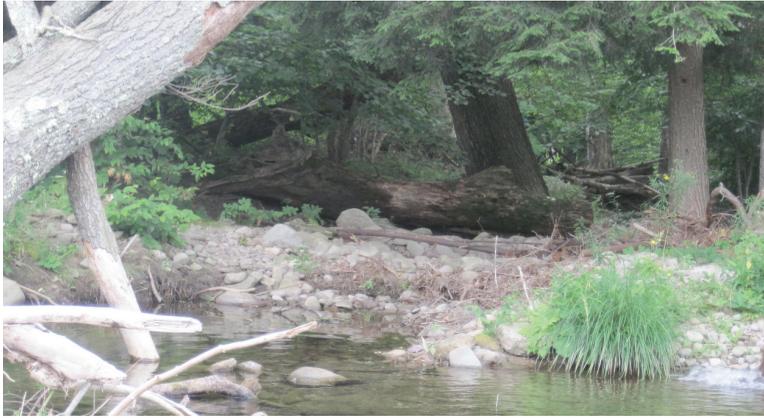
Downstream of the convergence the main channel begins a wide meander to the left. Upstream of this meander, a forested floodplain is formed on the left bank that features several flood chutes including two well-defined side channels. (B411) Across from the left bank floodplain on the

Side channels on left bank (B411)

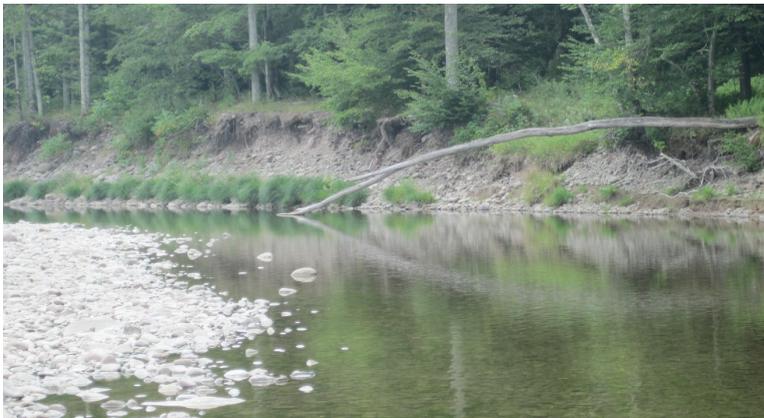
Erosion and fine sediment on right bank (A84)

outside of the meander bend 449 feet of the bank is eroding exposing alluvial materials, from Station 27220 to Station 26680. This bank was identified as a fine sediment source. Sedge has established at the toe of the eroding bank indicating that the bank is beginning to stabilize. However, this is not preventing entrainment of fine sediments higher on the bank slope. (A84) It is anticipated that this bank will revegetate and stabilize without treatment (passive restoration). However, it is recommended that this site be monitored for changes in condition.
