Neversink River Main Branch

MANAGEMENT UNIT 2

MAIN BRANCH MANAGEMENT UNIT 2
BETWEEN STATION 6300 AND STATION 3000

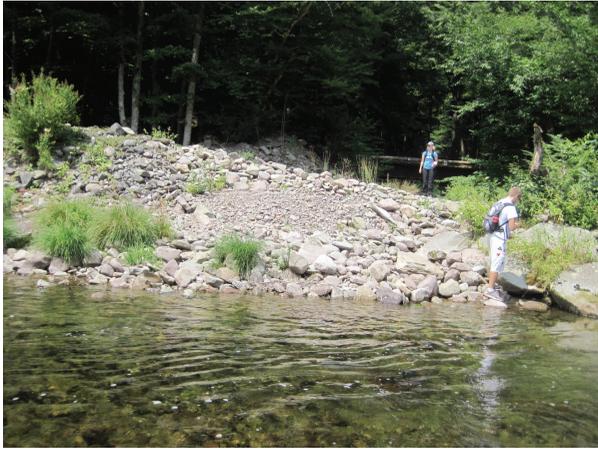
MBMU2 begins at the confluence of Dry Brook at Station 6300. The Dry Brook watershed is 0.77 square miles which includes 2 miles of stream channel. (A269). Directly downstream of the confluence a 280-foot long sloped stone revetment was observed from Station 6300 to Station 6020. This revetment was documented in good structural and functional condition, although some scour was observed behind

Dry Brook Confluence (A269)

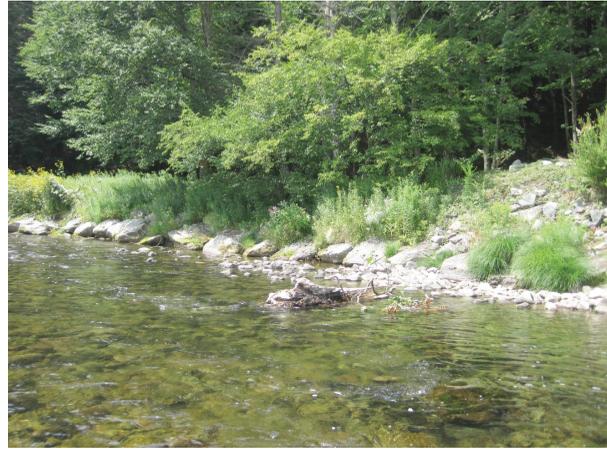
Sloped stone revetment on right bank (A270)

the revetment at the upstream and downstream ends. This revetment appears to protect the private road used to access the cabins on the stream bank upstream of the Dry Brook confluence. (A270)

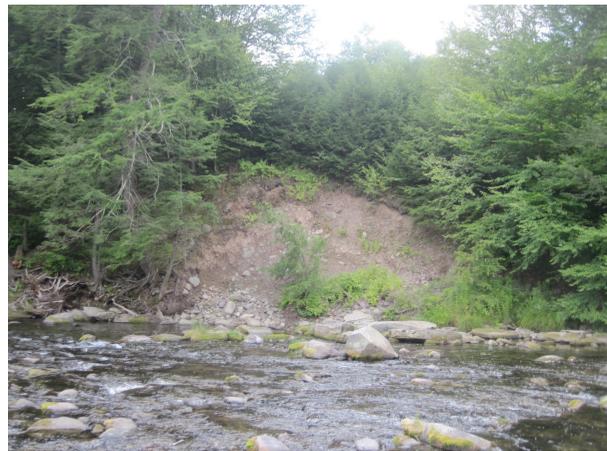
Approximately 150 feet downstream of the revetment, at the apex of the meander on the right bank, a 22-foot eroding bank segment was observed from Station 5840 to 5860 (BEMS NMB2_5840). The bank failure was documented as 25 feet high caused by hydraulic erosion, specifically fluvial entrainment, which exposed alluvial materials. (A272) A more detailed stability assessment including identification of possible drainage issues from the private road upslope is recommended.

Right bank failure (A272)

It is anticipated that the last two of these eroding bank segments will revegetate and stabilize without treatment (*passive restoration*). A more detailed stability assessment including identification of possible drainage issues from the private road upslope is recommended for the first site. It is also recommended that all three sites be monitored for changes in condition.

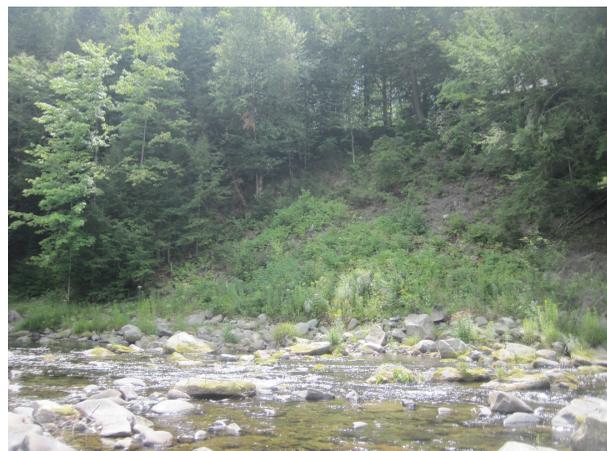
Another 100 feet downstream on the right bank, from Station 5700 to Station 5628 (BEMS NMB2_5600) a second eroding bank segment was observed with similar characteristics. Although it was slightly larger at 35 feet high and 72 feet long, it was also caused by hydraulic erosion perpetuated by fluvial entrainment exposing alluvial materials. Vegetation and large boulders were contributing to hardening at the toe and woody vegetation was observed from the toe all the way to the crown of the bank failure. (A275)

Hydraulic erosion on right bank with hardening at toe (A275)

There is a structure located on the crown of this bank failure within the 100-year floodplain. It is anticipated that this bank will revegetate and stabilize without treatment (*passive restoration*), however, it is recommended that this site be monitored for changes in condition.

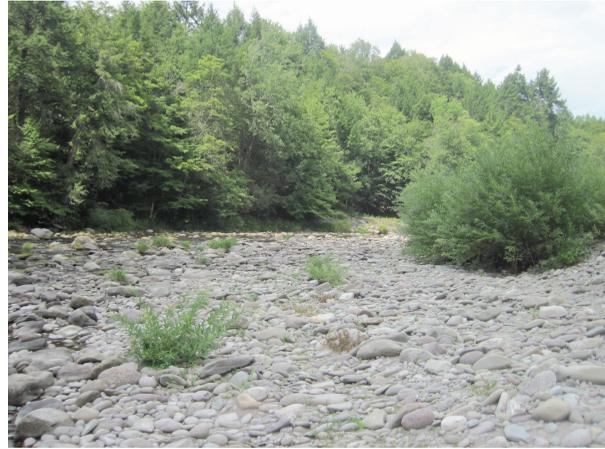
While the outside of the meander bend has occasional bank failures and revetment to protect the bank from erosion through this segment of the mainstem, the inside of the meander is formed by a vegetated cobble point bar which is separated from a forested floodplain by a well-defined flood chute. (A276) At Station 5400 the side channel that diverged at Station 6600 in MBMU3 re-joins the main channel. (B538)

Cobble point bar and flood chute (A276)

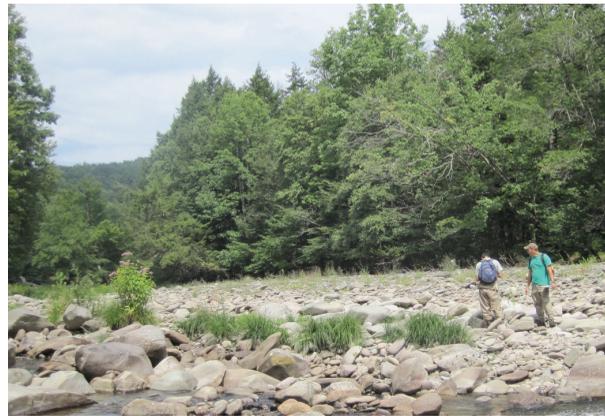
Convergence of side channel (B538)

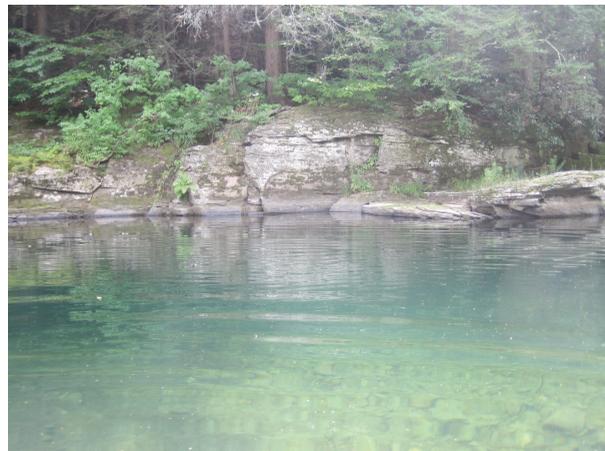
From Station 5400 to Station 5100 (300 feet downstream of the convergence) there is a rock riffle leading up to the apex of the final meander in the S-curve where the main channel forms a deep scour pool against exposed bedrock of the left valley wall from Station 5000 to Station 4700. (A280) This pool is called the Big Bend Pool and is known as a very productive and popular fishing spot. The inside of this narrow meander is formed by a depositional point bar with material size beginning as cobbles but eventually converting to a sandy beach at the downstream extent, likely due to additional sedimentation allowed by lower velocities in the large pool. (A278, A279) At Station 4970 a small intermittent tributary joins the main channel from the left valley wall at the upstream end of the Big Bend Pool.

Big Bend Pool, scour pool against left valley wall bedrock (A280)

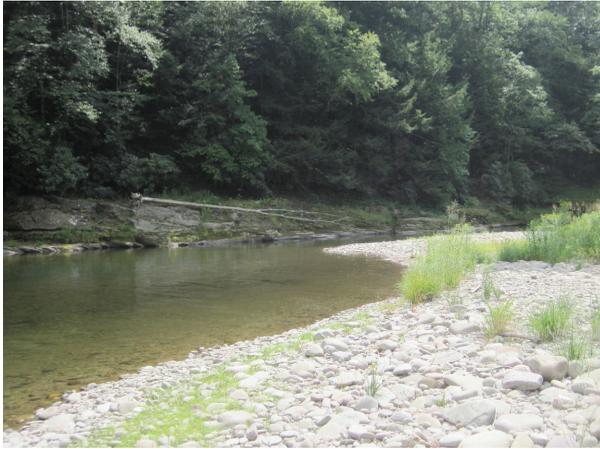
Upstream start of point bar, cobble composition (A278)

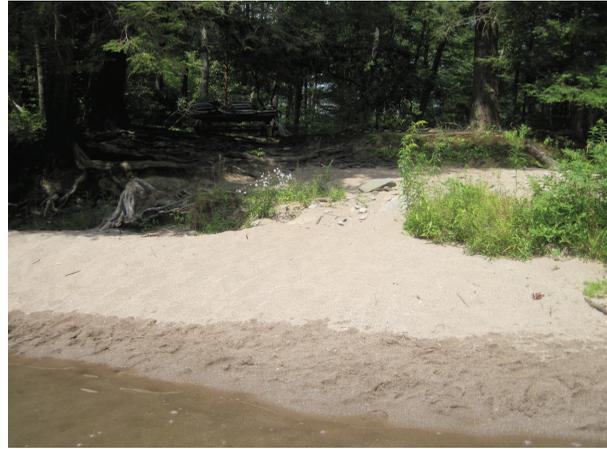
Downstream end of point bar, sand composition (A279)

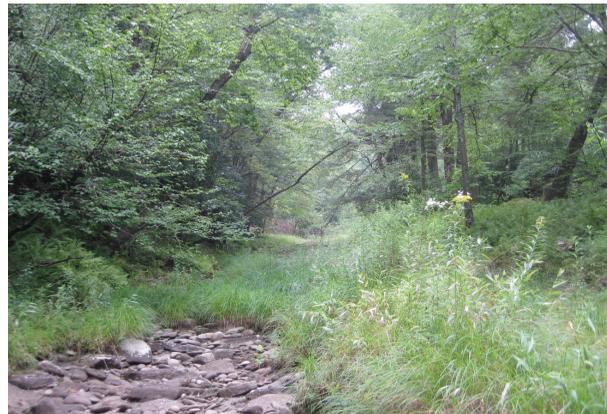
channel diverges into the forested floodplain on the right bank. Although the channel was dry during the stream inventory, it appears to convey flow during high flow events as evidenced by some bank scour and debris patterns along the cobble channel bed. (A284) This side channel rejoins the main channel at Station 3400 behind a vegetated cobble bar.

Divergence with side channel at right bank (A284)

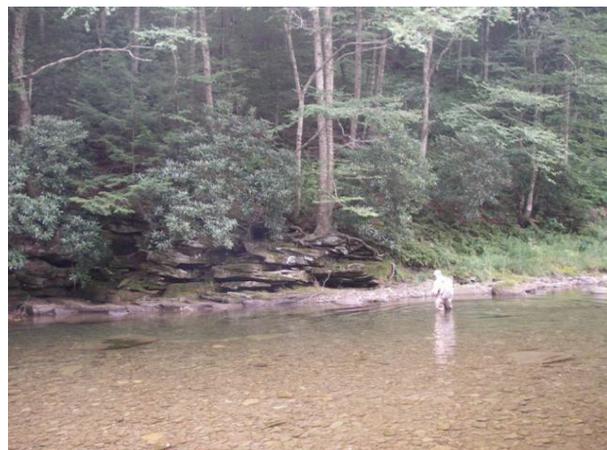
The main channel flows along the left valley wall with exposed bedrock providing lateral control for approximately 500 feet from Station 4260 to Station 3760. (B277) This reach is a sediment storage reach as evidenced by aggradation of depositional bars with a transverse bar and *head cut* migrating upstream observed at Station 3900. (B275)

Exposed bedrock on left valley wall (B277)

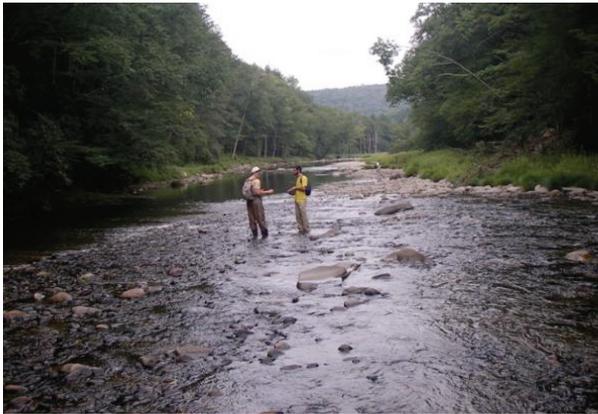
Transverse bar and headcut migrating upstream (B275)

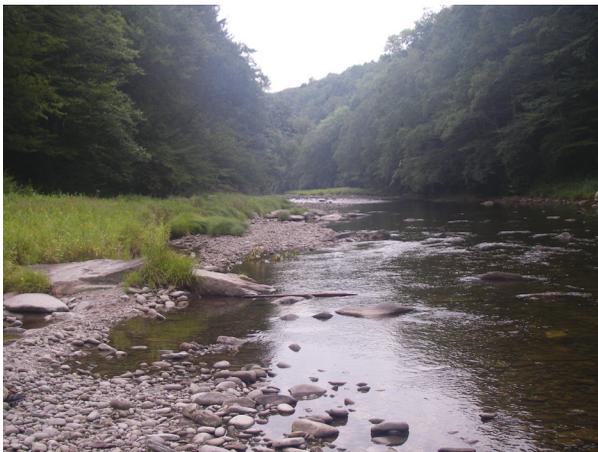
Scour pool downstream of headcut (B280)

structure. (B280) Another grade control structure was observed 120 feet downstream at Station 3420. This structure is constructed of boulders and extends 29 feet into the channel angled upstream. It was documented as in good structural condition. There is a scour pool immediately downstream of this structure followed by a vegetated depositional side bar. (A289) The final structure is log cribbing embedded in the stream bed at Station 3200 which was documented in poor structural condition. (A294) The functional condition of these three structures cannot be assessed as their purpose and maintenance history remain unclear. Given the history of this section of the river as a fishing destination, it is likely that these control structures were designed to improve or enhance fish habitat, and likely contributed to sediment deposition in this reach. There is a residential structure on the right bank near Station 3300 that appears to be within the 100-year floodplain; the structure may also have been designed to encourage deposition and protect the nearby bank, on which the residence is located, from erosion.

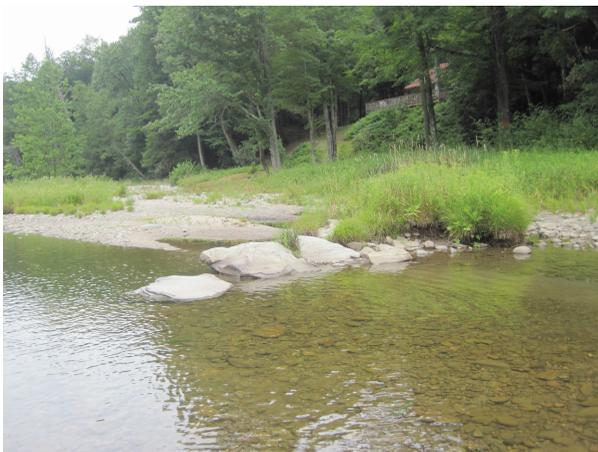
Downstream of the convergence of the side channel a series of grade control structures was observed extending from the right bank. The first is a boulder grade control observed at Station 3500 extending approximately 47 feet at a right angle from the right bank. This structure was documented as in good structural condition. A scour pool has formed downstream of the control

Boulder grade control (A289)

Features like these control structures were observed frequently on the main branch of the Neversink River. It is recommended that the history and original objectives of these features be investigated to better understand their current function and ongoing hydraulic effects. Long term monitoring of the structures is also recommended.

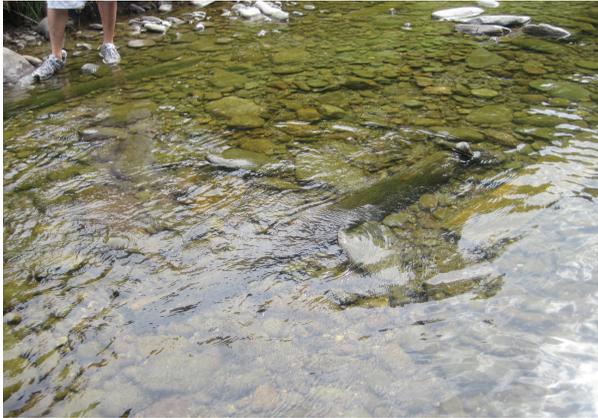
Log cribbing embedded in stream (A294)

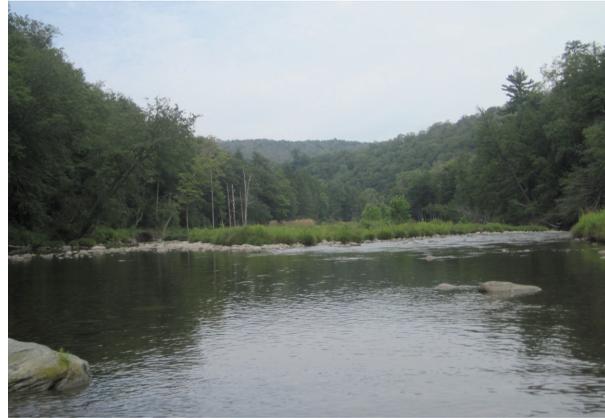
Divergence around cobble center bar (A293)

The final feature observed in MBMU2 is a divergence at Station 3100 around a cobble center bar vegetated with grass and sedge (A293). MBMU2 ends 100 feet downstream of this divergence at Station 3000.
