Neversink River Main Branch

MANAGEMENT UNIT 6

MAIN BRANCH MANAGEMENT UNIT 6
BETWEEN STATION 17200 AND STATION 14800

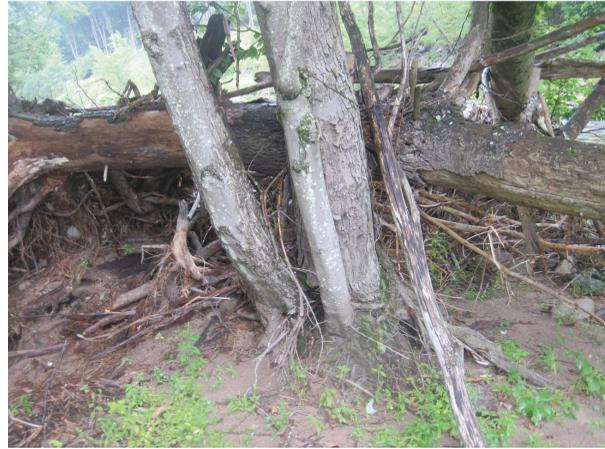
A depositional point bar also begins on the right bank at this location forming the inside of a meander bend. The point bar is vegetated with grass, sedge and willows which were documented as a potential plant source for future restoration projects in the watershed. (A188) Slightly downstream at Station 16680 an accumulation of woody debris was observed on the left bank as well as the divergence of a side channel with significant flow into the left floodplain. This is one of the several divergences into this floodplain, providing evidence that the floodplain features many braided flood chutes and is likely inundated during flood events.

Woody debris jam on left bank at divergence with side channel (A188)

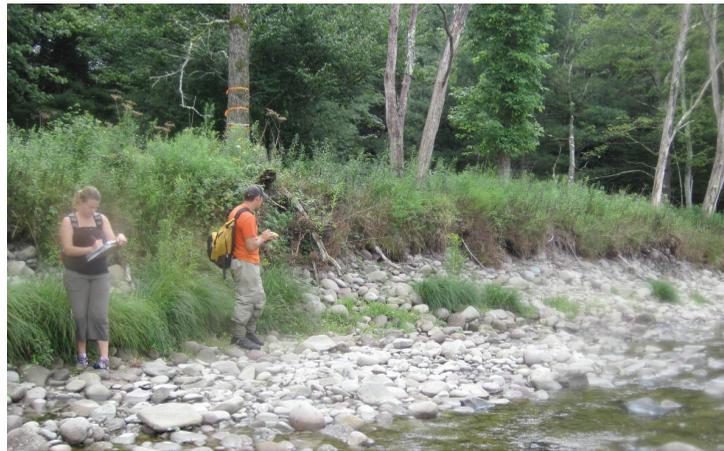
Approximately 100 feet downstream of the woody debris a 340-foot long segment of bank erosion was observed on the left bank from Station 16540 to Station 16200 (BEMS NMB6_16200) Sedge has established at the toe of the eroding bank indicating that the bank is beginning to stabilize. (B488) The riparian corridor is well-vegetated in this location, therefore it is anticipated that this bank will revegetate and stabilize without treatment (passive restoration). It is recommended that this site be monitored for changes in condition. In addition, there is some undercutting of the vegetated left bank apex of the meander bend evidenced by a downed tree at Station 16020. (B490)

Stabalizing left bank (B488)

Intervention Level	Passive Restoration of the left bank erosion site (BEMS NMB6_16200). Recommended Assisted Restoration via bioengineering of the right bank erosion site (BEMS NM6_15400).
Stream Morphology	Conduct baseline survey of channel morphology. Conduct assessment channel evolution at gauge.
Riparian Vegetation	Riparian buffer vegetation improvement as appropriate.
Infrastructure	Assess culverts conveying flow from side channels and tributaries under Hunter Road for possible upgrade.
Aquatic Habitat	Fish population and habitat survey.
Flood Related Threats	Assess threats to structures in 100-year floodplain of unnamed tributary.
Water Quality	Restore and monitor BEMS sites.
Further Assessment	Include MU6 in comprehensive Local Flood Hazard Mitigation Analysis of Claryville MUs.

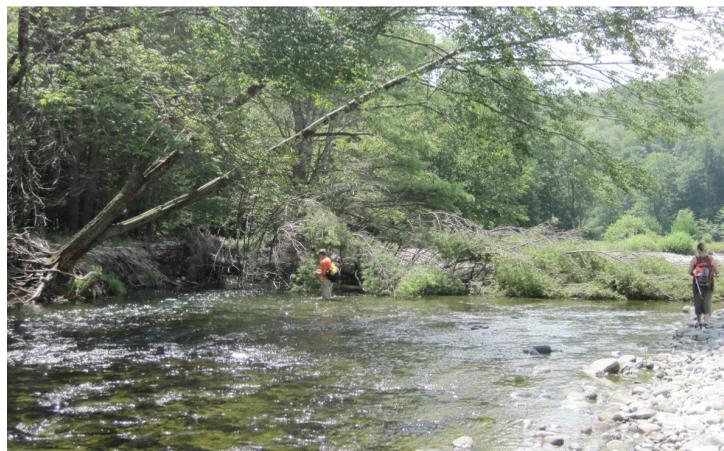
Undercutting of left bank and downed tree (B490)

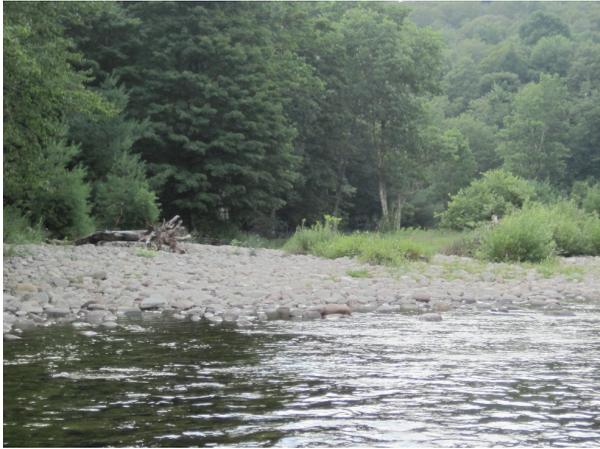
Cobble point bar on left bank (B491)

Directly downstream of the apex the main channel curves back to the right, and a vegetated cobble point bar begins on the left bank, extending from Station 15900 to Station 15200. This point bar is vegetated with trees and shrubs. (491) At the apex of this meander, documented near Station 15600, several unnamed tributaries join the main channel conveying drainage from Blue Hill and the side channel that diverged in MBMU8. (A190) The right bank of the main channel is revetted with dumped rock to protect a residence 60 feet upslope. This revetment which appears to be in poor functional condition may also be stabilizing the confluence of the main channel and the tributaries conveying drainage off Blue Hill (A191). FEMA Flood Insurance Rate Maps indicate that the 100-year flows from this tributary inundate adjacent residences along Hunter Road.

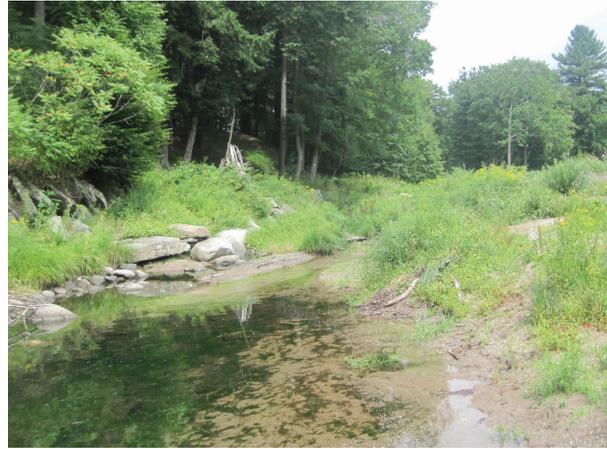
Upstream view of convergence of side channel (A190)

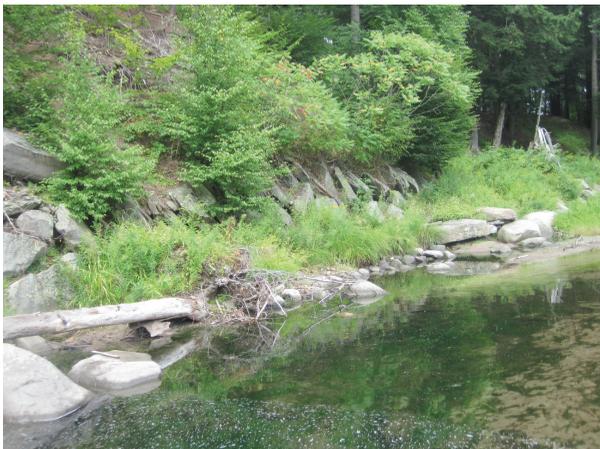
Dumped rock revetment on right bank (A191)

INFRASTRUCTURE Approximately 250 feet revetment was documented on the right bank downstream of the tributary confluence at Station 15600. This revetment was constructed with dumped or placed boulder rip-rap and was most likely designed to protect nearby residential property. Culvert conveying flow from side channels and tributaries under Hunter Road backwater during high flow conditions and should be assessed for possible upgrade. There were no berms documented in this Management Unit.

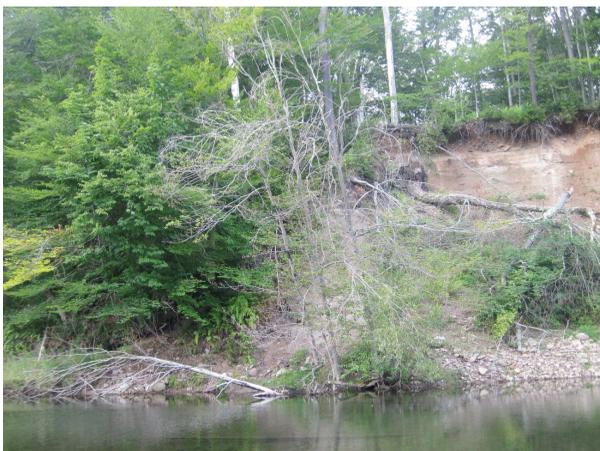
Hydraulic erosion on right bank exposing glacial outwash (A199)

Directly downstream of the tributary confluence erosion was observed on the right bank for 204 feet from Station 15604 to Station 15400 (BEMS NM6_15400). This erosion segment was documented as 45 feet high featuring hydraulic erosion via fluvial entrainment which has exposed glacial outwash. (A199)

Recommendations for this site include investigation of the tributaries conveying drainage off Blue Hill as well as the side channel in the right floodplain and the adequacy of all of the culverts conveying flow under Hunter Road and Blue Hill Road. Based on the geology observed in the eroding bank, it is likely that these tributaries have the potential to incise, which could have several impacts including further destabilization of the bank nearby, conveyance of additional fine sediment to the main channel, and aggravation of conditions leading to flood hazards for Hunter Road.

Although there is established vegetation providing some protection of the bank at the toe, continued entrainment of toe materials is likely during high flow events. Recommendations for this site include *assisted restoration* using *bioengineering* techniques to stabilize the eroding bank. The vegetation on the point bar beginning upstream at Station 16800 could be a plant source for this bank restoration effort.

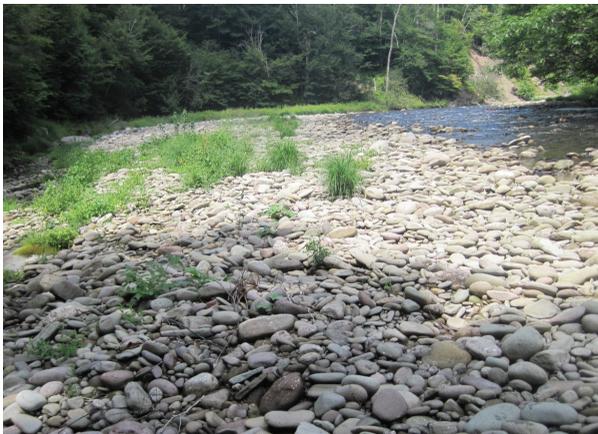
Around Station 15200 the channel is forced to the left by the right valley wall resulting in a depositional side bar along the right bank from Station 15300 to Station 15000 with some sedge vegetation (A208). There is a side channel between the bar and exposed bedrock interspersed with woody vegetation beginning at Station 15100. This bedrock provides control on both the stream bed and bank for 1,057 feet through the end of MBMU6, ending at Station 14050 in MBMU5. (A225) For this section of MBMU6, and into the first third of MBMU5 the river is semi-confined, indicating that while flow is constrained by the exposed bedrock on the right bank, the main channel is fairly well connected to the floodplain on the left bank. This is confirmed by the several flood chutes and debris piles on the left bank through out this segment of the river.

Depositional side bar on right bank (A208)

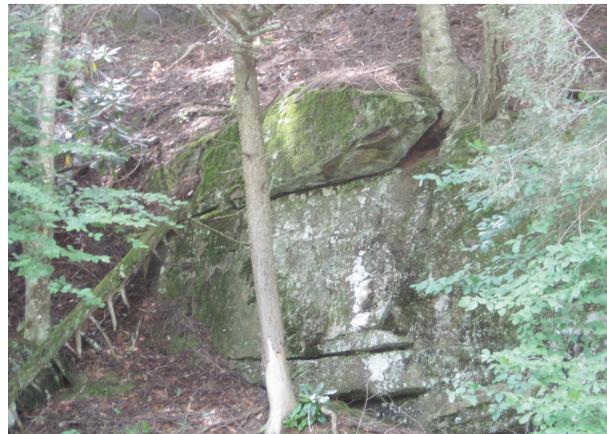
Bedrock on right bank (A225)
