Neversink River Main Branch

MANAGEMENT UNIT 9

Summary of Post-Flood Recommendations

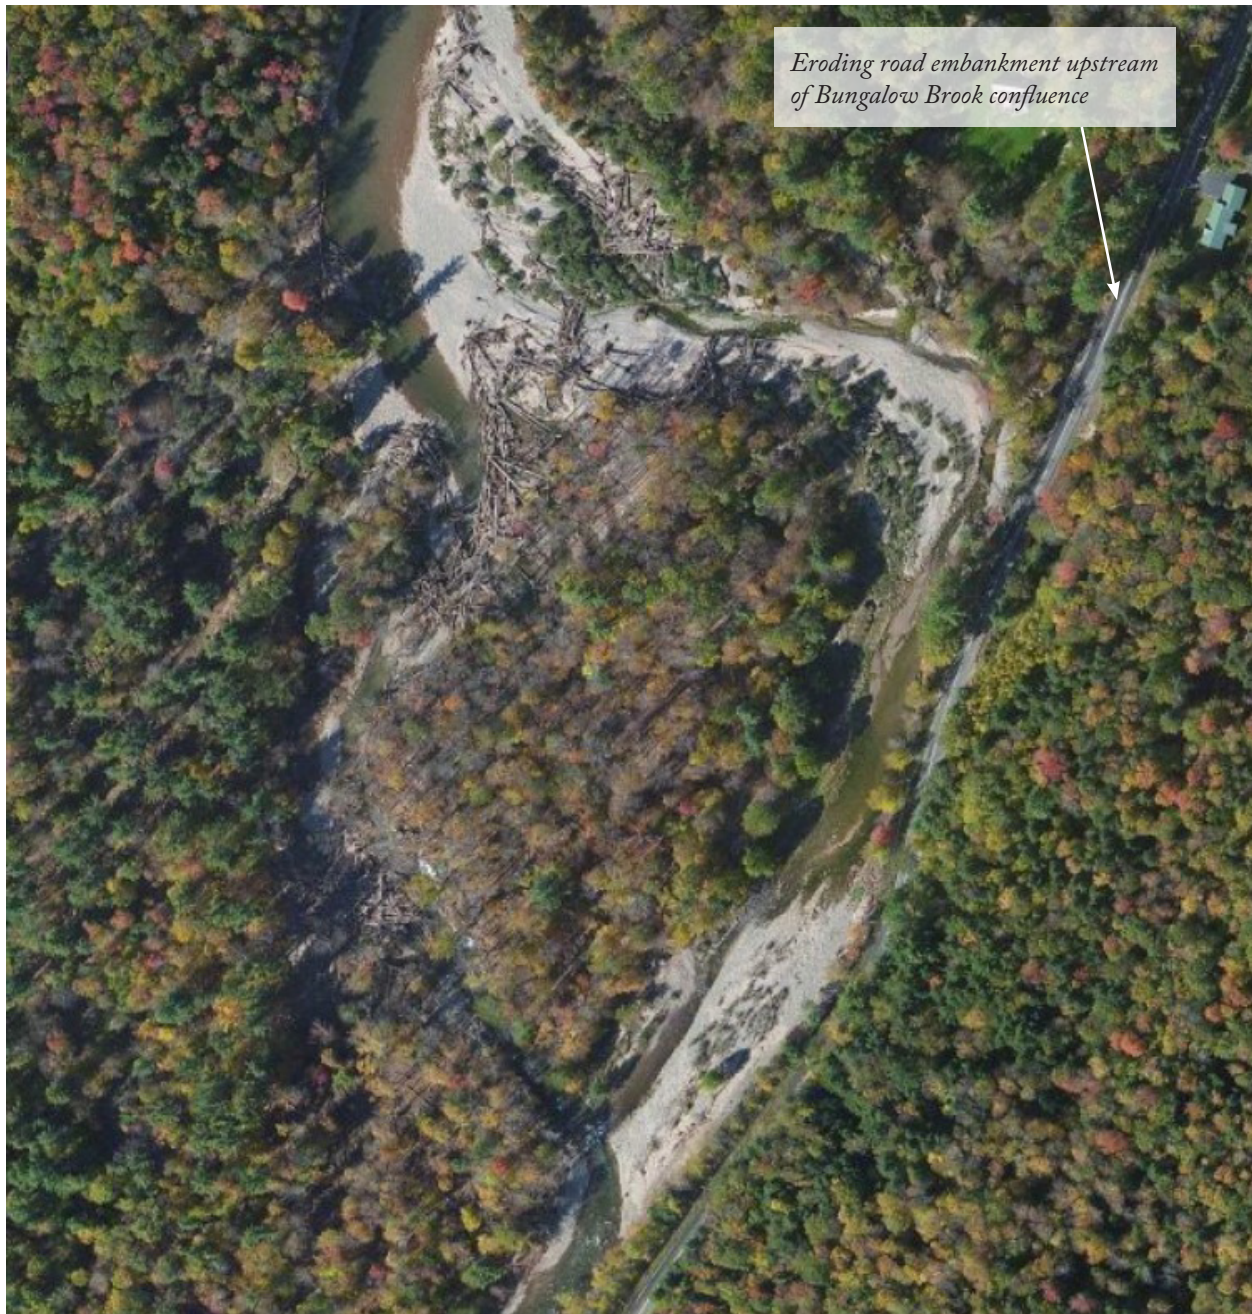
The accumulation of bedload and large woody debris at the outside of the meander at Station 26500 increased significantly following TS Irene. This aggradation is likely controlling the channel filling observed upstream, adjacent to Tannery Flats in MBMU10. Options for how to best manage this deposition should be evaluated as part of a comprehensive Local Flood Hazard Mitigation Analysis to investigate hydraulics and sediment transport in the stream corridor, from Station 10500 through the Halls Mills covered bridge downstream at Station 17350. The purpose of the analysis would be to develop a comprehensive solution for reducing flooding threats to this relatively dense population center of the Neversink Valley.

As a result of the accumulation of wood and bedload at Station 26500, the flood chute through the right floodplain became the primary channel, and bedload has accumulated in the left channel. What is now the primary channel on the right divides into multiple threads in the forested floodplain, most of it reemerging to join the left channel at Station 24400.

Eroding road embankment upstream of Bungalow Brook confluence

Accumulation of large woody debris diverts most of the flow through the floodplain

The severe floodplain chute channels, discussed in the Addendum for MBMU10, that eroded through the Tannery Flats reemerge around Station 25800, just upstream of the confluence of Bungalow Brook. Just upstream of this confluence, the embankment of County Road 19 as it runs adjacent to Bungalow Brook eroded significantly during TS Irene, probably exacerbated by sheet flow across the road and down the embankment, as the confinement of the valley wall on the left pinches any floodplain flow back into the mainstem of the Neversink. Many private crossings from the road into the flats are damaged when flooding overwhelms Bungalow Brook. It is recommended that an analysis of the volume of flow Bungalow Brook is currently carrying under different flood conditions be included in the comprehensive hydraulics analysis discussed above.

Intervention Level	Full Restoration
Stream Morphology	No change.
Riparian Vegetation	No change.
Infrastructure	No change.
Aquatic Habitat	No change.
Flood Related Threats	Address erosion of Cty Rd19 embankment along Bungalow Brook.
Water Quality	None.
Further Assessment	Include MBMU9 in comprehensive Local Flood Hazard Mitigation Analysis of Claryville MUs.

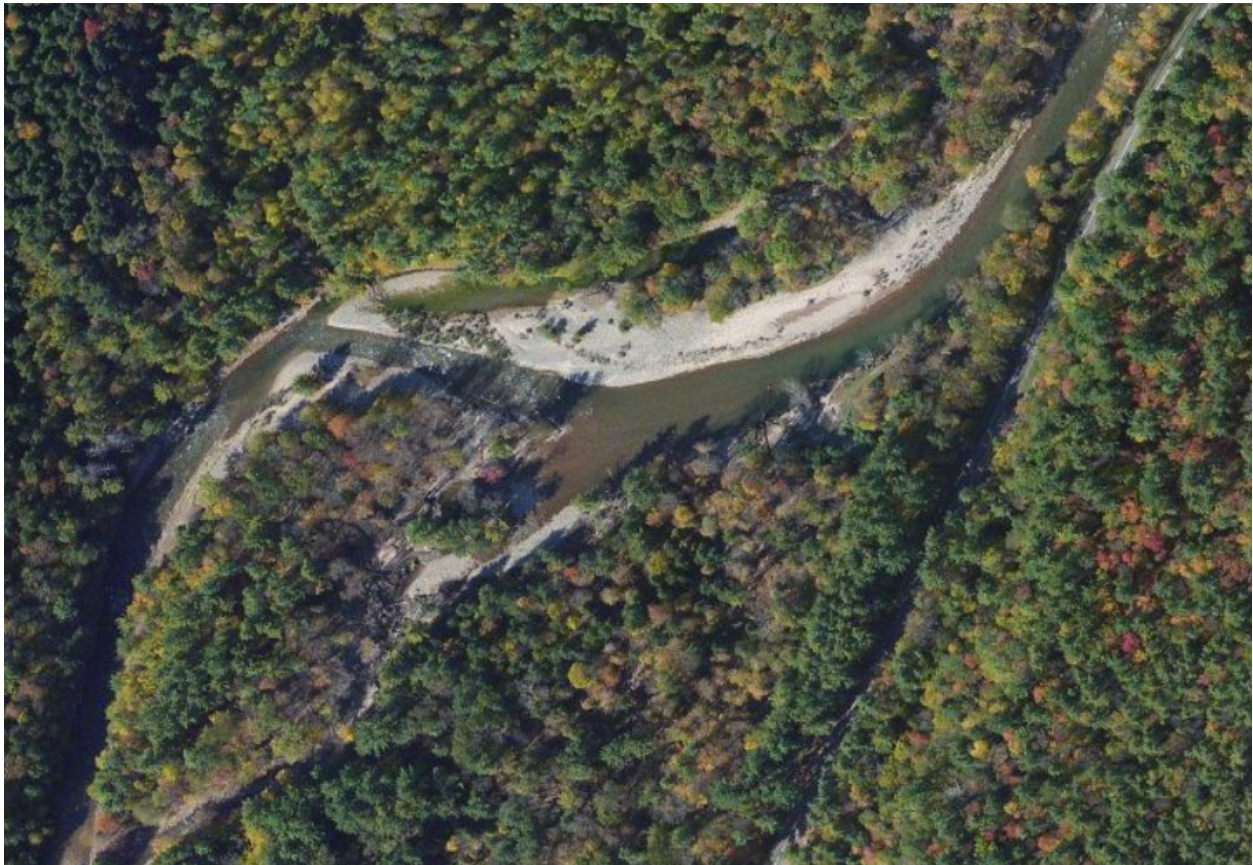
The flood chutes through the left floodplain starting at Station 23100 became more pronounced as a result of TS Irene, and currently take a much greater portion of the flow. However, no infrastructure or property threats were observed, and previous recommendations for preservation of these reaches as sediment storage areas remain unchanged, despite modest erosion of the till/outwash terrace on the left valley wall.

Flood chutes through the left floodplain enlarged following Irene.
