Neversink River West Branch

MANAGEMENT UNIT 10

WEST BRANCH MANAGEMENT UNIT 10
BETWEEN STATION 34300 AND STATION 40000

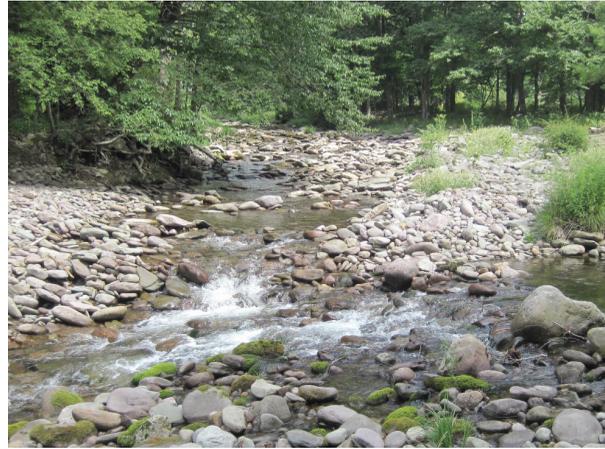
Confluence of Biscuit Creek and West Branch (B936)

WBMU10 begins at the confluence of Biscuit Creek near Station 40000 (*B936*). At the confluence with the West Branch of the Neversink Biscuit Creek has a drainage area of 9.5 square miles, conveying flow from both Pigeon Brook and Biscuit Creek which drain the slopes of Doubletop Mountain and Fir Mountain, respectively. Approximately 350 feet upstream of the convergence, Biscuit Creek flows under Frost Valley Road. Slightly downstream of the Frost Valley Road Bridge, a horse crossing through the creek and invasive Japanese barberry were observed. (*A673, A676*)

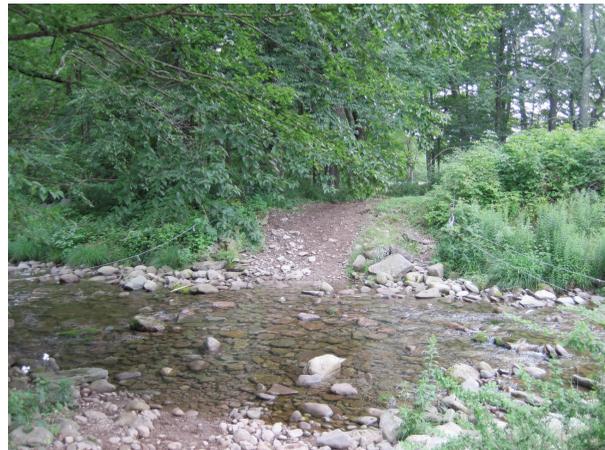
Horse crossing (A673)

Livestock grazing areas, like the horse pasture in the right floodplain of the Neversink River in this management unit, can be nonpoint sources of pollution as manure and urine are deposited directly into or near surface waters where leaching and runoff can transport nutrients and pathogens into the water. Areas like this crossing provide direct transport of these pollutants into Biscuit Creek and the Neversink River. It is recommended that an alternative method of river crossing be investigated in this situation to mitigate and prevent future water quality impairments from the horse pasture.

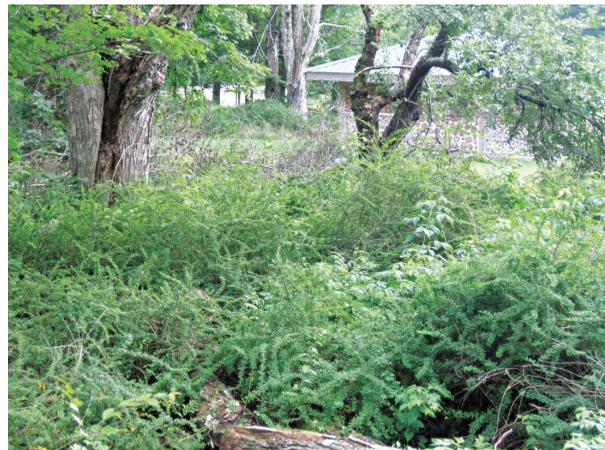
Japanese Barberry site (A676)

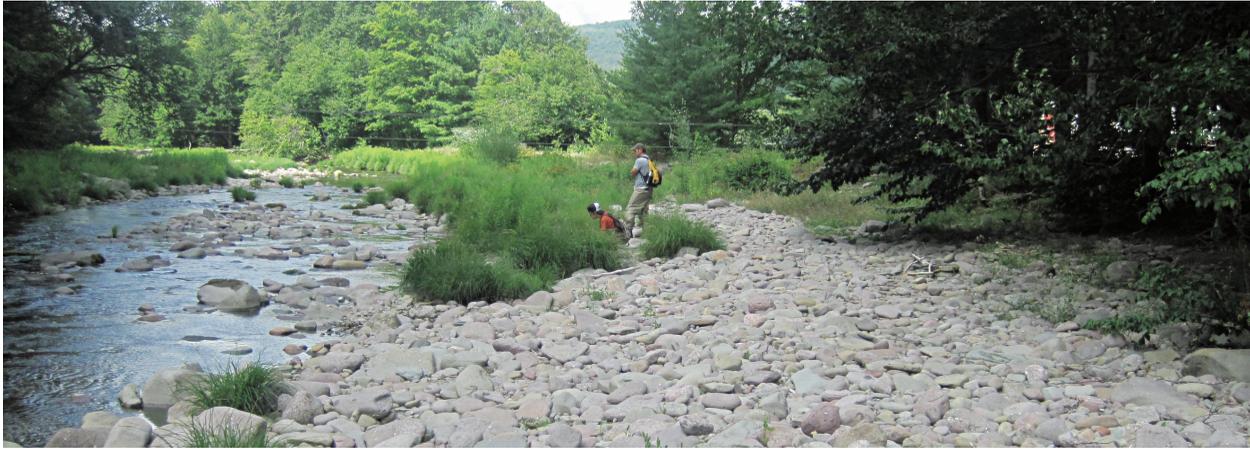
Cobble side bar on right bed (B904)

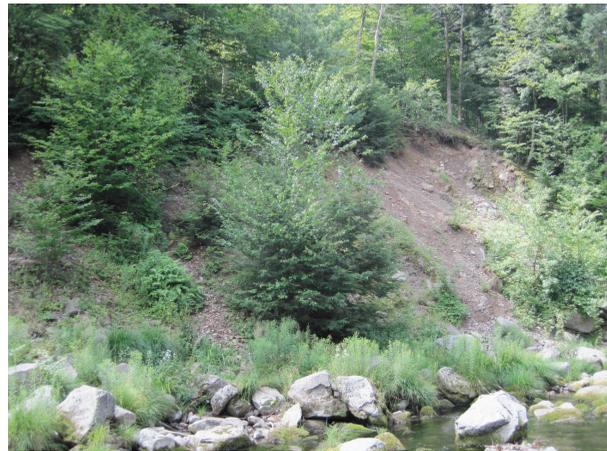
Re-vegetating hill slope failure (A1064)

Across from the depositional bar a mass failure was observed on the right bank extending approximately 100 feet from Station 39850 to Station 39750 (BEMS NWB10_39750). This site was documented as originally caused by a combination of surficial failure and hydraulic erosion, but no longer active as evidenced by thick woody vegetation growth on the slope of the failure. (A1064) It is likely that this bank will revegetate and stabilize without treatment (*passive restoration*). However, it is recommended that this site be monitored for changes in condition.

A mass failure was observed on the right bank extending approximately 100 feet from Station 39850 to Station 39750 (BEMS NWB10_39750). This site was documented as originally caused by a combination of surficial failure and hydraulic erosion, but no longer active as evidenced by thick woody vegetation growth on the slope of the failure.

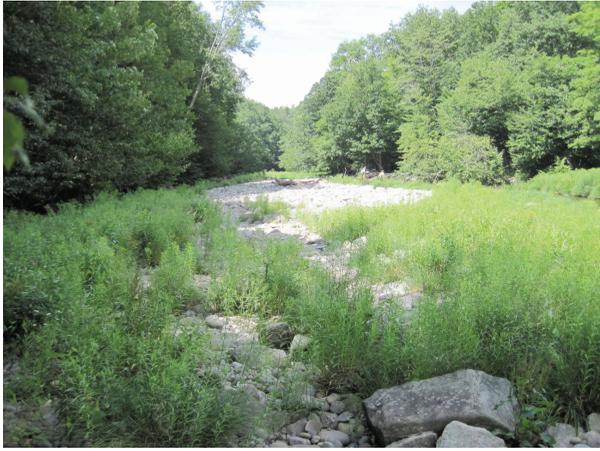
Depositional bar along right bank (A1070)

with no riparian vegetation, and extends 300 feet downstream. (A1070) A backwater channel was observed on the back side of the bar, which most likely conveys flow from the left valley wall to the main channel.

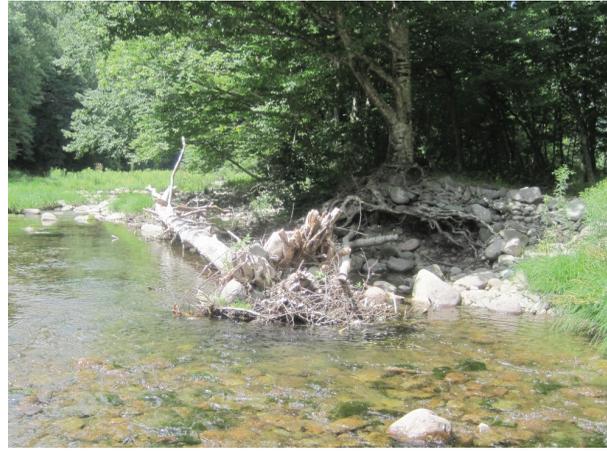
Hydraulic erosion with undercut root wads (B946)

Near the downstream extent of the depositional bar on the left bed, an active eroding bank segment was observed on the right bank extending 50 feet from Station 39300 to Station 39250 (BEMS NWB10_39250). The site was documented as caused by hydraulic erosion leading to scour with exposed alluvial materials and undercut root wads. Some leaning trees from the forested riparian buffer at the top of the bank were also observed.

(B946) While bank retreat can be expected in this area as the depositional bar on the left bed forces the main channel to migrate into this bank, the wide band of riparian forest between the main channel and the horse pasture will significantly slow erosion. Therefore, it is recommended that this bank be left to stabilize without treatment (*passive restoration*) and that the site be monitored for changes in condition.

An active eroding bank segment was observed on the right bank extending 50 feet from Station 39300 to Station 39250 (BEMS NWB10_39250). The site was documented as caused by hydraulic erosion leading to scour with exposed alluvial materials and undercut root wads. Some leaning trees from the forested riparian buffer at the top of the bank were also observed.

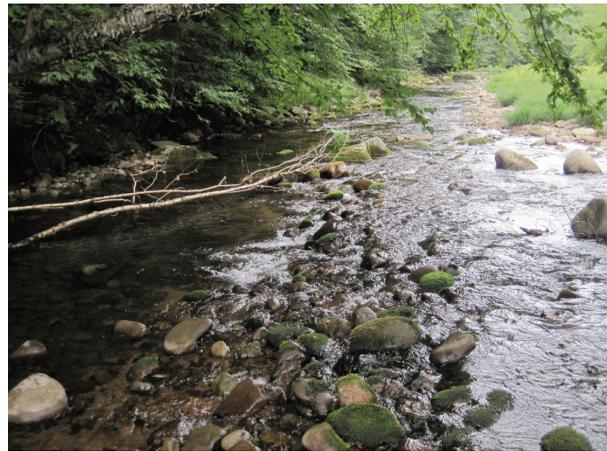
Transverse bar flowing towards left valley wall (A1078)

A transverse bar was observed extending across the cobble stream bed for approximately 100 feet near Station 39150 which forces flow toward the left valley wall. (A1078) Downstream of the transverse bar a depositional bar composed of cobble with some grass vegetation was observed on the right bank extending approximately 300 feet from Station 39100 to 38800. Behind the depositional bar a stone berm was observed on the the right bank extending 85 feet from Station 39150 to Station 39065. (B951) The berm appeared to be designed to protect a dirt road on the right bank. Near Station 38950 an intermittent tributary joins the main channel conveying runoff from the left valley wall.

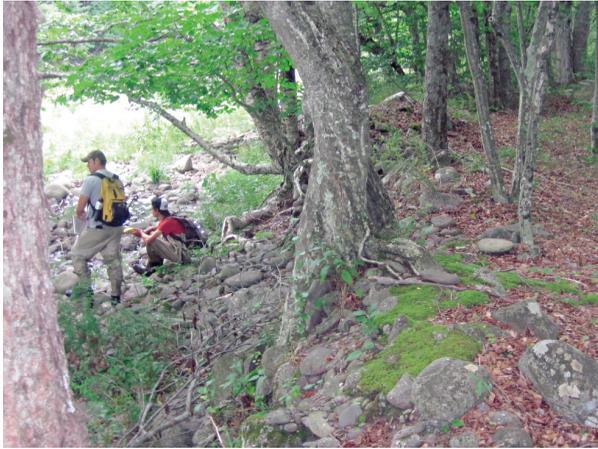
Stone berm on right bank (B951)

A stone berm was observed on the the right bank extending 85 feet from Station 39150 to Station 39065. The berm appeared to be designed to protect a dirt road on the right bank.

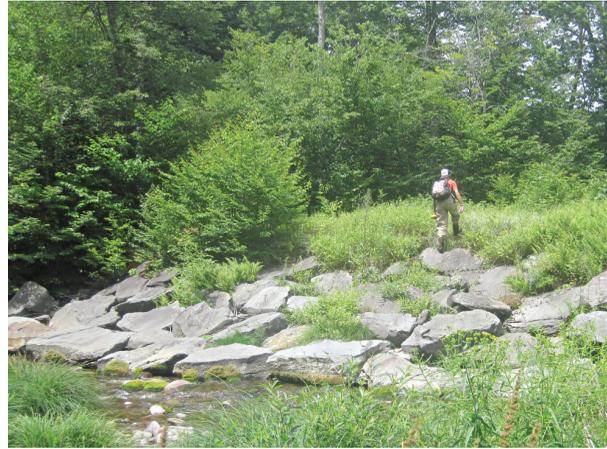
Sloped stone revetment (B959)

Water from the Neversink River is diverted to fill Cole Lake on the Frost Valley YMCA Campus. The diversion was observed near Station 38800 where it conveys flow through a culvert under a dirt road on the right bank and then through the riparian forest underneath Frost Valley Road to Lake Cole. A sloped stone revetment was observed protecting the dirt road along this section of the river with a sparse riparian buffer, from Station 38850 to Station 38600. The revetment was observed in fair structural and functional condition. (B959, A1082)

A sloped stone revetment was observed protecting a dirt road with a sparse riparian buffer from Station 38850 to Station 38600. The revetment was observed in fair structural and functional condition.

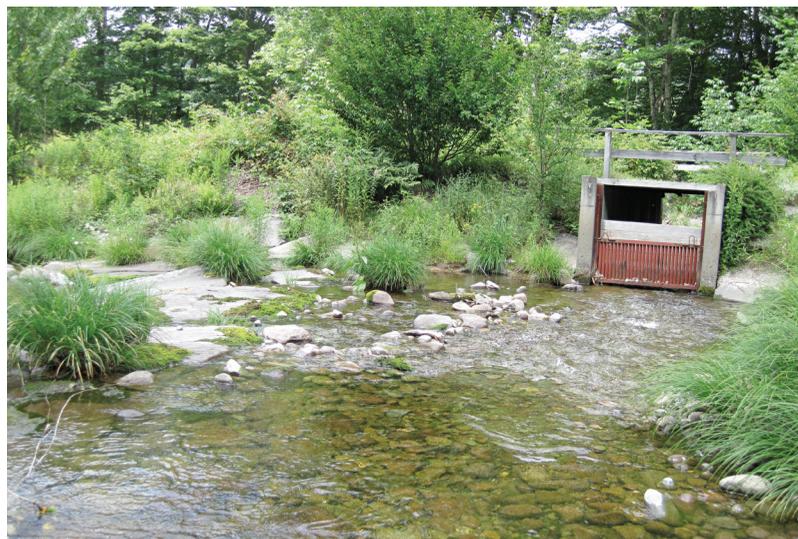
Water diversion to fill Cole Lake (A1082)

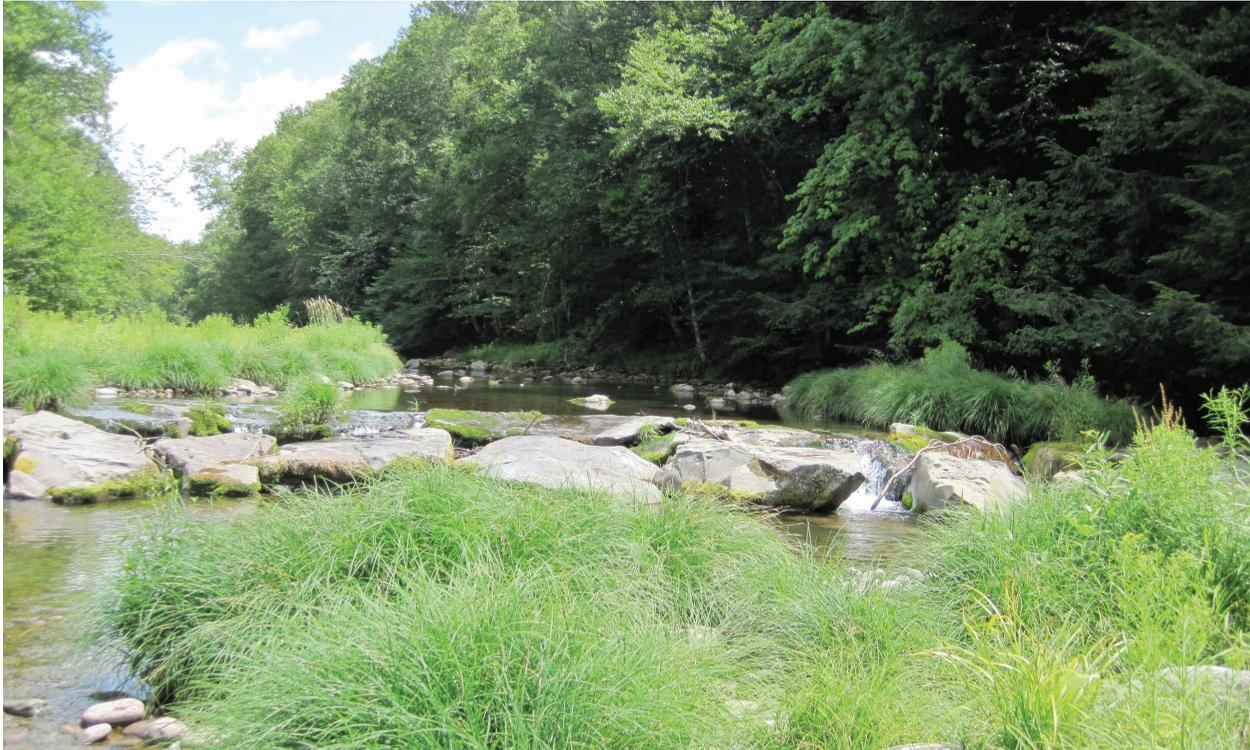
Looking upstream at center bar and boulder dam (A1085)

The boulder control was documented in good structural and functional condition. A cobble center bar with thick grass and sedge vegetation was observed extending 100 feet downstream. The center bar was most likely caused by decreased sediment transport capacity in the main channel due to the diversion of flow to Lake Cole. (A1085)

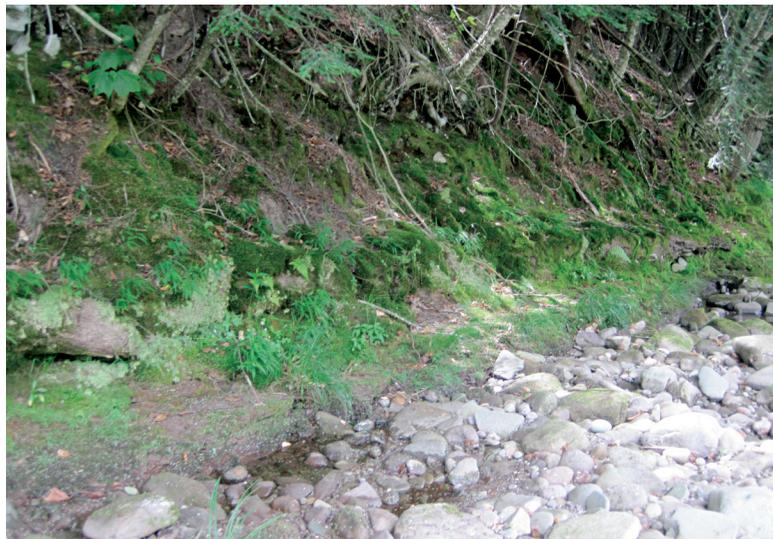
At the end of the center bar, near Station 38680, exposed bedrock was observed controlling the stream bed grade and constraining lateral migration on the left bank. This natural control continued approximately 600 feet downstream with intermittent tributaries conveying flow from the left valley wall joining the main channel at both ends. The bedrock is then not visible for approximately 200 feet before it is exposed again and continues another 400 feet. (A1104)

Exposed bedrock on left bank (A1104)

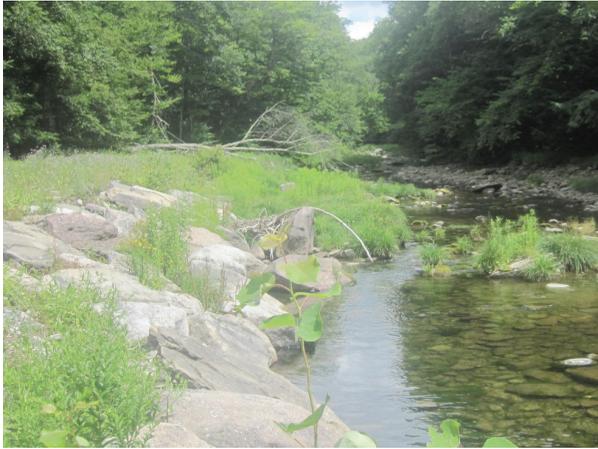
Sloped stone revetment stabilizing bank (B976)

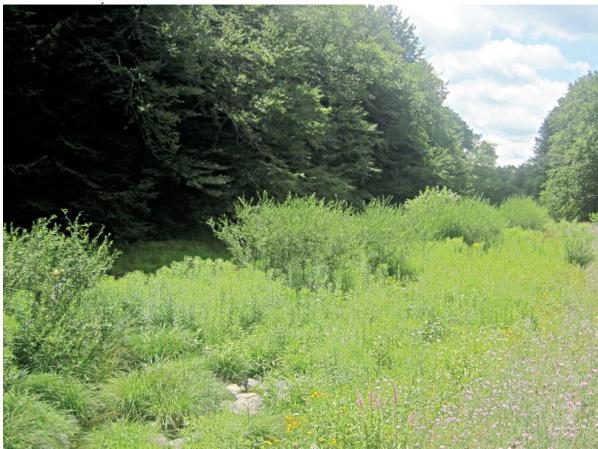
Potential willow harvest site (B979)

It is recommended these two river segments be further investigated for past management activities and that the sites be evaluated for potential riparian buffer improvement. The willows documented growing on the right bank at Station 37800 could be a plant source for future restoration or riparian buffer improvement projects in this area. (B979)

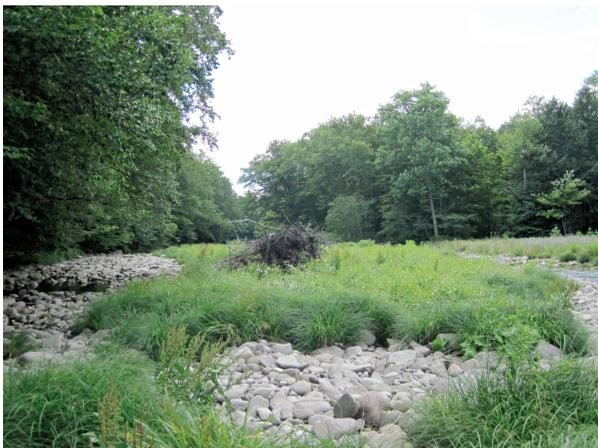
Depositional cobble center bar (A1113)

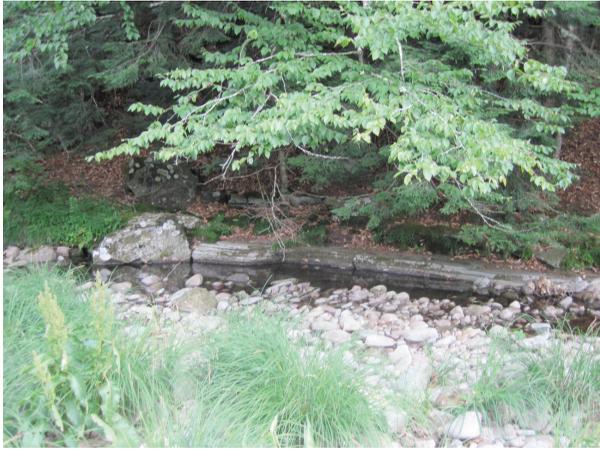
Exposed bedrock grade and planform control (A1112)

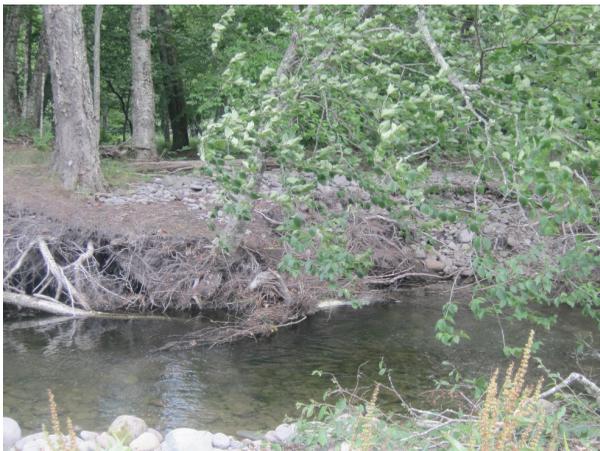
This site was documented as active with hydraulic erosion causing scour that has exposed alluvial materials and undercut the roots of woody

Hydraulic erosion of bank (B992)

riparian vegetation at the top of the bank. While bank retreat can be expected in this area as the depositional center bar forces the main channel to migrate into this bank, the wide band of riparian forest between the main channel and Frost Valley Road will significantly slow erosion. Therefore, it is recommended that this bank be left to stabilize without treatment (*passive restoration*) and that the site be monitored for changes in condition. (B992)

An eroding bank segment was observed on the right bank extending 120 feet from Station 36470 to Station 36350 (BEMS NWB10_36350). This site was documented as active with hydraulic erosion causing scour that has exposed alluvial materials and undercut the roots of woody riparian vegetation at the top of the bank.

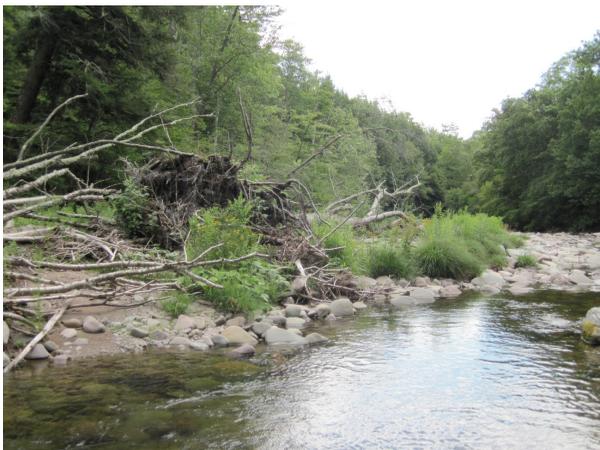
Deposition bar with sparse vegetation and woody debris (A1120)

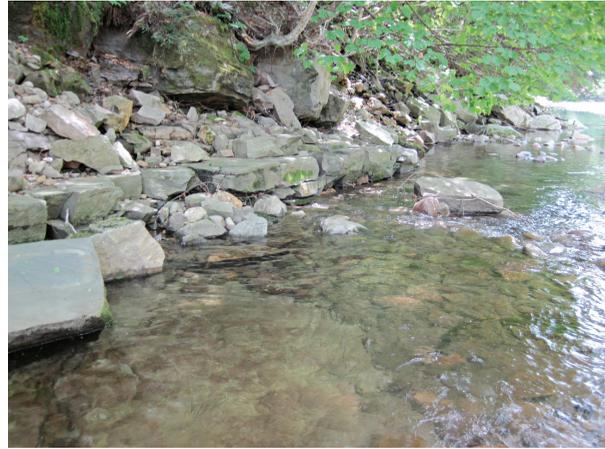
Downstream of the erosion site the main channel flows adjacent to exposed bedrock on the left bank for 200 feet between Station 35330 and Station 35130 (A1129). An eroding bank segment was observed on the right bank as the main channel meanders away from the bedrock control, extending 145 feet from Station 35220 to Station 35075 (BEMS NWB10_35075). This site was documented as active with hydraulic erosion causing scour that has exposed alluvial materials. (B1013) Although the site was documented as actively eroding during high flow events, grasses and sedges were observed growing at the bank toe. Therefore it is likely that this bank will revegetate and stabilize without treatment (*passive restoration*). However, it is recommended that this site be monitored for changes in condition.

Exposed bedrock on left bank (A1129)

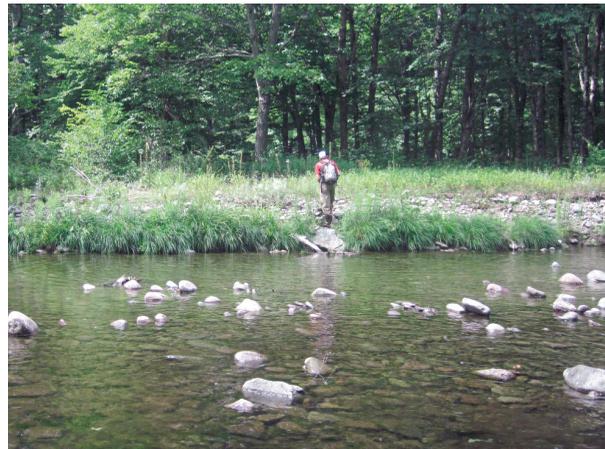
Re-vegetating bank (B1013)

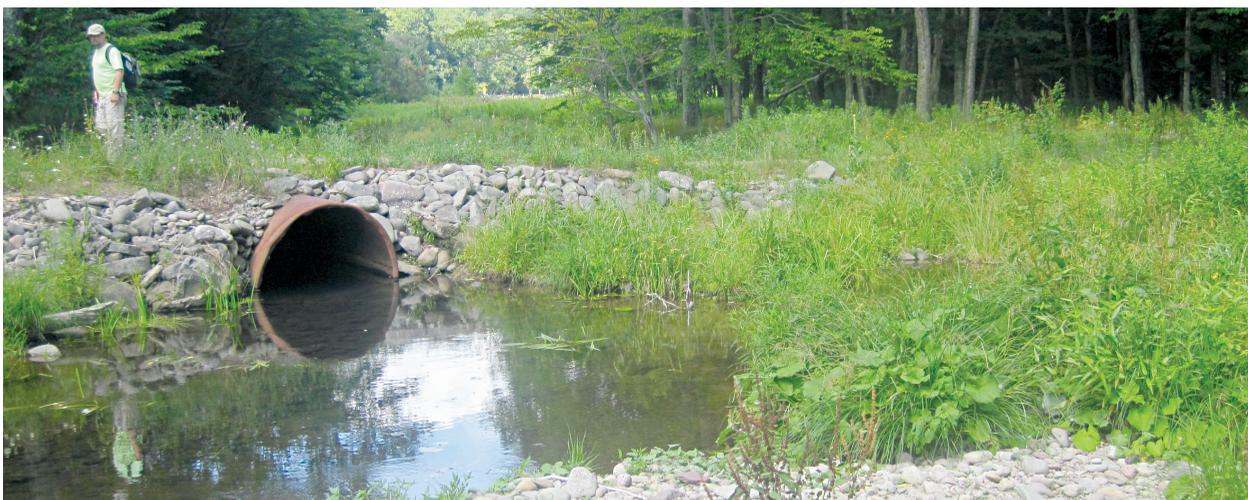
Convergence with outlet from Cole Lake (B1017)

right floodplain, converging with the outlet from Cole Lake near Station 34600. (B1017) A rip-rap revetment was observed extending 85 feet upstream of the Lake Cole outlet and a sloped stone revetment was observed extending 220 feet downstream of the outlet. Both revetments were documented in good structural and functional condition. The top of the banks at both revetments features a dirt road used for horseback riding in the summer and cross-country skiing in the winter with no riparian vegetation between the road and the bank. Recommendations for this site include *assisted restoration* using bioengineering techniques to re-establish a healthy riparian buffer which can aid in bank stability and control nutrient and sediment runoff from the dirt road. (B1021, A1137)

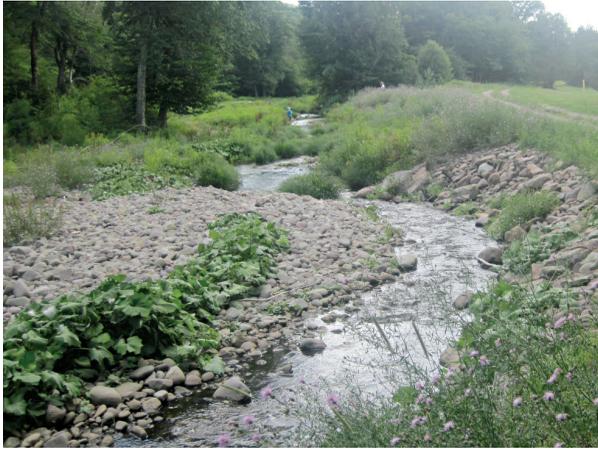
Rip rap revetment (B1021)

A rip-rap revetment was observed extending 85 feet upstream of the Lake Cole outlet and a sloped stone revetment was observed extending 220 feet downstream of the outlet. Both revetments were documented in good structural and functional condition. The top of the banks at both revetments features a dirt road used for horseback riding in the summer and cross-country skiing in the winter with no riparian vegetation between the road and the bank.

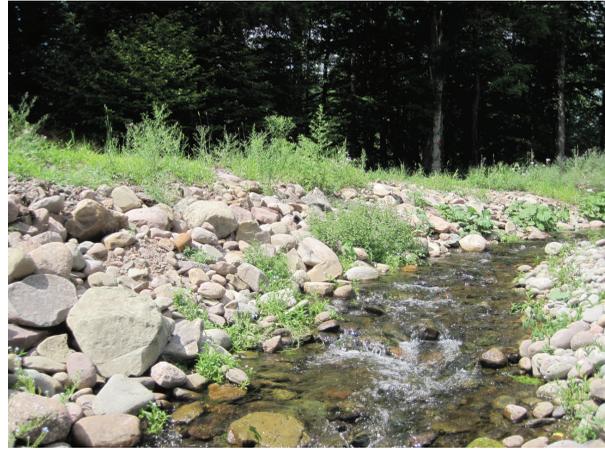
Sloped stone revetment (A1137)
