Neversink River West Branch

MANAGEMENT UNIT 2

WEST BRANCH MANAGEMENT UNIT 2
BETWEEN STATION 2200 AND STATION 5700

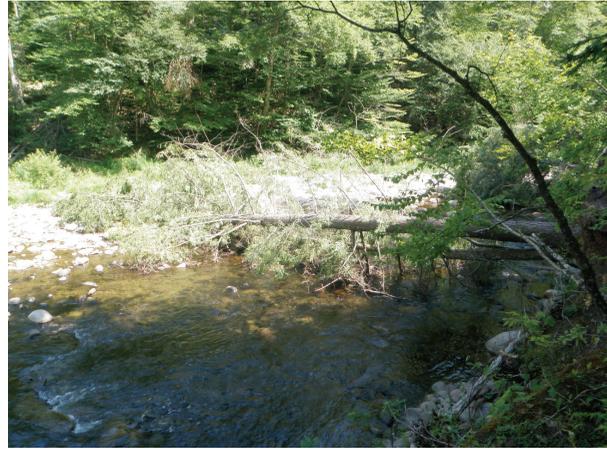
One such flood chute was observed diverging from the main channel at Station 5600. Near Station 5340 a recently downed tree from the right bank was observed across the main channel. (P7290176) Exposed bedrock was observed from Station 5260 to Station 4980 at the foot of the left valley wall forming both a stream bed grade control on the left stream bed and a planform control on the left bank. (A327) At the downstream end of the exposed bedrock a cobble side bar vegetated with grass and sedge was observed on the left bed. The side bar extends approximately 180 feet from Station 4960 to Station 4780. (P2790181) Various potential riparian buffer improvement areas exist along the left side of the stream between Station 4830 and Station 4110 (Figure 7).

Downed tree across main channel (P7290176)

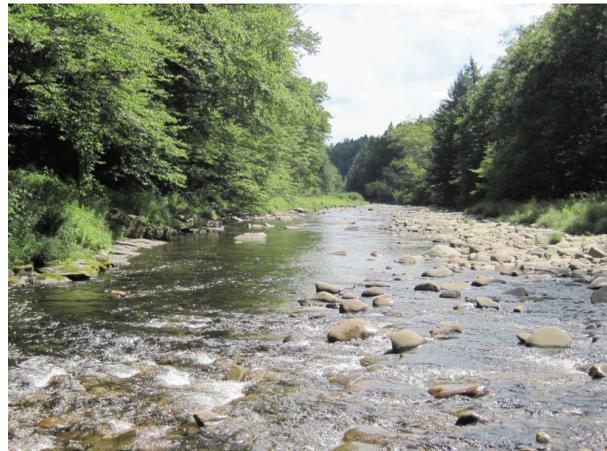
Bedrock forming grade and planform control (A327)

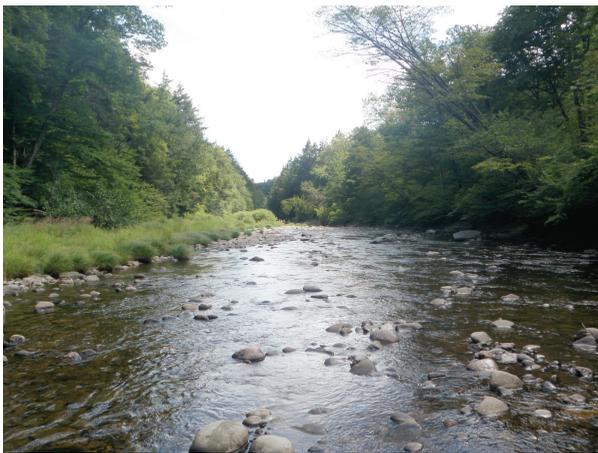
Vegetated cobble side bar (P7290181)

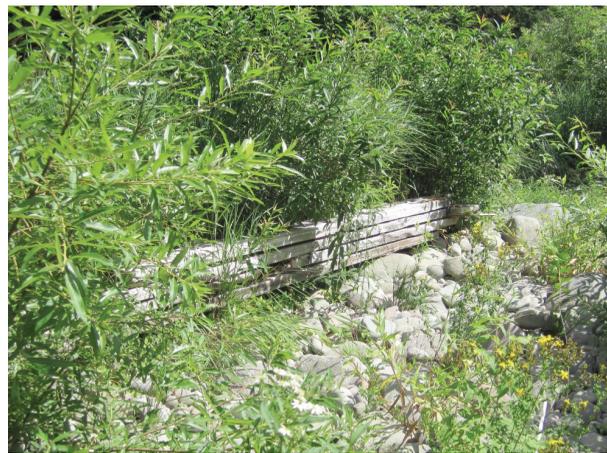
From Station 4500 to Station 4100 a depositional point bar was observed littered with at least three large woody debris piles (including some plywood construction debris) near Station 4500. (A331) This depositional feature appeared to be forcing flow in the main channel into the right bank during high flow events, where an eroding bank segment was observed extending 380 feet from Station 4405 to Station 4025 (BEMS NWB2_4025). (A339)

Side bar with construction debris (A331)

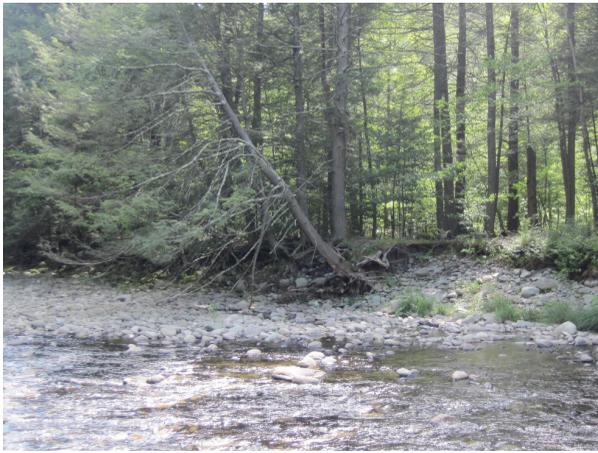
Eroding segment on right bank (A339)

This eroding bank segment was documented as inactive; hardening at the toe and vegetation on the slope were observed, as well as downed trees near Station 4380 and Station 4280 that appear to be causing sediment deposition and further bank stabilization. It is recommended that this bank be left to further revegetate and stabilize without treatment (*passive restoration*) and that the site be monitored for changes in condition.

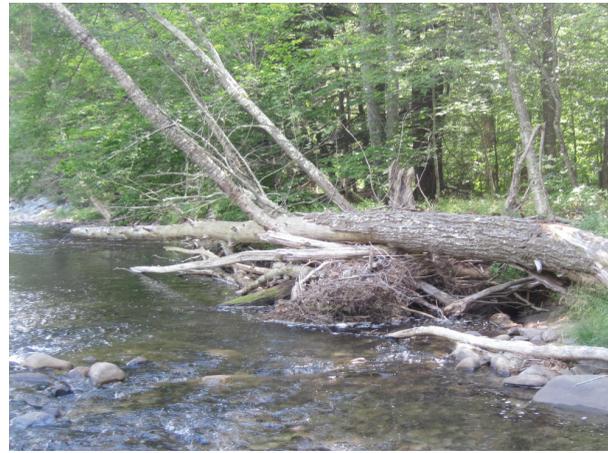
Woody debris jam on right bank (A344)

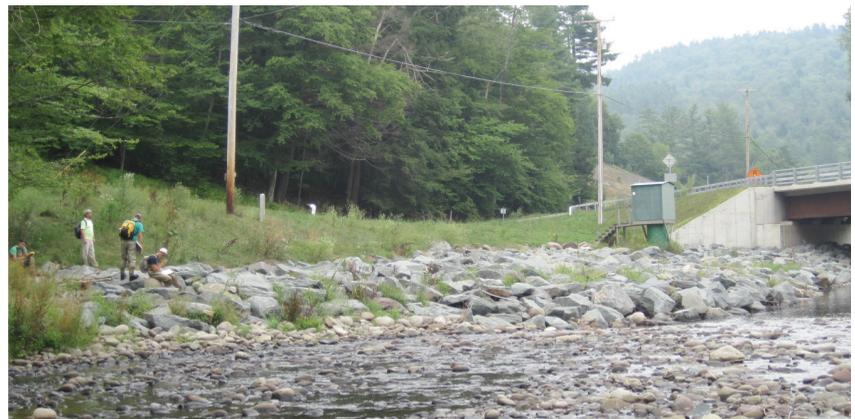
Left bank revetment (B355)

revetment was observed on the left bank extending from Station 2300 to the left abutment of the Frost Valley Road Bridge, and continues on the left bank for 100 feet downstream of the bridge. This revetment was documented in good functional condition and new structural condition. A piped outfall was observed at the end of this revetment constructed of an 18 inch diameter plastic pipe conveying road drainage from the bridge. The USGS gauge station #01434498, West Branch Neversink River at Claryville, was observed on the left bank at the end of this revetment. (B355, A345)

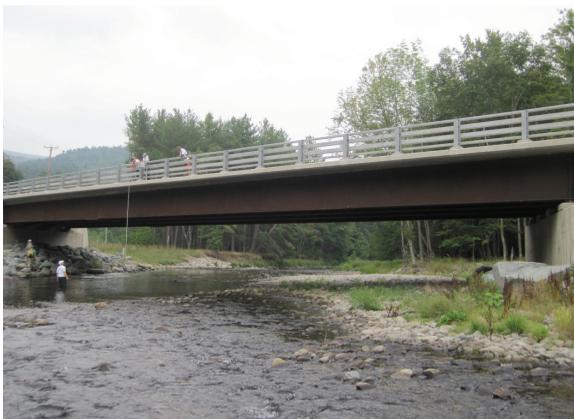
The Frost Valley Road Bridge, County Bridge #187, has a *normal span* of 155 feet and an *effective span* of 138 feet, with 10 feet on encroachment on the right bank and no encroachment on the left bank. These documented field conditions indicate that this bridge does obstruct floodplain flows. However, the exceptionally wide span of this bridge is twice the typical width for a channel with this drainage area in the Catskills region. This overwidened condition creates a shallow channel which lacks the power to convey sediment from upstream, contributing to the aggradation observed both upstream and downstream of the bridge. The bridge was documented in good structural and good functional condition. (A11)

Frost Valley Road bridge (A11)

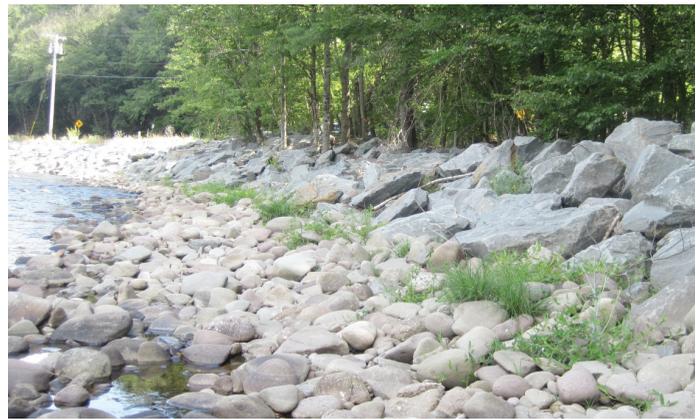
A revetment was observed on the right bank beginning at Station 2980 and continuing to the right abutment of the Frost Valley Road Bridge. The revetment is constructed of dumped and placed rip rap, and was documented in good functional and good structural condition. After the main channel converges downstream of the center bar near Station 2400, a dumped rip rap

Right bank revetment (A345)

Recommendations for this site include a *full restoration* project from Station 3000 continuing into WBMU1 to Station 1900. This project would require geomorphic and sediment transport analyses of the reach and would likely include construction of a vegetated bankfull height bench on the right bank at the toe of the existing revetment, which would be designed to increase the radius of curvature of both meanders near the bar and a establish a channel width closer to the typical width for this drainage area in the Catskills region. The depositional materials of the current center bar and the willow growing on the bar could potentially be used to form the bench and plant the right bank revetment, respectively. Soil *bioengineering* and inter-planing of the right bank revetment with willow, low shrubs, sedge and grasses will establish a healthy riparian buffer and decreased flow velocities along the right bank and the road during high flow events.
