Neversink River West Branch

MANAGEMENT UNIT 7

WEST BRANCH MANAGEMENT UNIT 7
BETWEEN STATION 25000 AND STATION 27500

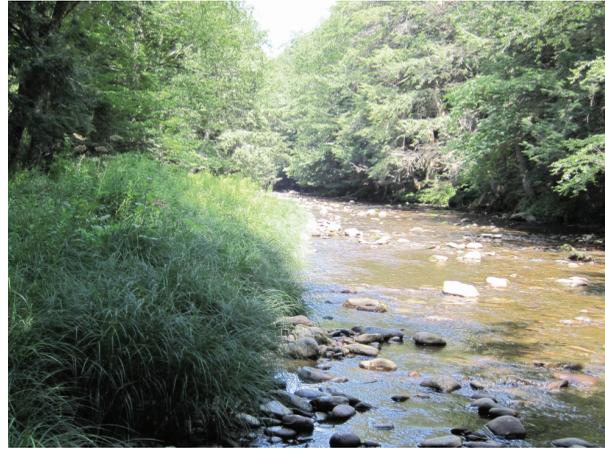
Upstream of this convergence the main channel is a sediment storage reach with several depositional features including a side bar on the right bed continuing from WBMU8 which ends at Station 27320 and full channel aggradation documented at Station 26700. (A82) Large woody debris piles were documented on the forest floodplain between in the main channel and the side channel near Station 27000, indicating that the floodplain likely conveys flow during high flow events. (A83). An intermittent tributary conveying flow from the left valley wall joins the main channel near Station 26700.

Side bar along right bed and full channel aggradation (A82)

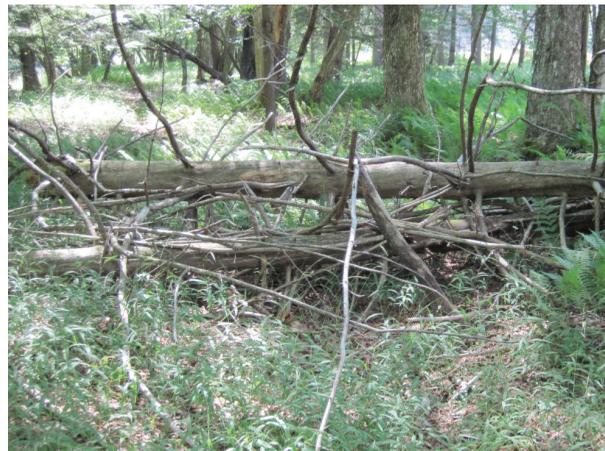
Large woody debris piles in forest floodplain (A83)

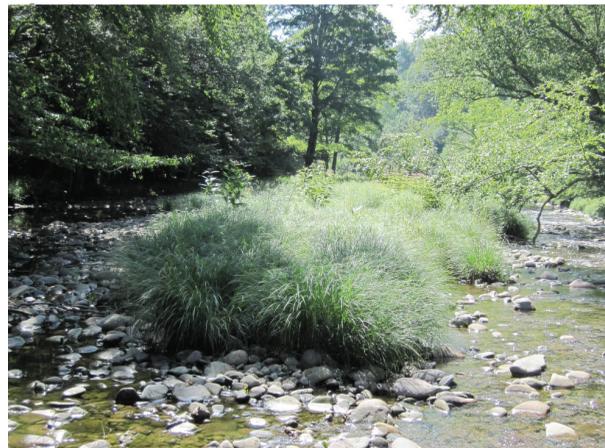
Near Station 26550 the left valley wall curves to the south leaving some open forested floodplain on the left bank, and main channel splits around a vegetated center island with the majority of the flow on the right near Station 26550. (A84) The side channel continues south along a terrace on the left, continuing through the end of WBMU7. At Station 25900 another depositional bar was observed in the main channel and a dry side channel diverges into the floodplain on the left bank. This side channel converges with the channel flowing along the terrace approximately 500 feet downstream of the convergence, eventually flowing adjacent to the left valley wall through the end of WBMU7. There were some beaver dams observed acting as stream bed grade controls and forming pools throughout these side channels, and several large woody debris jams were observed throughout the left floodplain and these side channels

Vegetated center island (A84)

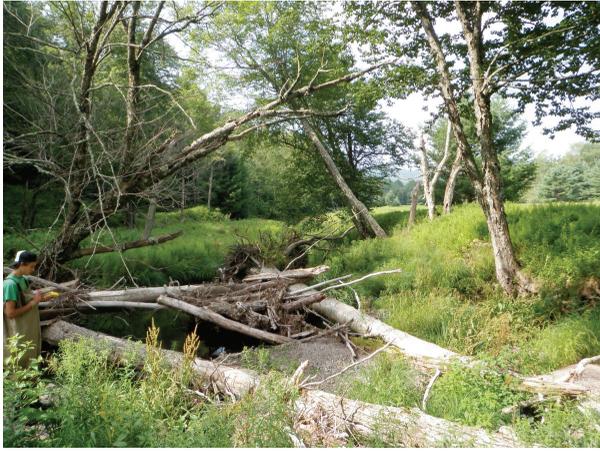
Large woody debris jam (P7280018)

indicated that the floodplain is inundated during high flow events. (P7280018, P7280008) Several sites consisting of herbaceous vegetation or bare soil between Station 26500 and Station 25000, particularly along the left bank, should be further investigated for the potential to improve the riparian buffer through planting efforts (Figure 7).

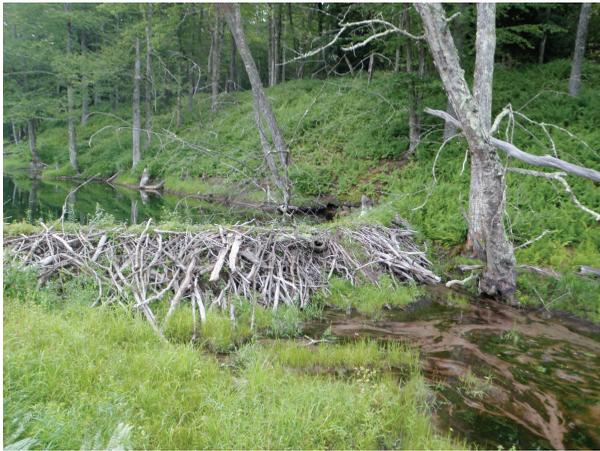
Beaver dam (P7280008)

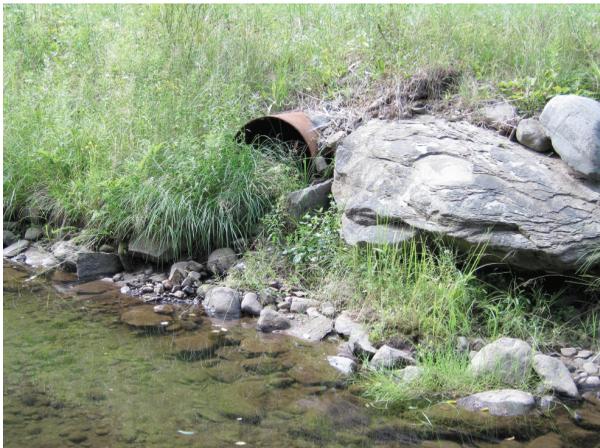
Piped outfall conveying flow into side channel (A85)

The side channel (2001 channel alignment) converges with the main channel at Station 25850 as the main channel begins to flow directly adjacent to Frost Valley Road. Slightly upstream of the convergence, a piped outfall conveys flow from Frost Valley Road and the right valley wall to the side channel. The flow is conveyed in a 30-inch diameter smooth steel culvert with 1 foot of outfall and no headwall. The outfall protection was documented in fair condition. (A85) It is recommended that the water quality impacts of this outfall be investigated to better understand and possibly mitigate the water quality implications of this piped outfall.

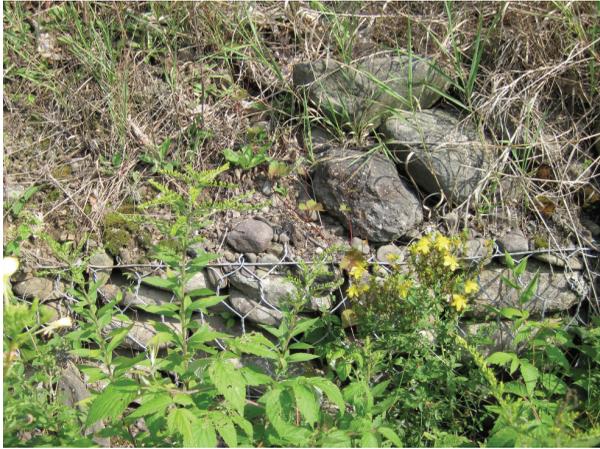
A revetment was observed on the right bank immediately adjacent to Frost Valley Road for the remaining 900 feet of channel in WBMU7. Rip-rap revetment in gabion baskets was observed for 100 feet beginning at Station 25900 in good structural and functional condition. (A91) The revetment was constructed of stacked rock with some vegetation from 220 feet downstream of Station 25800 documented in good structural and functional condition. (A101) Downstream of Station 25600 the stacked rock revetment is also in good structural and functional condition with toe protection provided by dumped rock and significant vegetation. (A99) The next segment of revetment continues 120 feet to Station 25480 where the revetment is composed of stacked rock with grassy and wildflower vegetation in good structural and functional condition for 310 feet. (A106)

Rip-rap and gabion baskets along right bank (A91)

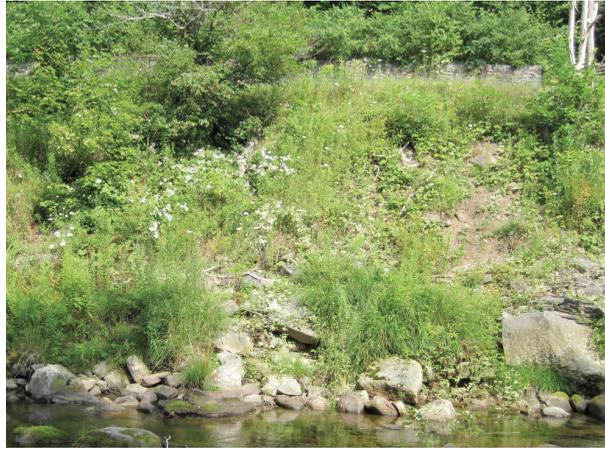
Stacked rock revetment (A101)

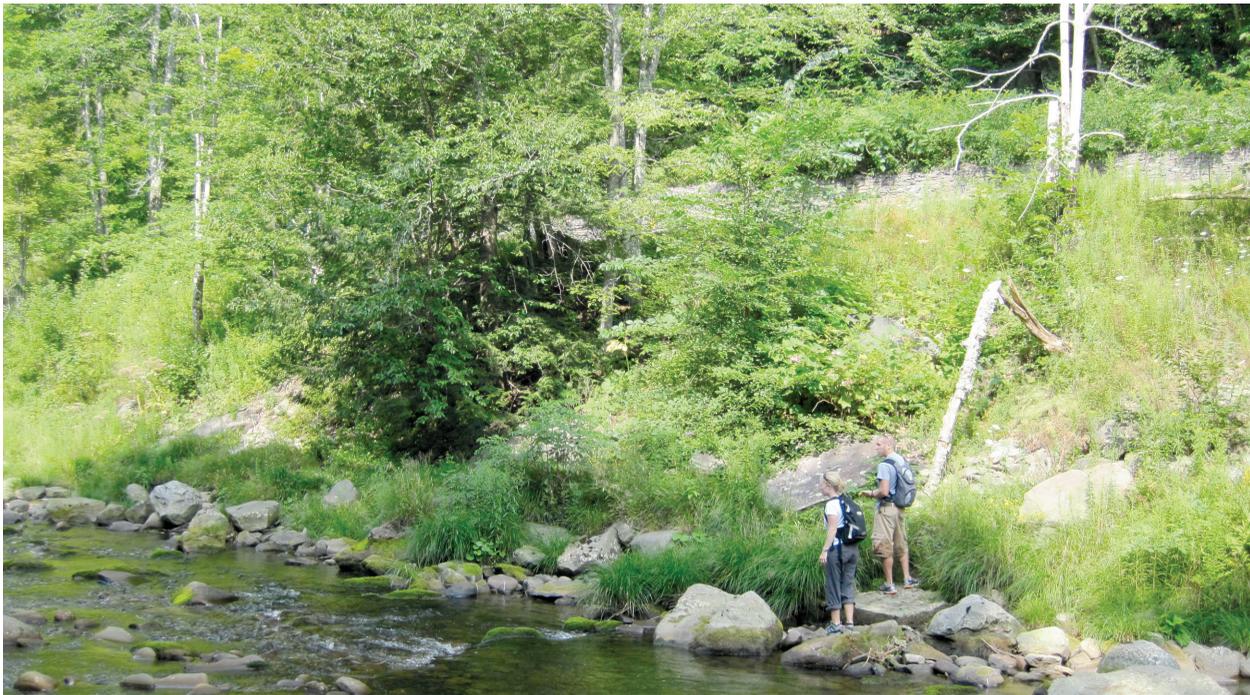
Dumped rock and stacked rock revetment (A99)

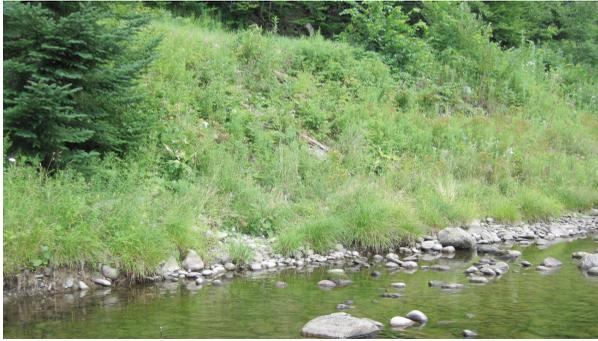
Vegetated stacked rock revetment (A106)

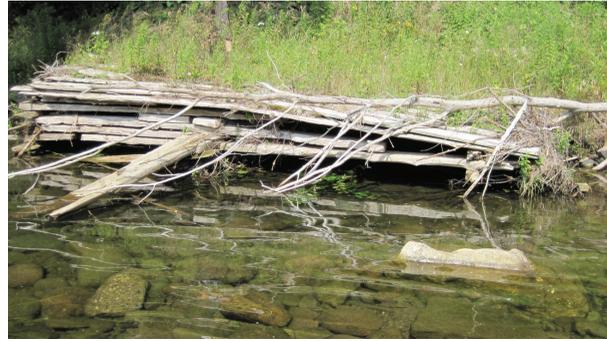
The revetment ends briefly at Station 25130 where a lunger structure constructed of timber boards and logs was observed on the left bank. It is likely that this structure was designed to provide fish habitat in this otherwise straight reach. It appears to be in good functional condition as a deep pool was observed under the structure. (A107)

Timber board and log provided fish habitat (A107)

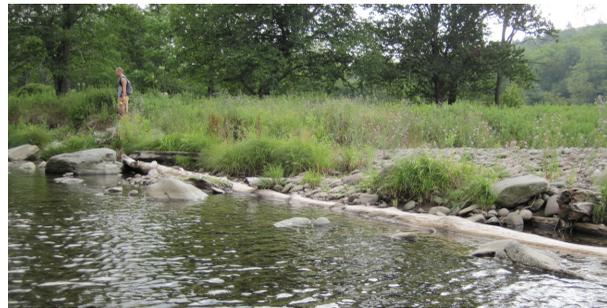
A short rip rap revetment was observed on the left bank across from the lunger structure constructed of log cribbing. The revetment was documented in good structural and functional condition although the purpose of the revetment in this location remains unclear. Recommendations for this reach include further investigation of the management history and possible restoration of the structures to ensure functionality. (A111)

Log cribbing rip-rap (A111)
