Broadstreet Hollow Stream Restoration Project

IMPLEMENTATION & MONITORING REPORT

Broadstreet Hollow
Town of Lexington, Greene County, NY

UPDATED
March 2008

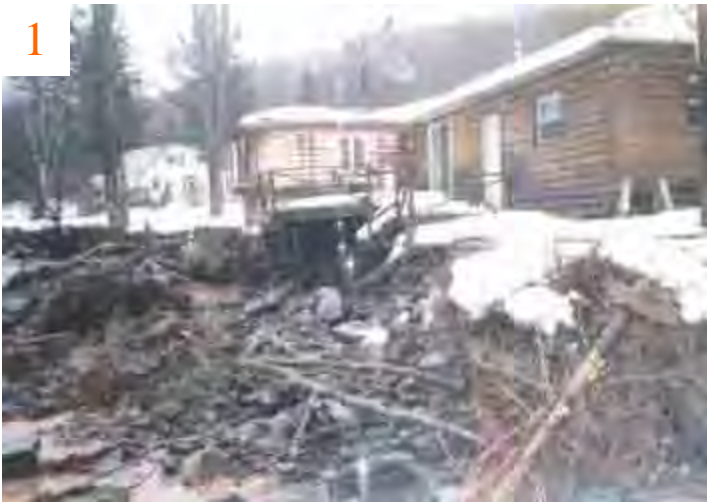
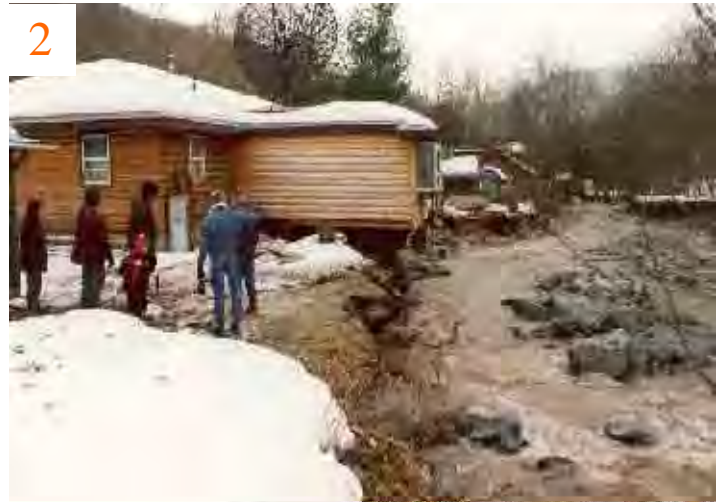
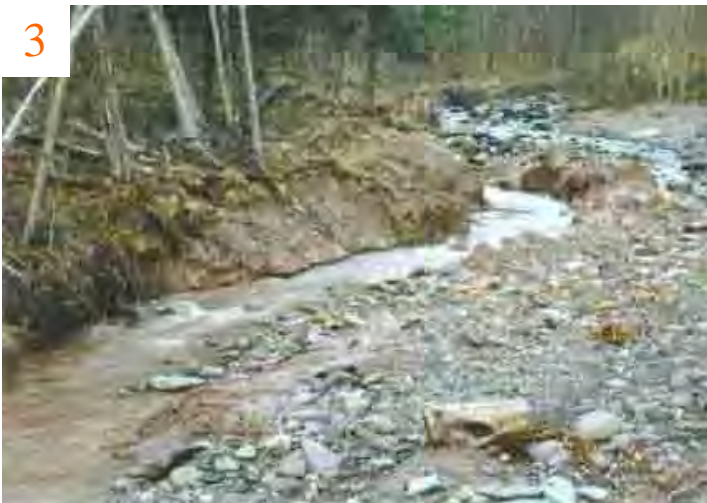
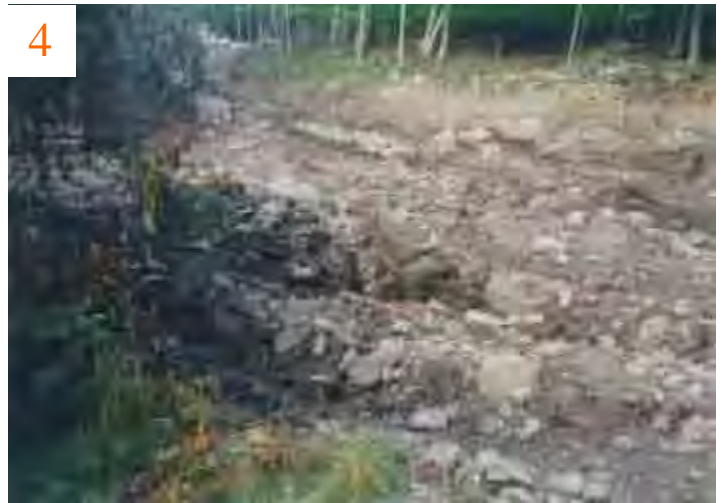
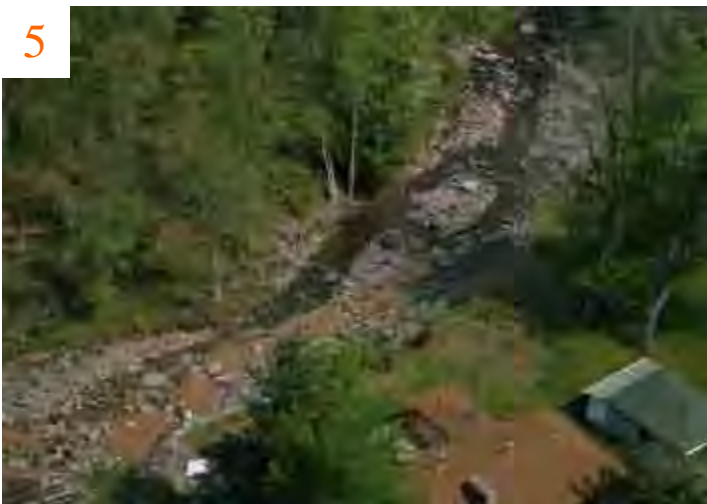
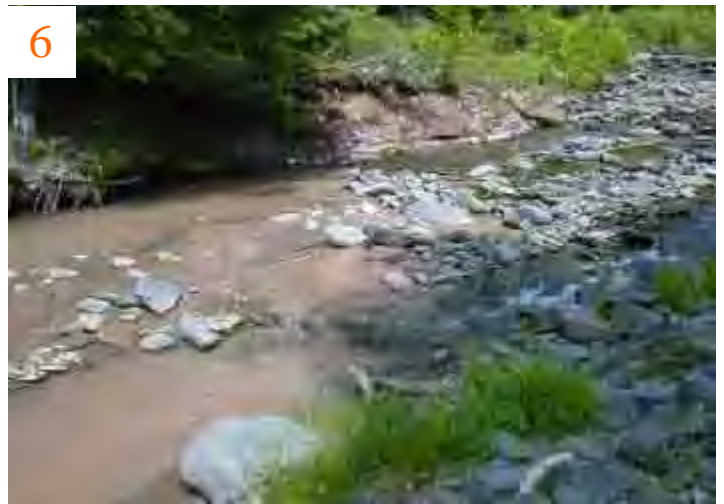
- Photograph 79: View looking upstream at upper bridge noting minor right bank scour.
- Photograph 80: Image looking downstream through middle of reach displaying right and left bank erosion and damaged well.
- Photograph 81: Left bank erosion near cross section 4, at fourth downstream cross vane with exposed keyway.
- Photograph 82: Right bank erosion near cross section 5 and exposed well casing.
- Photograph 83: Left bank erosion near cross section 8.
- Photograph 84: Right bank erosion near cross section 8 .
