BRANDYWINE RESTORATION PROJECT - BATAVIA KILL -

IMPLEMENTATION & MONITORING REPORT

BRANDYWINE PROJECT - BATAVIA KILL
TOWN OF ASHLAND, GREENE COUNTY, NY

UPDATED
MARCH 2008

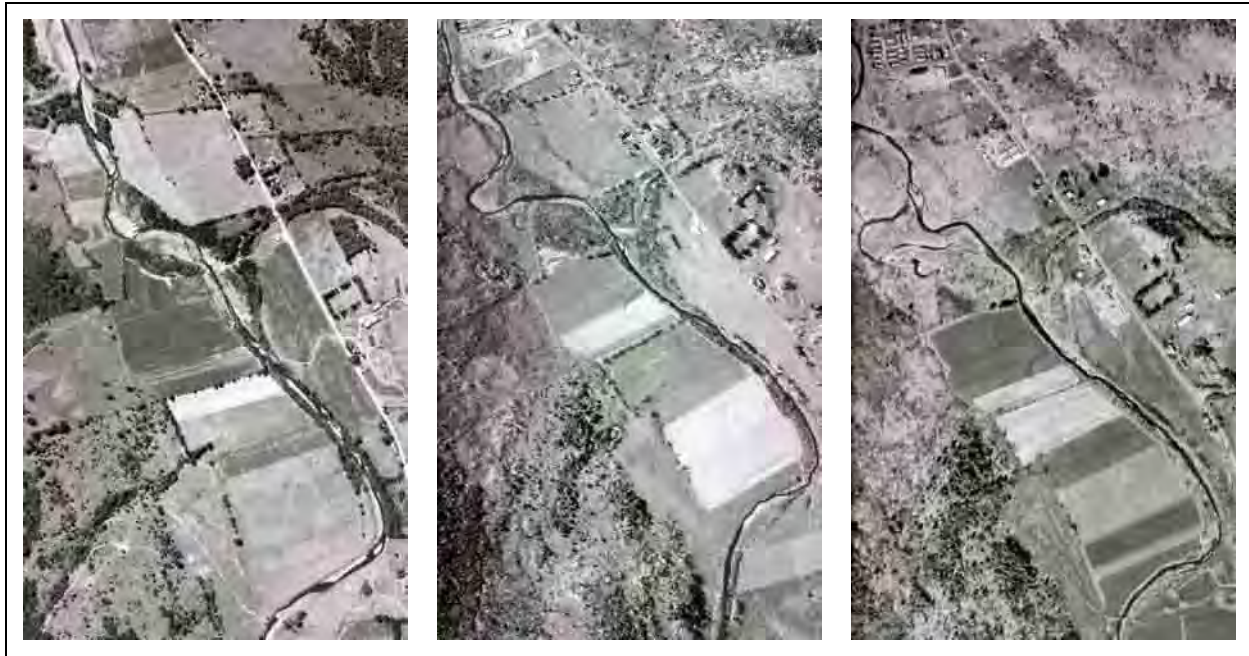
Figure1 Historic Aerial Progression of the Brandywine Reach

A historical aerial photograph progression was performed which characterized the lower reach as exhibiting unstable planform behavior and excessive channel migration (Figure 1). This was particularly apparent in the area downstream of the confluence with North Settlement Creek in which channel migration and several channel avulsions had resulted in oxbow and oxbow cutoffs formations (Figure 4). Measurements determined 980 feet of channel migration between the years of 1959 and 1997.

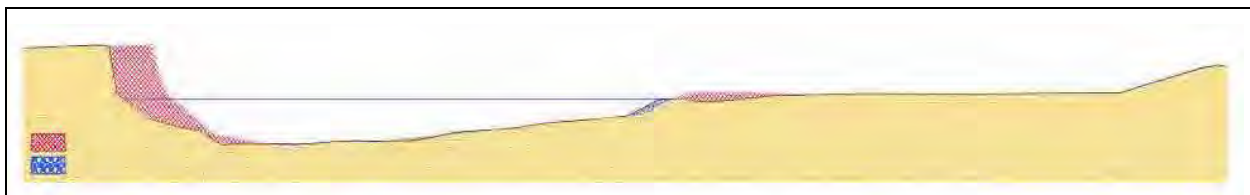
Figure 2 Overlay of cross section #1 on the Brandy Wine site, 1997 - 1999.

The Brandywine site was classified as a Rosgen C4 stream type with channel sediment dominated by very coarse gravel. In general, the assessment determined a over-widened channel condition and high width/depth ratios. The principal channel erosional processes were lateral migration and avulsions during extreme events and inefficiency to transport the sediment regime.

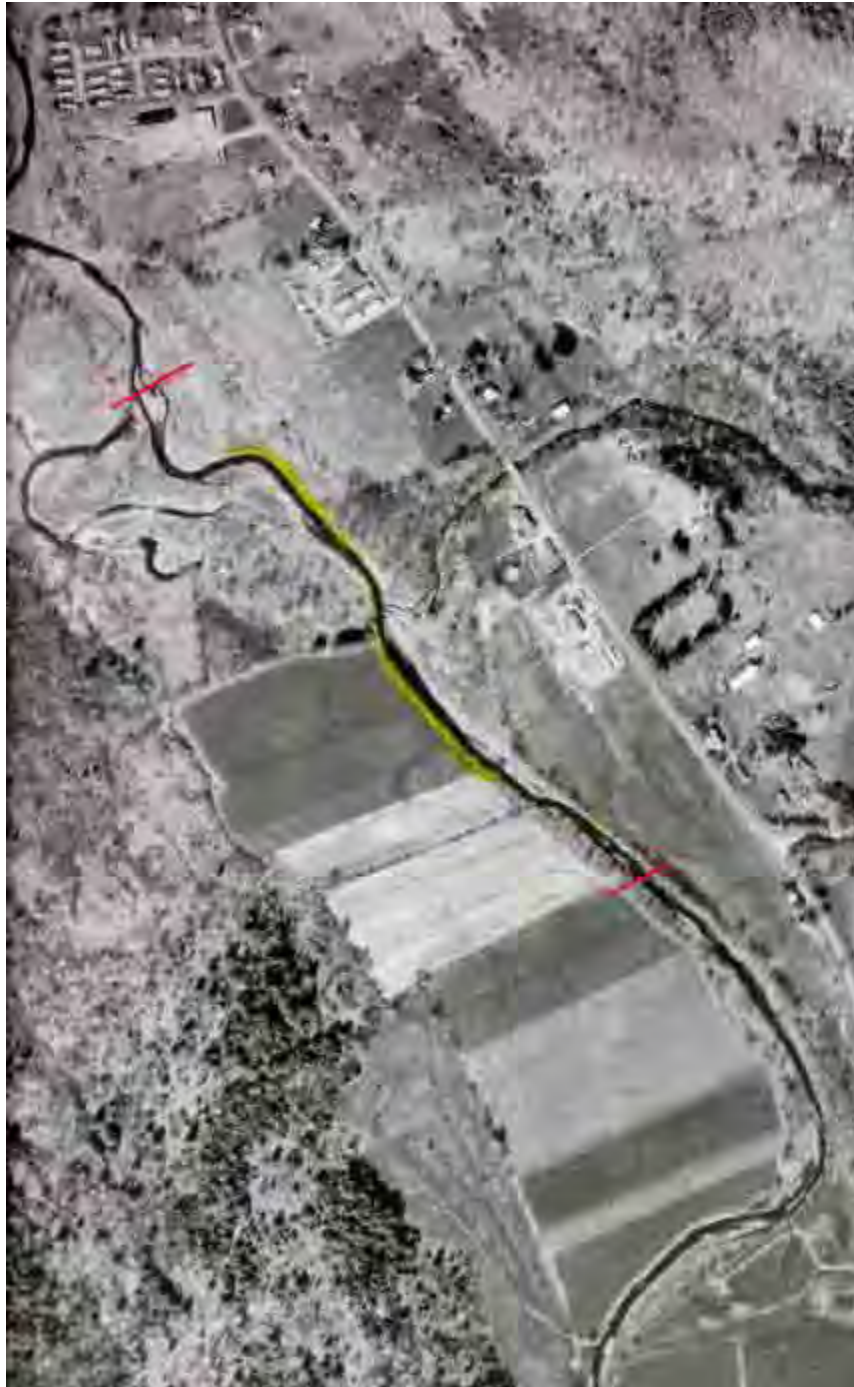
The “Brandy Wine” project was surveyed and classified by Greene County Soil & Water Conservation District Technicians in October of 1997. The approximate beginning and ending points of the survey are noted on the May 1995 aerial photograph (Figure 3.1) by red bars, and the eroded sections of the bank are highlighted in yellow.

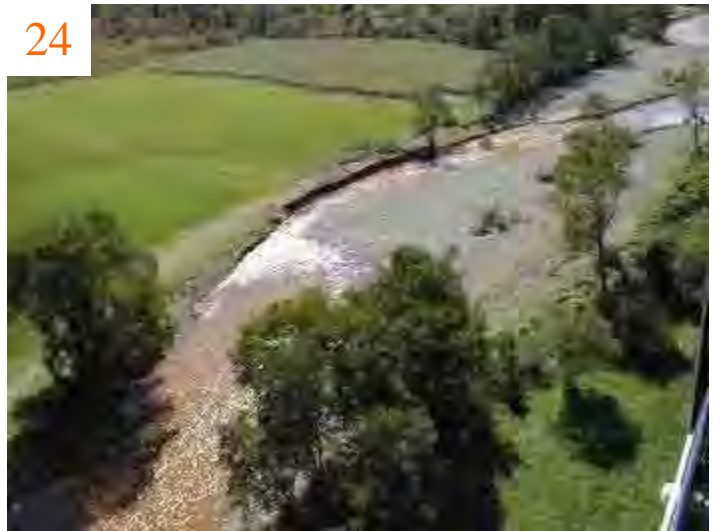
Brandywine Stream Restoration Project
Post Flood Damage September 24, 1999

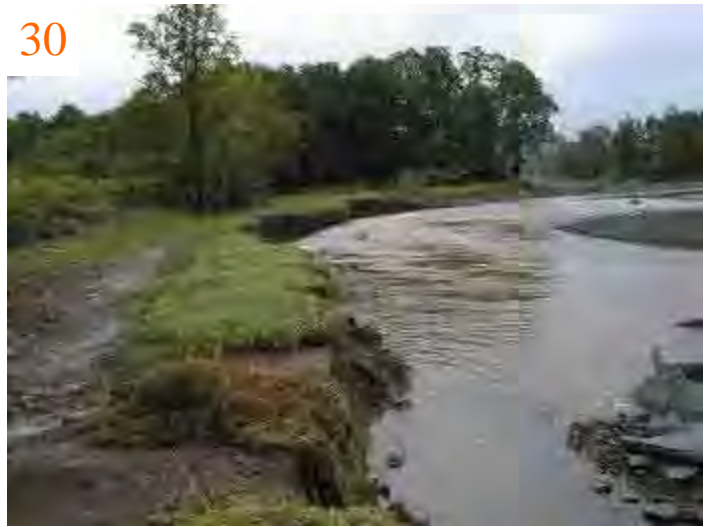
Brandywine Stream Restoration Project
Post Flood Damage December 1999

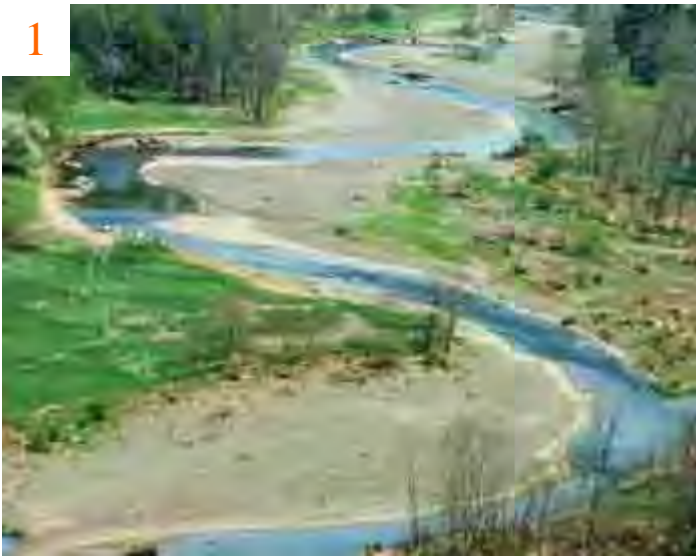
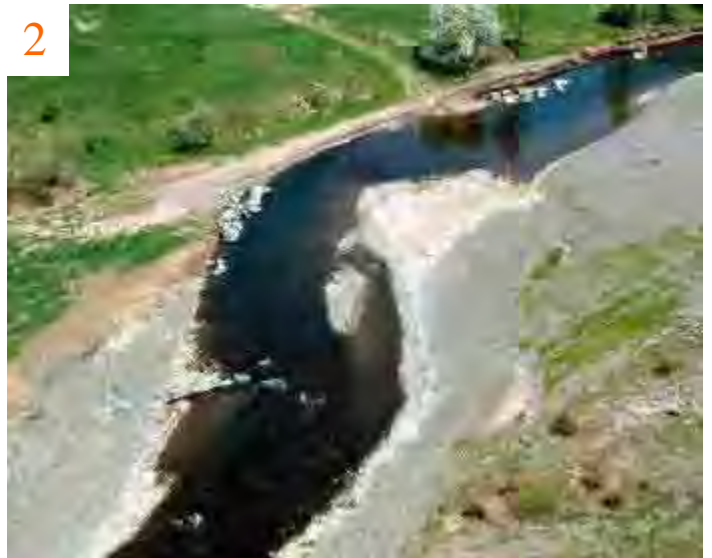
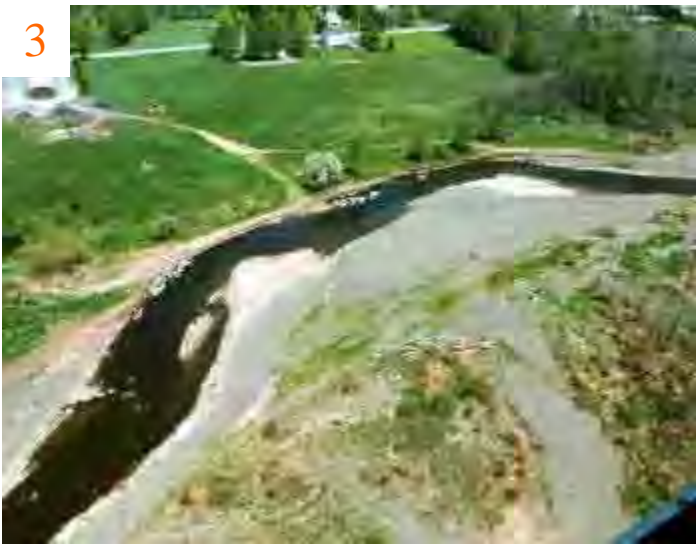
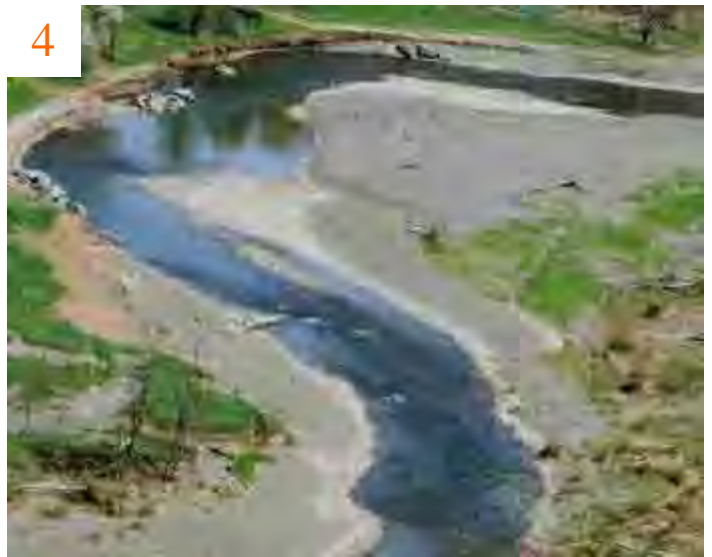
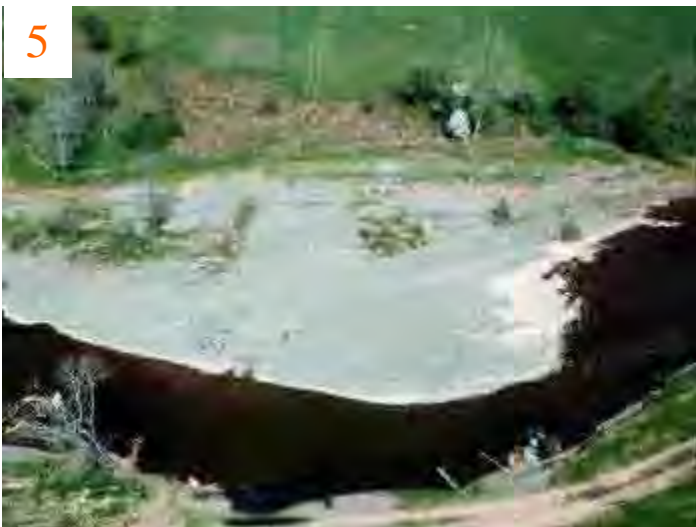
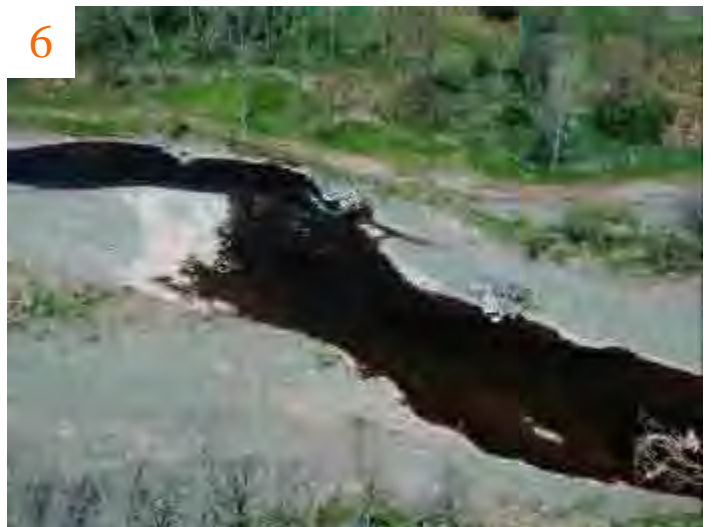
Brandywine Stream Restoration Project
Post Flood Damage May 2000

Photograph 11: Construction equipment used to repair and reset rock vanes.

Photograph 12: Construction equipment being used to repair the channel at the end of the project site.
