IMPLEMENTATION &
MONITORING REPORT
MAIER FARM PROJECT - BATAVIA KILL

TOWN OF ASHLAND, GREENE COUNTY, NY

UPDATED
MARCH 2008

MAIER FARM RESTORATION PROJECT

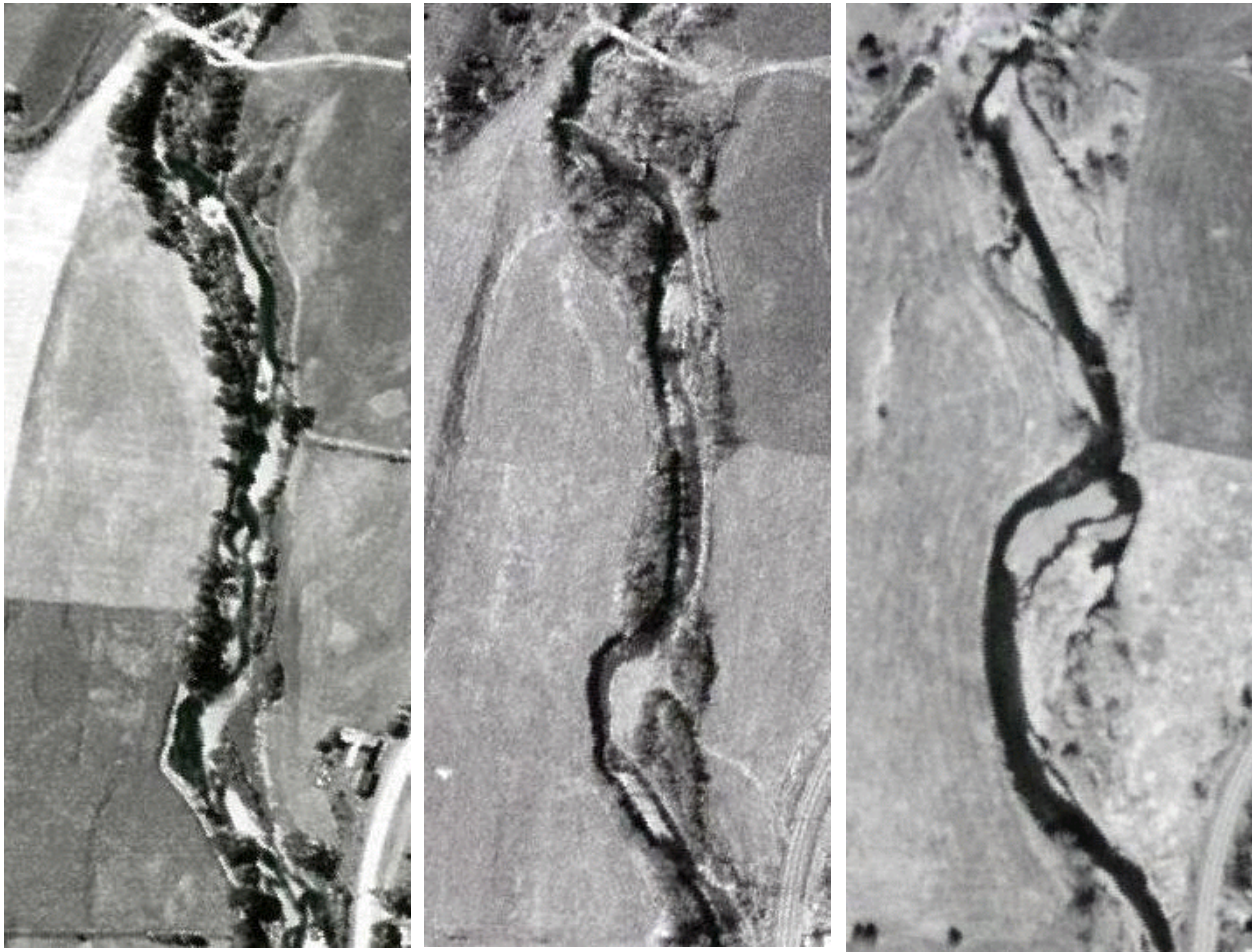
An initial assessment of historic aeriels surrounding the reach, indicated accelerated lateral migration of the lower meander bends, and a relatively stable plan form in the upper meander bend (Figure 1). In more recent aerial photography, localized channel braiding was present in the area immediately upstream of the bridge. Several relic channels were inventoried, indicating the dynamic nature of the reach historically. The meander bend along the upstream portion of the project had been stabilized in the past using riprap to protect the streambank along State Highway 23. It is surmised that the riprap influenced the accelerated migration occurring downstream, by redirecting forces to the downstream area. Further, the change in density and structure of riparian corridor along the channel, evident from the photography also influenced the instability of the

Figure 1: Aerial photograph displaying progression of Maier Farm Reach, left to right; 1959, 1980, and 1995. The direction of stream flow is from the top of the photograph to the bottom.

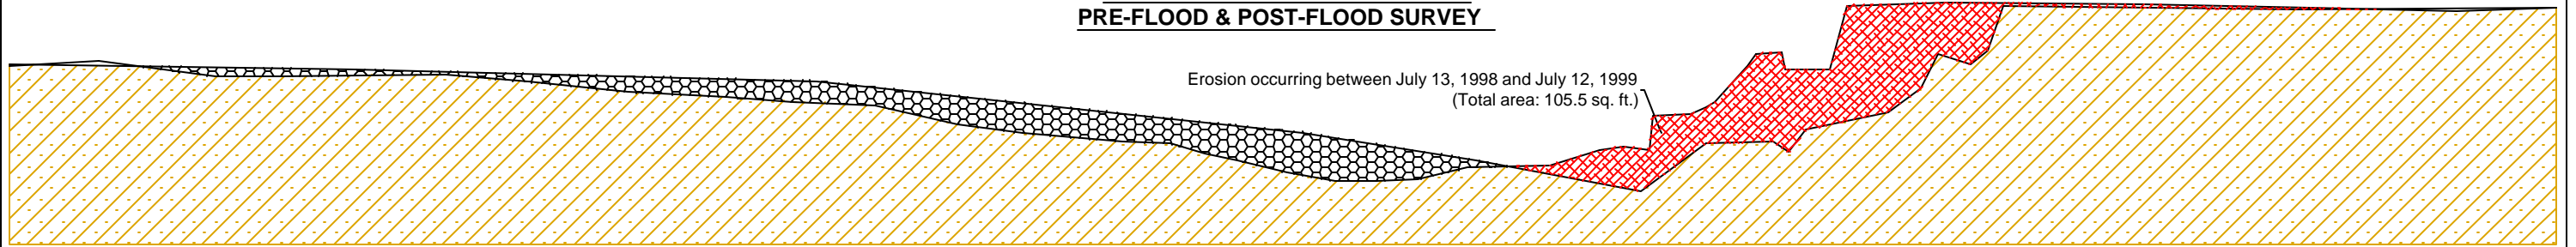
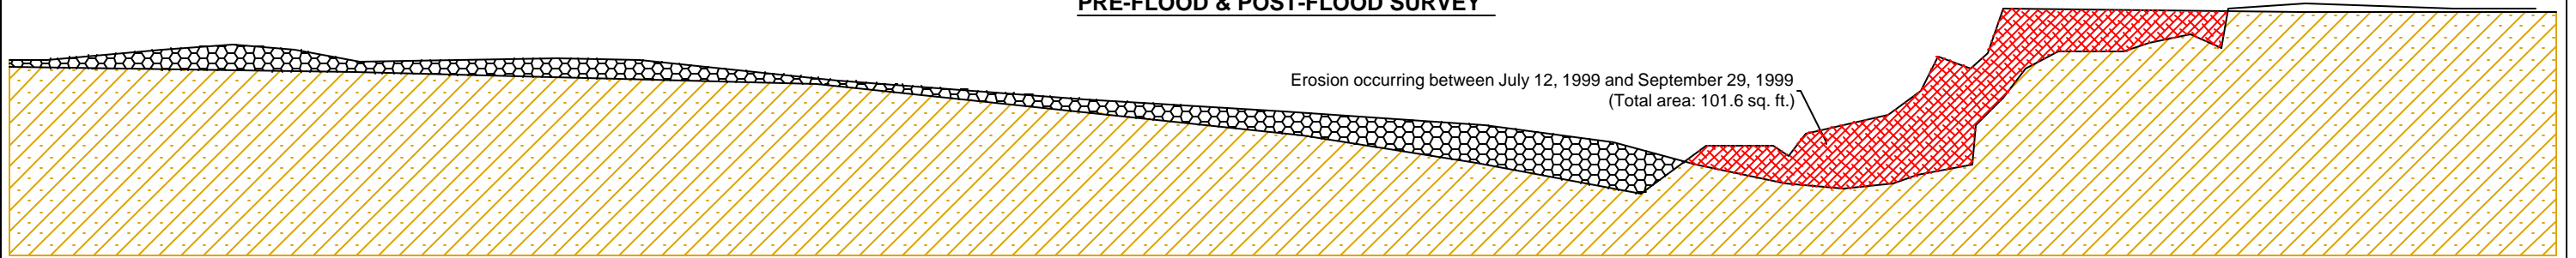
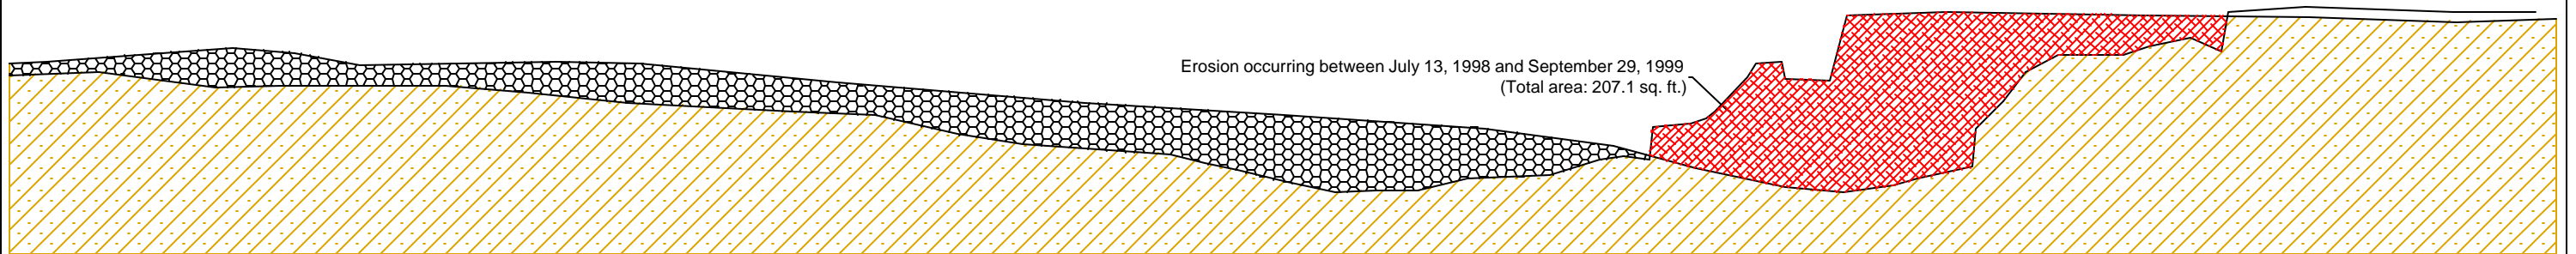
Erosion occurring between July 13, 1998 and July 12, 1999
(Total area: 105.5 sq. ft.)

Erosion occurring between July 12, 1999 and September 29, 1999
(Total area: 101.6 sq. ft.)

Erosion occurring between July 13, 1998 and September 29, 1999
(Total area: 207.1 sq. ft.)

Figure 4b: Monitored cross sections surveyed at the Kastanis site (control) pre-flood and post-flood (Scale: 1" = 10').

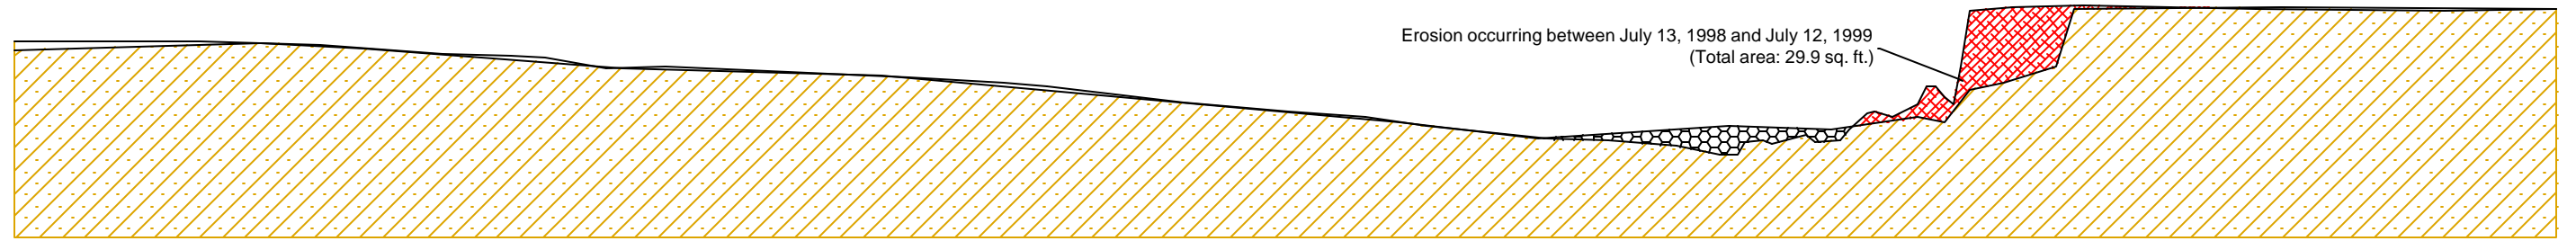
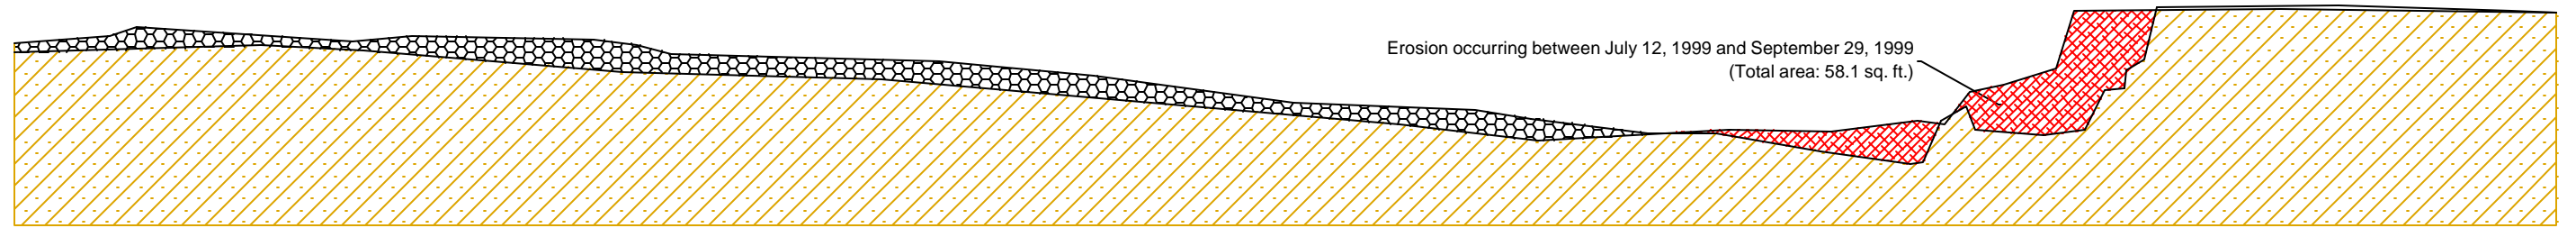
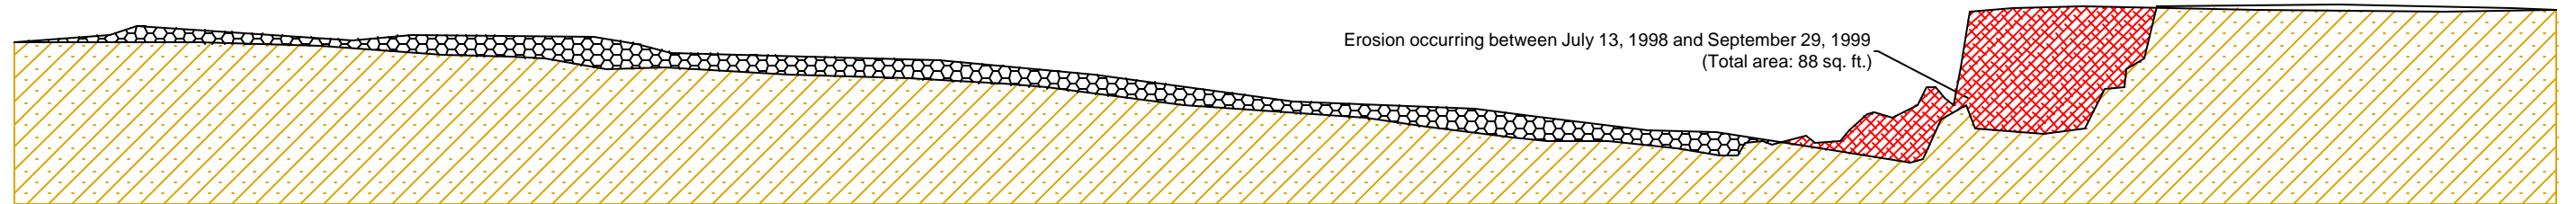
Figure 4a: Monitored cross sections surveyed at the Kastanis site (control) pre-flood and post-flood (Scale: 1" = 10').

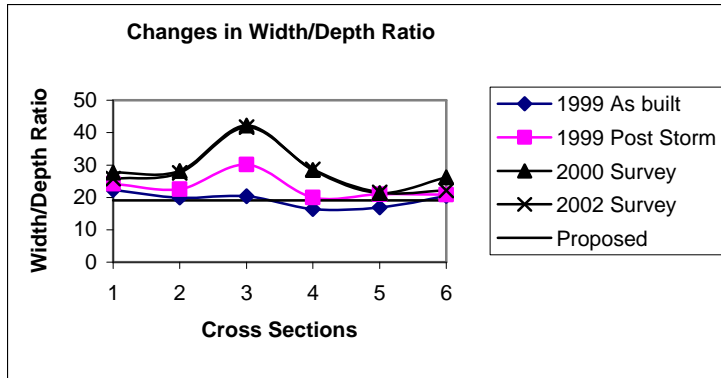
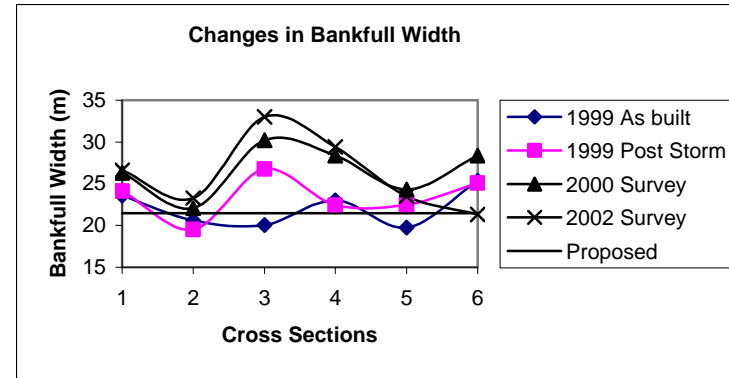
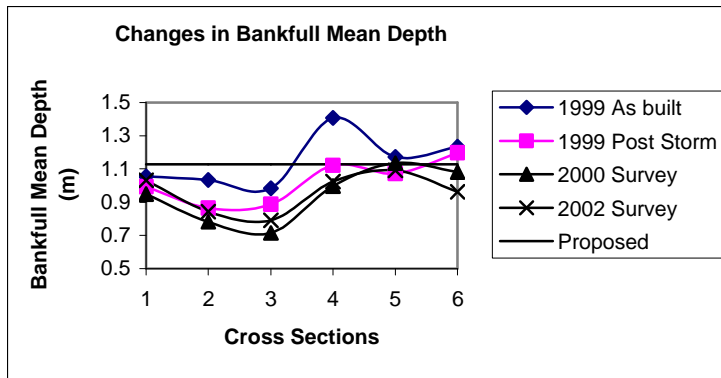
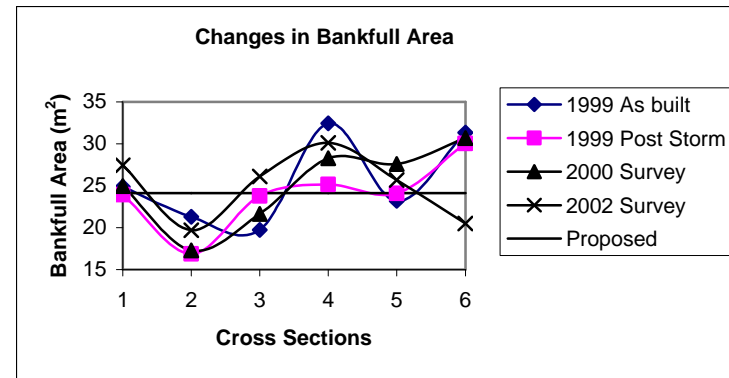
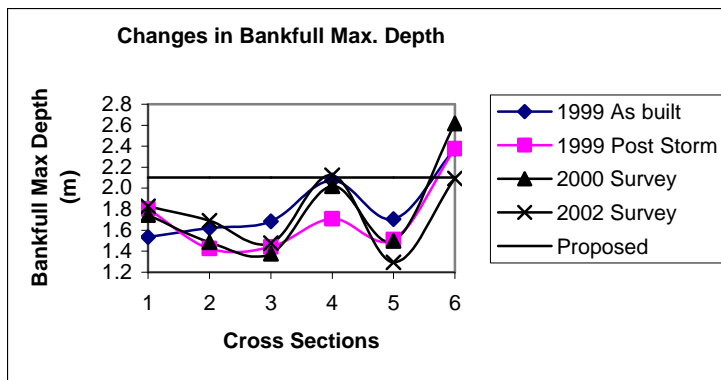
Figure 3: Changes of Post-project Morphological Characteristics from 1999 to 2002 at 6 Cross Sections on the Maier Farm Project Reach in the Batavia Kill watershed
