**Project Design Report
R.A. Hill Stables Demonstration Project
West Kill Creek**

**December 31, 2006
Prepared by Mark Vian¹ and Joel Dubois²**

¹ New York City Department of Environmental Protection Stream Management Program

² Greene County Soil and Water Conservation District

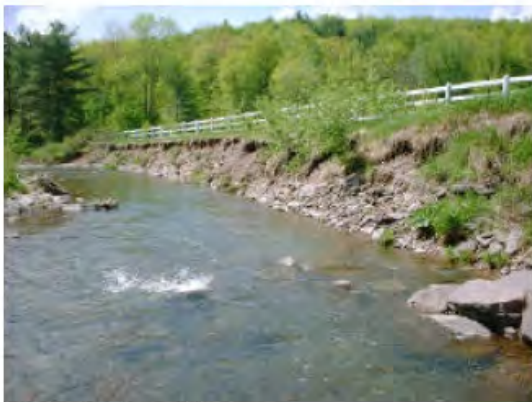
The project addressed bank erosion that had undermined several hundred feet of fencing along a horse pasture on the right bank, and threatened the main drive into the stables. Some sections of the restoration treatment area had become overwidened, and had developed large center bars. The erosion documented at the site during the Stream Feature Inventory conducted during the summer of 2004 worsened significantly as a result of the high flows that occurred in the West Kill watershed in April, 2005.

Bank Erosion, 2004

Bankfull “benches” or terraces were installed along the face of each eroding stream bank, over approximately 1600 ft.. The face of each terrace was constructed of appropriately sized rock material to protect the bank from continued erosion at high flow, with rock “deadmen” or cutoffs placed perpendicular to streamflow at approximately 20’ intervals to forestall the development of channelized flow across the benches, and the bench itself was backfilled with soil. The toe and

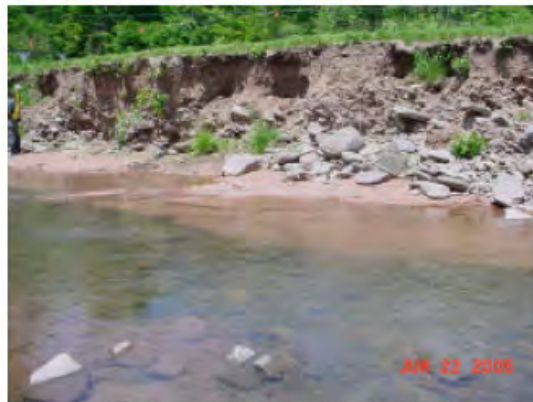
Worsening streambank erosion in 2005

Three stream banks on the site experienced significant erosion during the April 2005 flood. Extensive exposures of lacustrine clay deposits were documented at two of the three eroded banks (see photo above). Entrainment of colloidal clay materials from these deposits represents a water quality concern. Turbidity

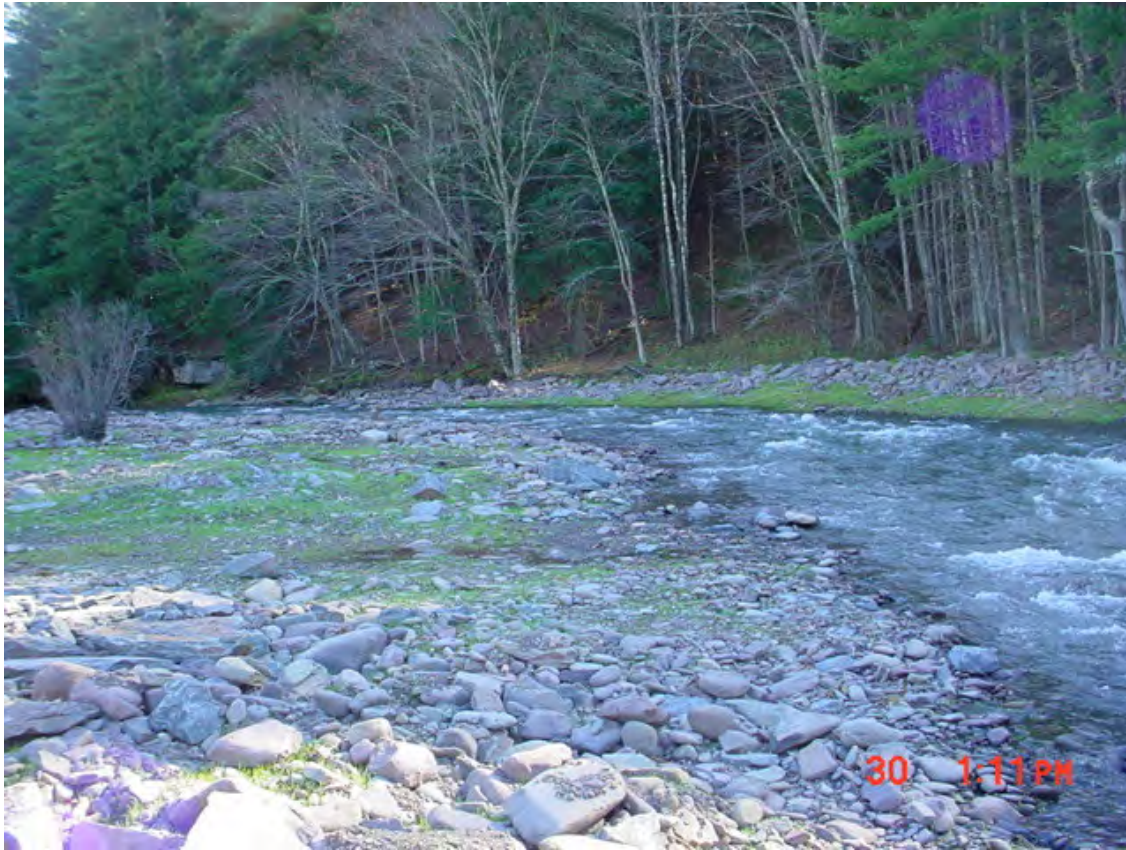
Figure E3 Looking upstream from right bench at pasture

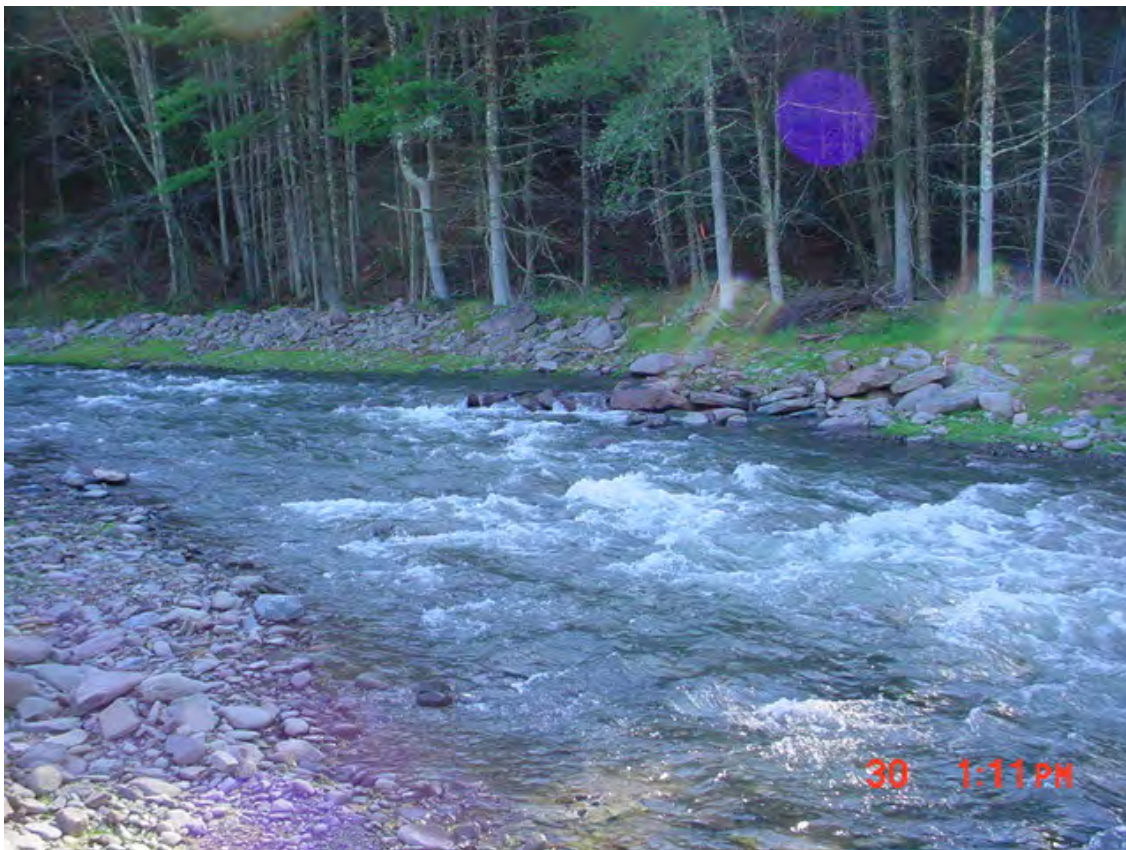
Figure E4 Looking upstream at top rock vane on left bank

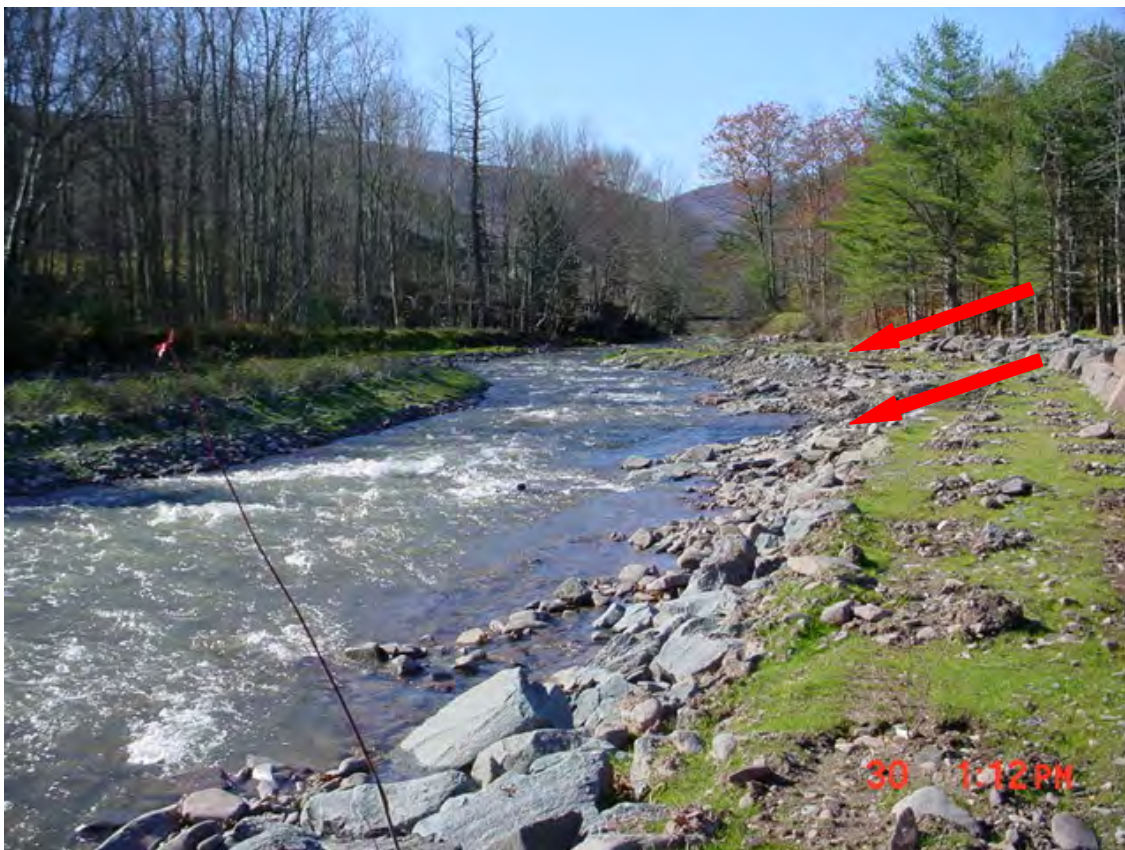
Figure E6 Two rock vanes (red arrows) on lower third of right bankfull bench. Note that turbulent flow is moved off-bank, toward center of channel. Bench is seeded and planted with potted material.
