PROJECT REPORT  
Westkill Stream Restoration Demonstration Project

Greene County & Water Conservation District  
December 2005

# **West Kill Stream Restoration** **Demonstration Project**

## **2005 Damage Repairs** **Post Construction Report**

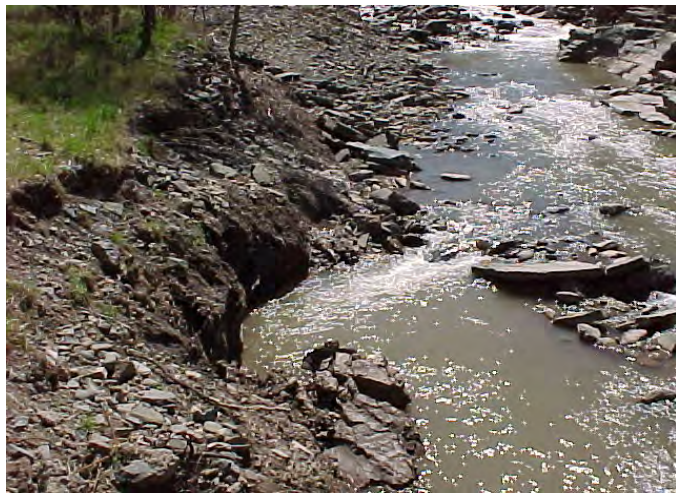
While the GCSWCD did not install monitoring cross sections in the reach, repeated visits to the site during development of the project resulted in observations that the channel had downcut as much as six (6) feet in depth or more in less than two years. In addition, down cutting of the channel under the Shoemaker Road Bridge also resulted in a bank failure that resulted in the abutment dropping approximately four feet making the bridge impassable.

Figure 1: Extensive clay exposures due to channel down cutting presented a significant water quality impact, as well as extensive infrastructure damage.

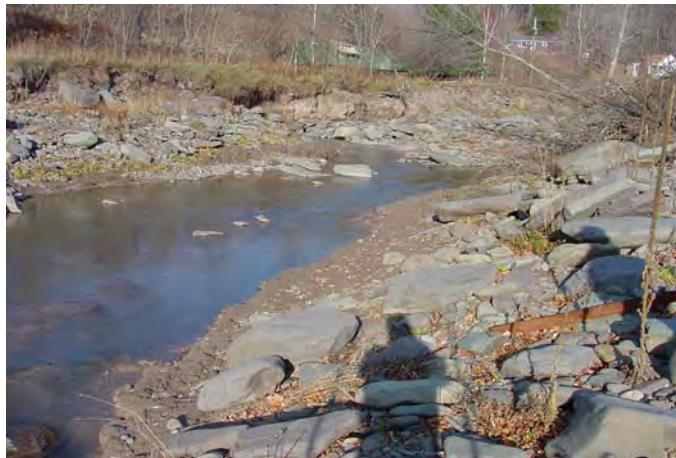
Figure 2: Coarse gravel/cobble materials seen on the right and left banks represent the channel invert elevation prior to downcutting. Note the clay present in the current channel bottom

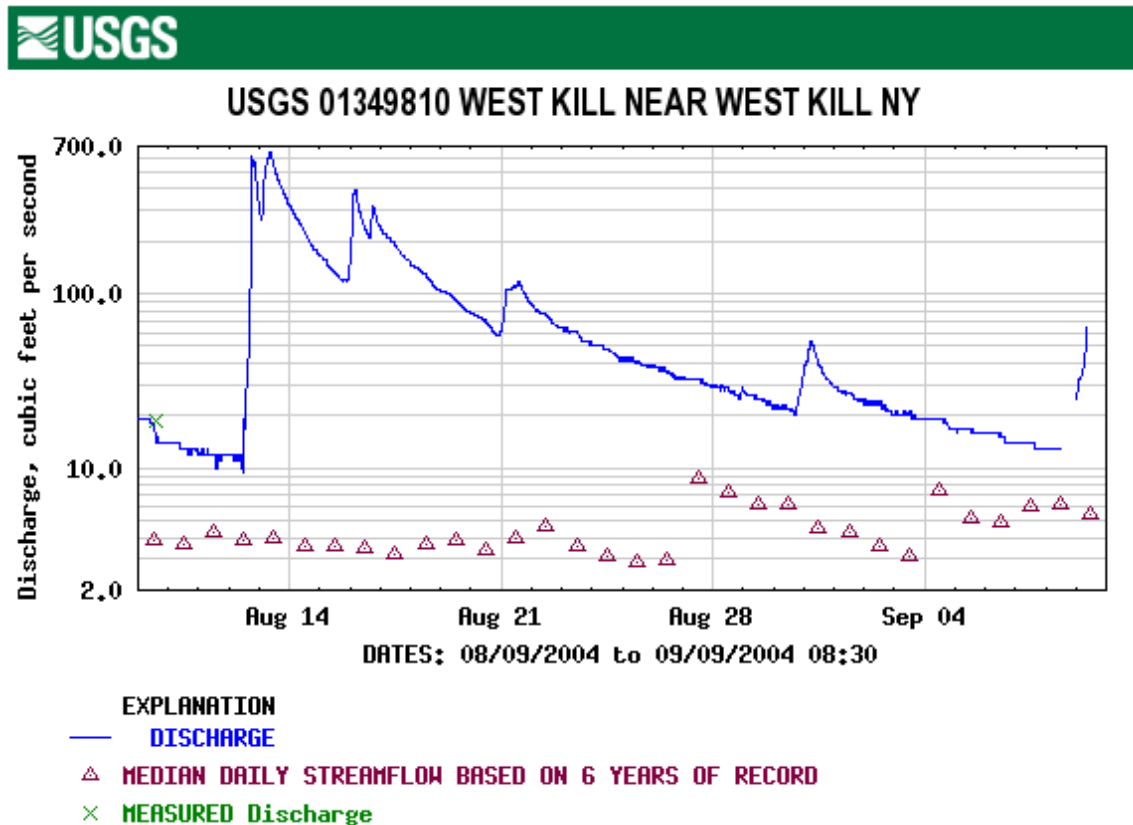
**9.2 Construction Schedule** - Construction activities were initiated in the beginning of July 2003. While work progressed fairly smoothly through July of 2003, above average rainfall and an associated high stream flows overwhelmed the dewatering equipment for much of the construction season after the end of July. After repeated week or longer shutdowns due to the inability to either dewater the work area or handle sediment control, the project was closed down for the season in mid-September 2003.

Similar problems were experienced during the summer of 2004, however approximately 75% of the project was completed. Figure 3 below shows a hydrograph for the West Kill that was typical of the 2003 and 2004 construction seasons. Please see Appendix D for a sample of the available documentation for the above average stream flow during the 2004 construction season. A late spring storm in 2005 caused excessive runoff and damaged a portion of the work completed during the 2004 construction season which added repair work on to the 2005 construction season's schedule. Please see Appendix E for a description of the repair work.

Figure 3: Hydrograph from lower West Kill stream shows the impact of repeated storm events in the watershed.

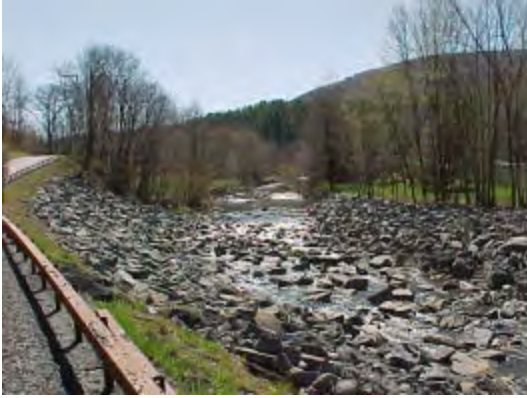
**Figure 1: Preconstruction channel**

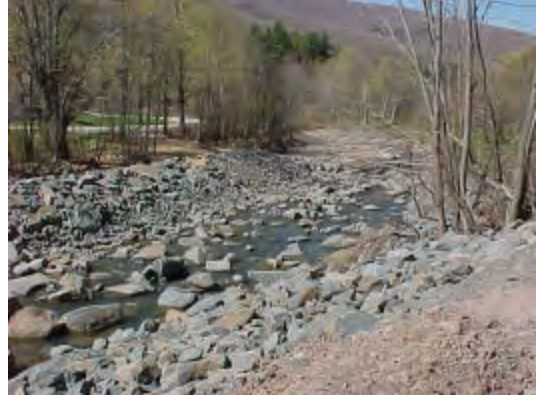
**Figure 2: Preconstruction channel**

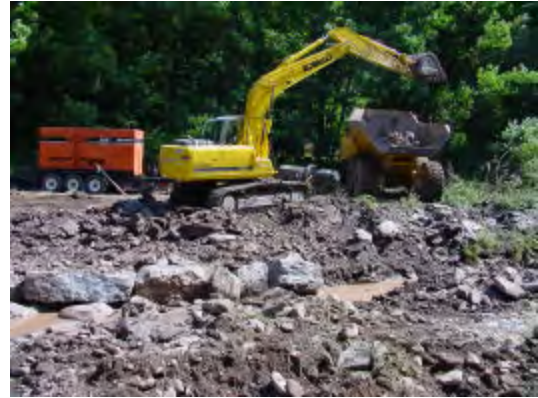
**Figure 10: Excavating excess clay from the channel bottom**

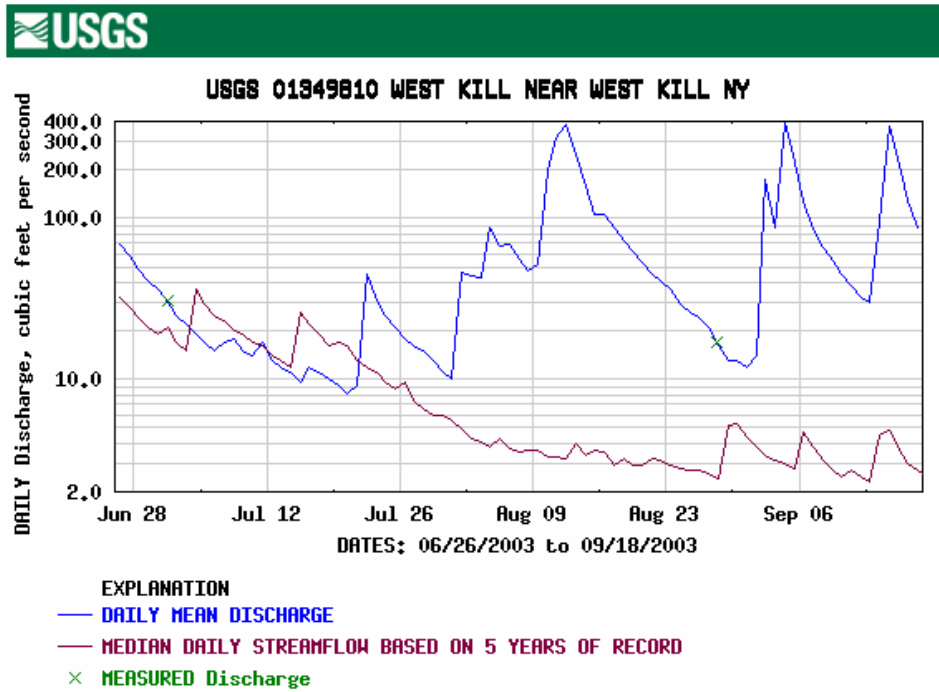
Hydrograph for 2003 construction window.

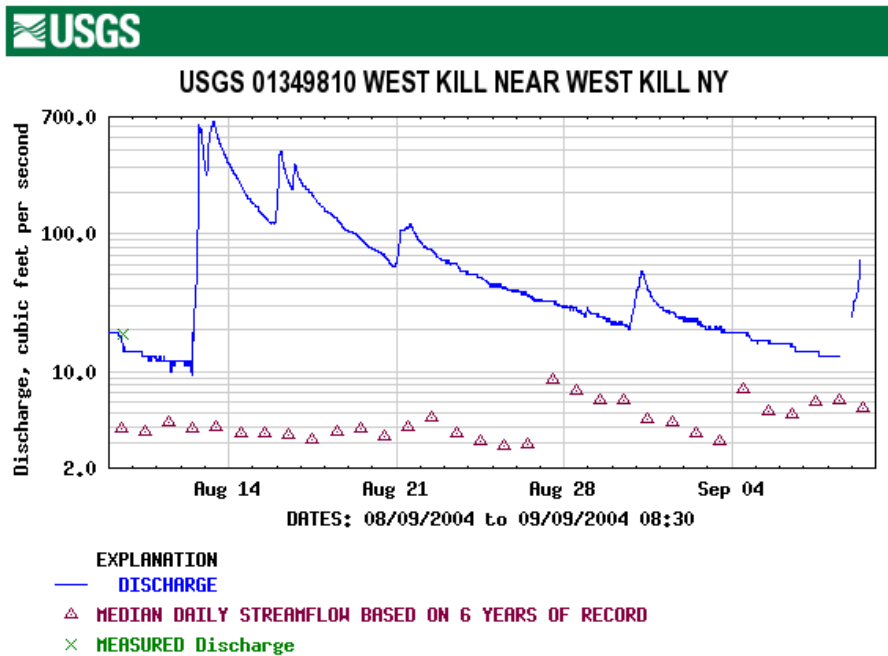
Hydrograph for portion of 2004 construction window

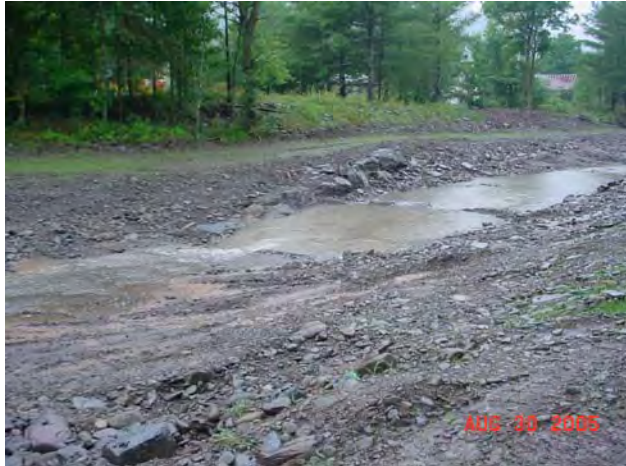
#### 10+50 – 12+00

Aggradation in this reach resulted in lateral channel migration. Following reestablishment of the design channel grades in phase 1 of the repair work, an additional rock cross vane was installed at station 11+00. The structure is intended to promote stable sediment transport through the reach. The cross vane will also provide structural control of the channel plan, dimension and profile. Keyways were installed, as components of the vane installation, which reduce the risk of structure flanking on both the left bankfull bench and the right flood plain. The keyway at the right extended across the entire floodplain and tied into the toe of the low terrace. 2 additional rock sills were added to the structure at

approximately 1/3 and 3/4 of the way along the vane arms. The sill elevations were set in such a way that each sill was slightly lower in elevation than the sill immediately upstream of it. This resulted in a cascading step pool feature. The additional sills were intended to improve grade control while facilitating fish passage through the structure. The effectiveness of the

structure modification will be evaluated over time for its applicability on future projects.
