**Management Unit 1**  
Greene County - Town of Hunter  
NYS DEC Forest Preserve to Notch Inn Bridge

**Management Unit Description**

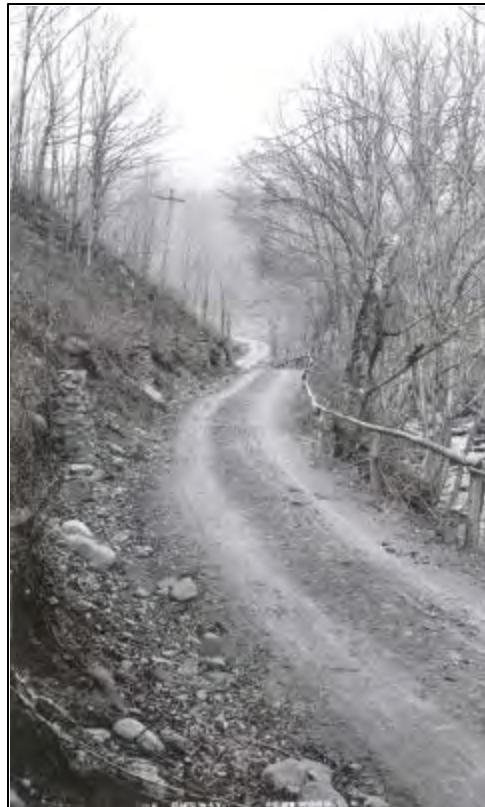
**Figure 4 (right) NYS Route 214, near Edgewood**

The photograph of the highway somewhere in the vicinity of Edgewood would suggest that maintenance of NYS Route 214 (and perhaps of the railroad bed as well in places) would have involved a recurrent struggle with erosion of the toe of the embankments by the stream during floods, as it still does (Fig. 4). The absence of large trees illustrates the extent of deforestation in the valley. Stacked rock walls were frequently used for bridge abutments and stream bank revetment (Fig. 3).

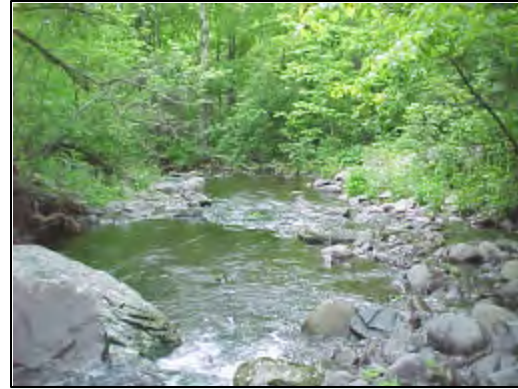
**Figure 6 Cross-section 1  
Stream Type F3**

This management unit starts with a short 80 ft. reach of F3 stream (Fig. 6). This reach is dominated by small cobble bed material and is *entrenched*, or confined within its banks during flood events. This entrenchment is partially due to the 146 ft. cobble *berm* constructed on the right bank (Inset C). This old berm may once have protected a pasture or residence from flooding but presently the land use is forested. This berm prevents flood waters from spilling into the floodplain. As a result flood velocity is increased, which has caused moderate stream *degradation*, and which is destabilizing the adjacent road embankment.

The berm, however, has become vegetated with fairly mature woody vegetation, the benefits of which probably outweigh those of complete removal. Therefore, it is recommended that the berm be breached in strategic locations to provide floodplain access for stormwaters while preserving mature trees. The embankment could then be repaired using *bioengineering* techniques.

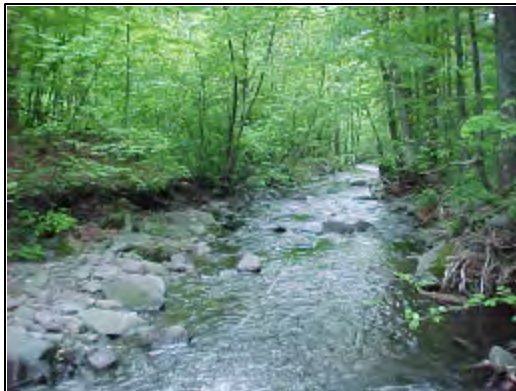
**Figure 7 Cross-section 2  
Stream Type C3b**

At the end of the berm, channel entrenchment decreases significantly and the stream is reconnected with its floodplain for the next 90 ft. of C3b stream (Fig. 7). The channel slope increases to 3.7% and the bed material is dominated by cobble.

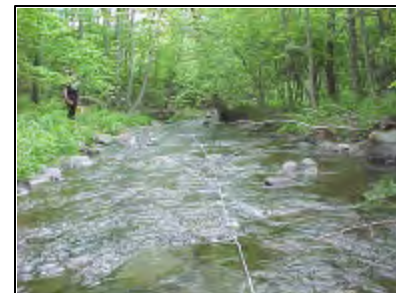
**Figure 8 Cross-section 4  
Stream Type B3**

Proceeding downstream, the stream becomes moderately entrenched for the next 484 ft. as stream type transitions into B3 (Fig. 8). As the stream *meanders* to the right at the end of the reach, there is a 30 ft. long stacked rock wall on the left bank. Due to its low height, this wall does not

significantly impact the stream channel. A small tributary from the right bank enters Stony Clove Creek just downstream of the stacked rock wall. This tributary is not classified under the NYS DEC best usage classification system.

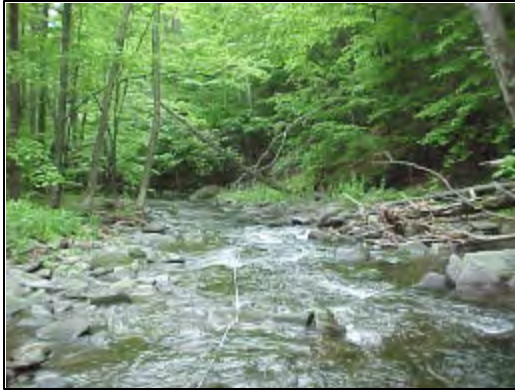
**Figure 9 Cross-section 6  
Stream Type C3b**

Once again, channel entrenchment decreases and the stream reconnects with its floodplain over the next 151 ft. of C3b stream (Fig. 9). The channel slope is fairly steep at 2.9% with small cobble bed material. At the end of this reach another small tributary enters from the right bank. This tributary is not classified under the NYS DEC best usage classification system.

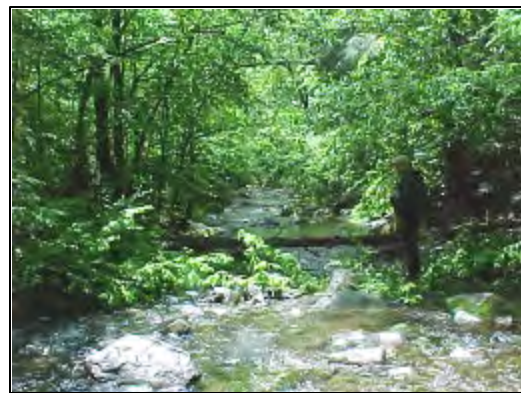
**Figure 10 Cross-section 10  
Stream Type B3**

The next 843 ft. of stream alternates between B3 and B3a and is moderately entrenched, still allowing the stream limited access to its floodplain (Fig. 10). This reach is steep, with slopes ranging from 3.6% to 4.7%. This long reach of stream is stable with cobble bed material until the last 173 ft. where the bed material decreases to large gravel. This decrease in bed material size may be an indication of sediment transport limitations caused by *backwatering* at the downstream bridge. A garage has been built on the right stream bank just upstream from the bridge. There is some evidence of minor erosion on the bank behind the garage, which could be treated with bioengineering techniques.

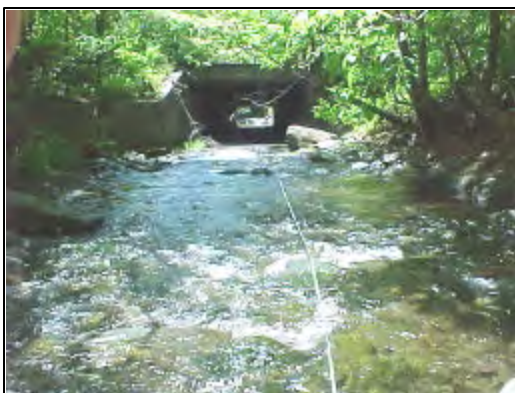
**Figure 11 Cross-section 13  
Stream Type F1b**

As the stream approaches the NYS Route 214 crossing, stream type changes to F1b (Fig. 11 & Inset B). This 156 ft. reach of stream becomes entrenched just before it passes under the road through NYS Bridge #1041280. This bridge, built in 1948, is maintained by NYS DOT. The bed material in this reach is dominated by the concrete bed through the box culvert.

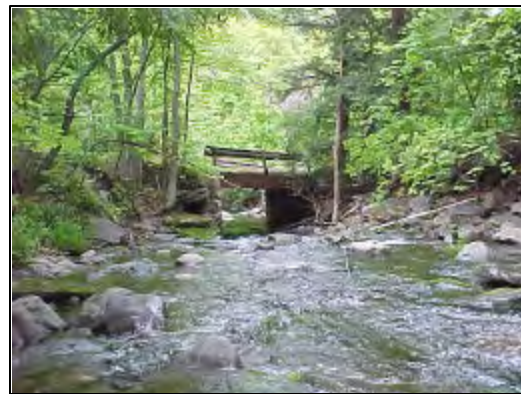
**Figure 12 Cross-section 15  
Stream Type B3c**

Continuing downstream, stream type changes to B3c, for a short 73 ft. reach (Fig. 12). This moderately entrenched reach remains fairly flat with a 0.8% slope and the streambed material remains cobble. There is a 71 ft. stacked rock wall along the right bank to protect the Notch Inn dirt access road (Inset E).

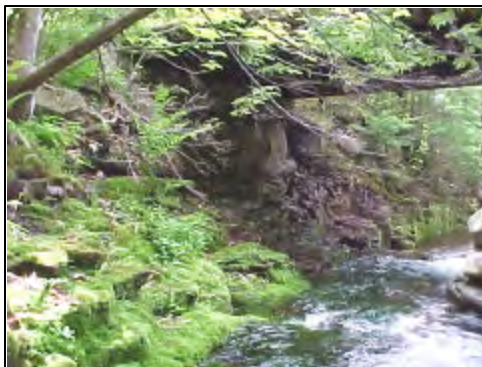
**Figure 13 Stream Type A1a+**

In the last 31 ft. of stream of this management unit, the stream turns sharply to the right and stream type changes to A1a+ (Fig. 13). The stream remains entrenched but bed material changes to bedrock and slope increases. As management unit #1 ends, the stream passes under a third bridge (Inset D). This bridge, also maintained by the Town of Hunter, is no longer necessary due to the rerouting of Notch Inn Road. The bridge span is scheduled for removal in 2004.
