Management Unit 2

Greene County - Town of Hunter
Notch Inn Bridge to Cross Section 34

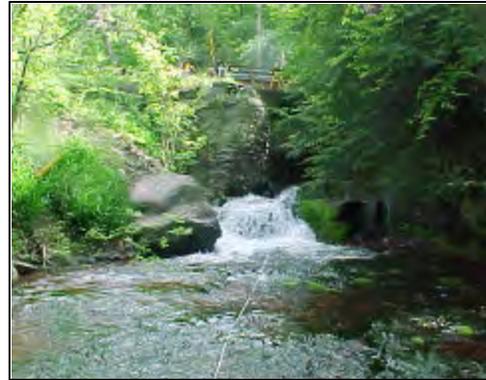
**Figure 4 Cross-section 18
Stream Type A1a+ looking upstream**

Management unit #2 begins at the Notch Inn Bridge. As the stream emerges from underneath this bridge, it plunges down a 10 ft. waterfall. The first 85 ft. of this section is classified as A1a+ stream (Fig. 4 & 5). This reach has a bedrock bed and an extremely steep slope of 12%.

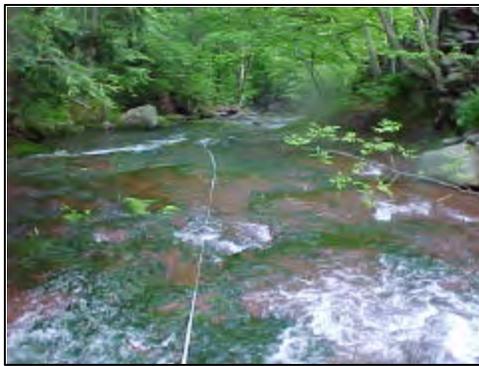
**Figure 5 Cross-section 18
Stream Type A1a+, looking downstream**

At the bottom of this waterfall a 10 ft. high, 495 ft. long historic stacked rock wall begins on the right bank (Inset D). At the top of the bank, along the length of the stacked rock wall, is a maintained grass corridor. Above this corridor sits the Notch Inn.

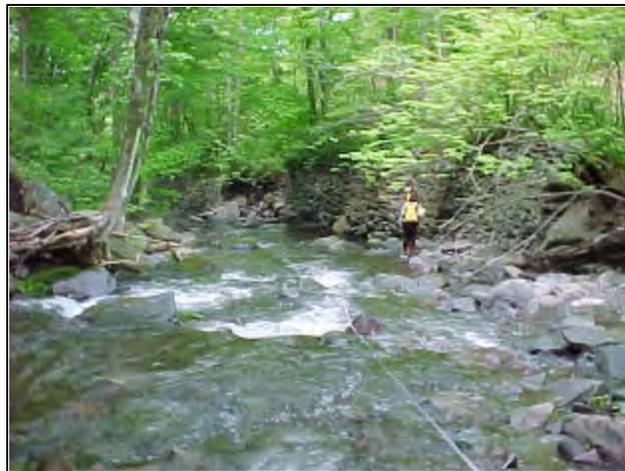
**Figure 6 Cross-section 20
Stream Type A3**

As the bedrock bed material abruptly changes to cobble and stream slope decreases, stream type changes to A3 for the next 161ft. (Fig. 6). This stream reach is *entrenched* with high stream banks, which limits the stream's access to its floodplain during high flow events. As the bed material changes, the stream drops off the bedrock into a pool. Bank erosion monitoring site #2 is on the right bank where *scour* has eroded away the toe of the stacked rock wall (Inset C). This toe failure, has caused an 11 ft. stretch of the wall to fall into the stream, leaving bare soil exposed. Without treatment, this "crack in the armor" may lead to further failure of the wall along its length. This is the first of three erosion sites along the stacked rock wall.

The Bank Erodibility Hazard Index (*BEHI*) score of site #2 is ranked "High", the third highest prioritization category in terms of its vulnerability to erosion. However, this bank erosion site is considered a low priority for restoration due to its small eroding area (133

ft²) and its lack of significant threat to infrastructure or water quality. According to Rubin's 1996 stream corridor geology mapping, the stream throughout most of this management unit is cut through unconsolidated deposits (See Section 2.4).

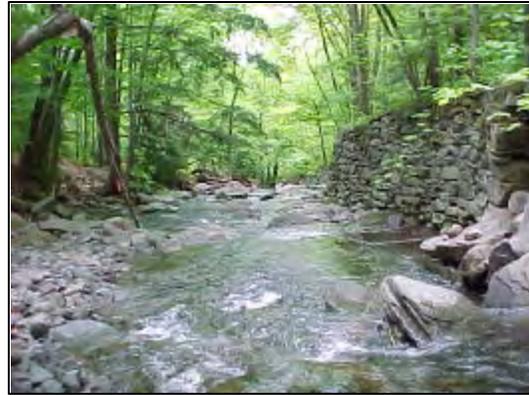
**Figure 7 Cross-section 21
Stream Type B3a**

As the stream continues with the stacked rock wall on the right, the left floodplain opens up slightly and entrenchment moderates, changing stream type to B3a for the next 604 ft. (Fig. 7). This reach remains steep with an overall slope of 5%. Approximately 40 ft. into this reach, the *thalweg* is forced, by channel constriction, into the stacked rock wall resulting in bank erosion monitoring site #3 (Inset H). The stress produced the *thalweg* against this bank has eroded the bank toe causing the bank to fail. Many large cobbles and small boulders remain at the base of this bank providing some erosion protection.

The BEHI score of site #3 is ranked “Low”, the second lowest prioritization category in terms of its vulnerability to erosion. This bank erosion site is considered a low priority for restoration due to its small eroding area (210 ft²) and its lack of significant threat to infrastructure or water quality. The stream continues (Inset B) for another 150 ft. until again the *thalweg* runs against the stacked rock wall at bank erosion monitoring site #4 (Inset A).

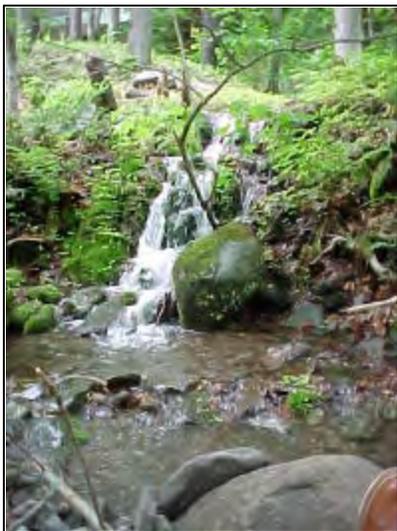
Figure 8 Tributary

The stacked rock wall on the right bank ends approximately 120 ft. downstream from erosion site #4. On the left bank a small unnamed tributary flows into Stony Clove Creek. The confluence is *perched*, but still appears stable. This tributary, shown in the picture at the left, is approximately 0.7 miles long. The tributary is rated D, the lowest classification under the NYS DEC best usage classification system. The best usage for this tributary according to the classification is fishing.

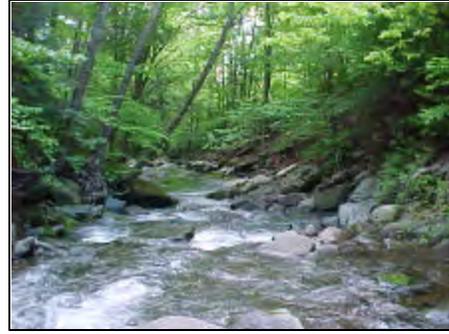
**Figure 9 Cross-section 24
Stream Type B3a**

The last 240 ft. of this B3a stream reach is stable and gently meandering (Fig. 9). At the end of this reach there is a stormwater culvert with a concrete headwall on the right stream bank (Inset G). The culvert outlet drops stormwater onto a fairly steep slope before entering Stony Clove Creek. This is normally a cause for concern because it may result in bank erosion, but this drainage way has large bed material providing some protection from erosion.

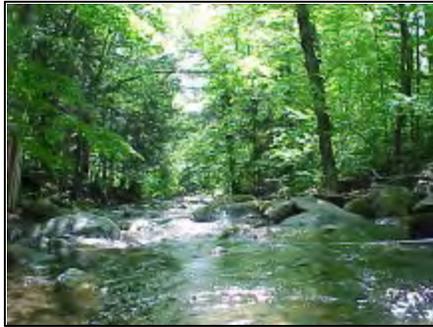
**Figure 10 Cross-section 25
Stream Type B3**

Continuing downstream, slope decreases to 3.1% as stream type transitions to B3 (Fig. 10). This 426 ft. reach is stable with a meandering *planform*. Approximately 270 ft. downstream from the beginning of this reach, at cross section 26, a tributary enters on the right bank. At the end of this reach is another small unnamed tributary on the left bank (Inset F). Neither of these tributaries is classified by the NYS DEC.

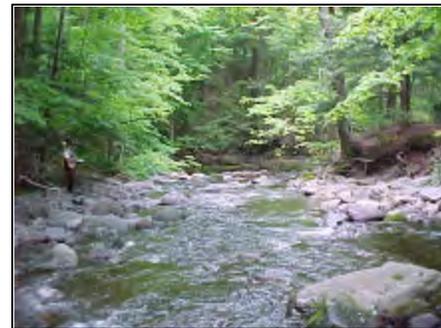
**Figure 11 Cross-section 28
Stream Type F3b**

Proceeding downstream, the channel becomes entrenched again and slope decreases to 2.6%, changing the stream type to F3b for 118 ft. (Fig. 11).

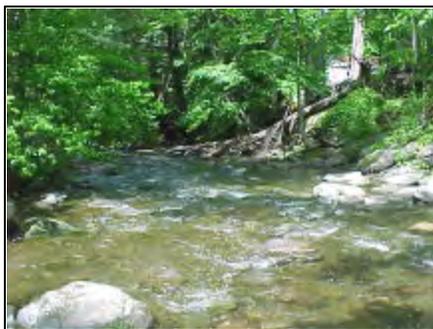
**Figure 12 Cross-section 30
Stream Type B3**

At the end of this reach, there is 100 ft. bedrock outcrop on the left bank, forcing the stream turn sharply to the right. As the stream comes out of this turn the slope decreases to 2.8%, transitioning to B3 stream type for this 316 ft reach (Fig. 12). This moderately entrenched reach poses an erosion threat to the right bank, at the property with the newly renovated red barn. This bank is a prime candidate for plantings to reduce this erosion risk.

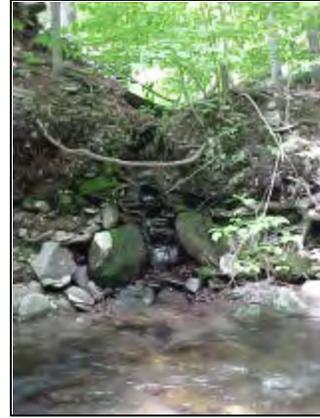
Figure 13 Tributary

A small unnamed tributary enters the creek from the right stream bank at the end of this reach (Fig. 13). This tributary is not classified under the NYS DEC best usage classification system. According to landowner accounts, during heavy rainfalls, water crosses their lawn to enter the creek. This overland flow has begun to form gullies and contributes to streambank erosion.

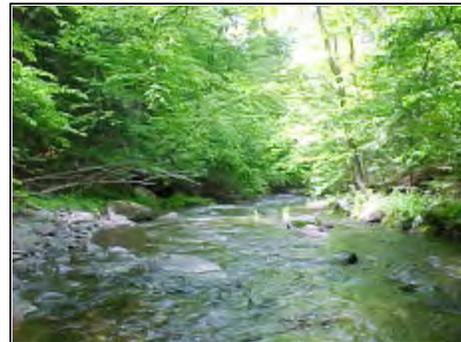
**Figure 15 Cross-section 34
Stream Type B3c**

As the management unit comes to an end, the stream type changes to B3c (Fig. 15). Entrenchment moderates and slope decreases dramatically to 0.9% through the final 115 ft. of this unit.

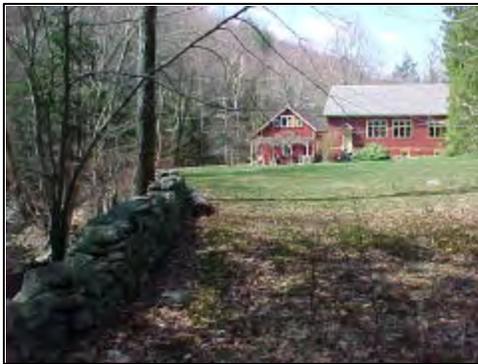
Figure 21 Planting Site #4

Planting site #4 is located at the newly renovated red barn on the right side of NYS Route 214 (Fig. 21). The right stream bank located on this property is fairly steep with scattered trees and shrubs. This stream bank is slightly eroded and is susceptible to erosion in the future. To reduce this risk the stream bank should be planted with trees and shrubs. Due to the steepness of this bank, use of a *geotextile* may be necessary to ensure planting success. To improve buffer function in this area, it is recommended to plant the mowed area with native trees and shrubs. If this option is

disagreeable to the landowner, increasing the buffer width by at least 20 ft. beyond the stone wall could increase buffer functionality while still allowing a significant lawn area.
