**Management Unit 4**  
Greene County - Town of Hunter  
Cross Section 65 to Cross Section 90

**Management Unit Description**

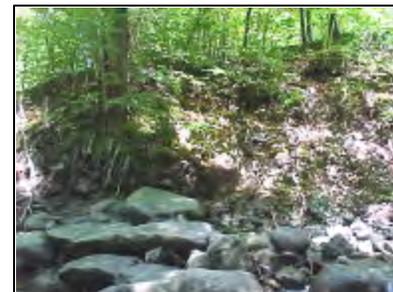
**Figure 9 Bank Erosion**

The *thalweg* moves against the right bank, which is actively eroding (Fig. 9). This stream bank is subject to scour at the toe during high flow events, causing the bank to become undercut, despite riparian vegetation including mature trees at the top of the bank, which provides some protection against this erosion.

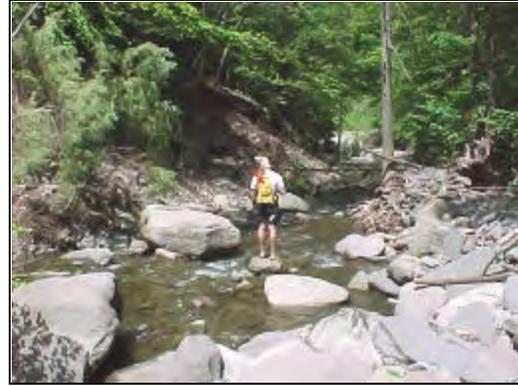
**Figure 10 Cross-section 70  
Stream Type B4a**

At the next meander bend, *dominant bed material* size decreases to very coarse gravel, and stream type changes to B4a for the next 155 ft. (Fig. 10). The channel is moderately entrenched with a steep slope of 4.6%.

On the outside of the meander bend at the top of this reach, the stream begins to erode the left bank. Bank erosion monitoring site #8 is 273 ft. in length and 8941 ft.<sup>2</sup> in area, qualifying it as the fifth largest eroding area along Stony Clove Creek (Inset H).

This erosion site is more than thirty ft. in height with no vegetation remaining on most of its face. Previous geologic mapping indicated the presence of *lodgement till* along this section of the management unit, and the stream feature inventory identified large areas where the bank material is clay or clay-rich lodgement till, evident at this erosion site. During high flows clay exposed to stream flow is introduced into the stream as *suspended sediment*. Introduction of clay into the stream represents a threat to water quality and aquatic habitat.

The Bank Erodibility Hazard Index (*BEHI*) score of site #8 is ranked “Very High”, the second highest prioritization category in terms of its vulnerability to erosion. This bank erosion site is considered a high priority for restoration due to its large eroding area and severe water quality threat.

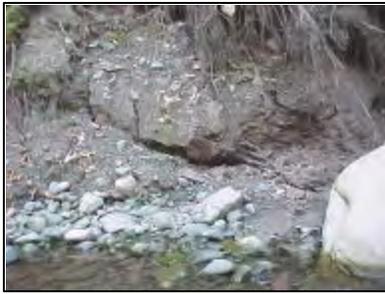
**Figure 13 Clay Exposure**

F3b stream reach is 81 ft. in length with a slope of 2.5%. Bank erosion site #8 ends at the bottom of this reach. There is a large clay-rich exposure of lodgement till on the left bank (Fig. 13).

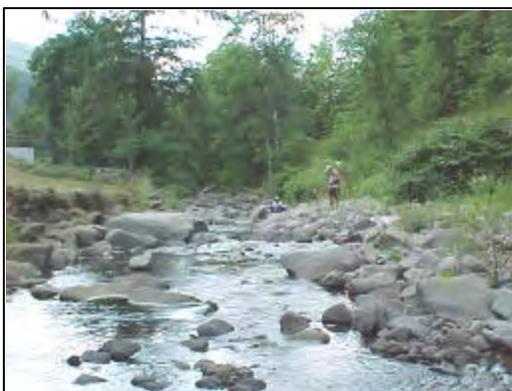
**Figure 15 Cross-section 75  
Stream Type F3b**

Aggradation also steepens stream channel gradient downstream of the deposition site. This proves true for the next 578 ft. reach of F3b stream type (Fig.15). Slope at the top of this entrenched reach increases to 4.1%. Along 217 ft. of the right bank, road embankment protection continues as concrete T-wall with sheet piling at the toe (Inset C). After the first 50 ft. of this reach, stream slope decreases to 2.3%

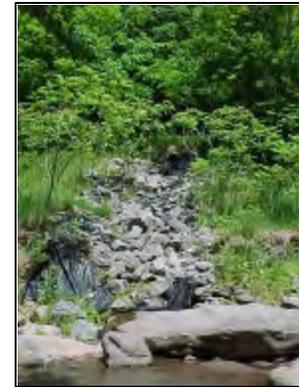
**Figure 16 Culvert**

At the end of the T-wall there is a culvert with rip-rap on the right bank (Fig. 16). The culvert outlet is set back from the stream channel on a steep slope. This outlet could be highly prone to erosion if the outlet channel was not lined with stone material. Along the left bank of this reach is a residential property with a grass lawn mowed to the edge of the stream bank. This bank is experiencing minor erosion which may become a larger problem in the future. Streamside plantings of trees and shrubs would reduce this erosion threat.

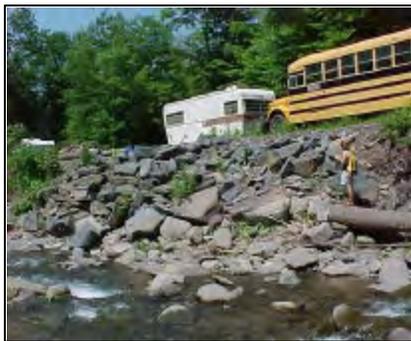
**Figure 17 Rip-Rap**

As the stream bends left away from NYS Route 214, the toe of the right stream bank has eroded and rendered the face of this bank raw and unvegetated. Bank erosion monitoring site #9 is 93 ft. in length along this bank (Inset B).

The BEHI score of site #9 is ranked “High”, the third highest prioritization category in terms of its vulnerability to erosion. Previous geologic mapping did not identify lodgement till or glacial lake clay exposures in this reach. This bank erosion site is considered a lower priority for restoration due to its small eroding area (807 ft<sup>2</sup>) and low threat to infrastructure or water quality.

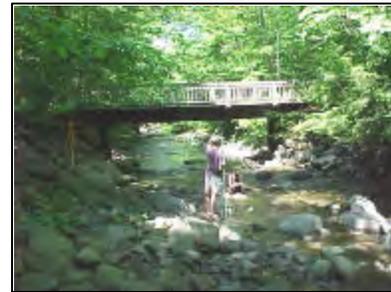
**Figure 20 Private Bridge**

At the top of this reach, the stream passes under another private bridge (Fig. 20). This bridge was damaged in the

January 1996 flood. Additional *floodplain drainage*, using culverts set at the floodplain elevation under the north bridge approach, may help prevent future damage. Most of this 224 ft. reach is fairly straight but stable.

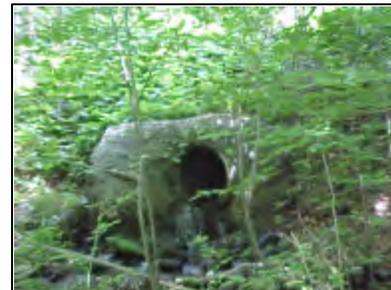
**Figure 22 Culvert**

At the top of this reach, a culvert with a concrete headwall drains to the stream at the right bank (Fig. 22). The culvert outlet is on a steep slope. This outlet could be highly prone to erosion if the outlet channel was not lined with stone material.

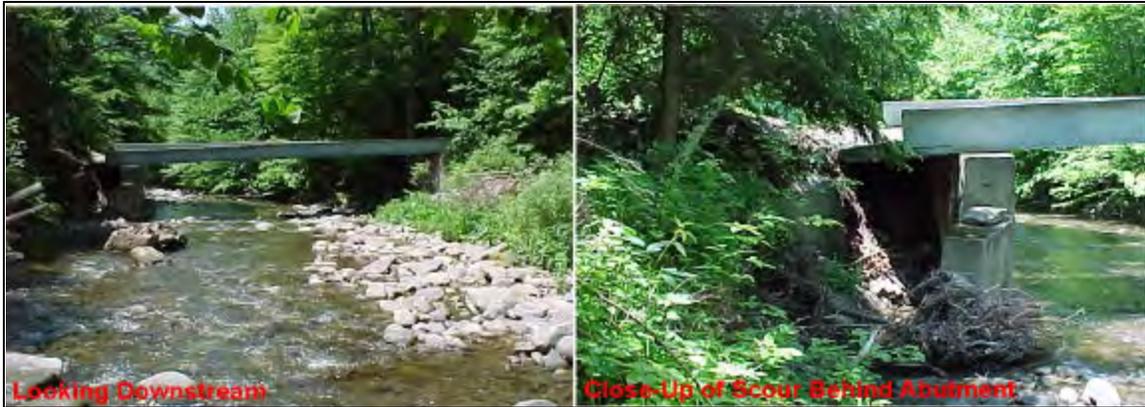
**Figure 23 Private Bridge**

Moving away from NYS Route 214 again, entrenchment moderates, and stream type transitions into B3. At the top of this 325 ft. reach, the stream passes under a private bridge (Fig. 23). During a high flow event in 2000, scour occurred behind the left bridge abutment. Due to damage to the abutment, the deck of the bridge has tilted to one side, rendering the bridge impassable since the flood. Landowners are still unable to access their property on the opposite side of the stream.

Inadequate sizing of bridge openings commonly causes severe damages to bridges. An undersized bridge opening (i.e., too narrow) causes water to back up upstream of the bridge and scour abutments. A geomorphically appropriate bridge design is necessary for a suitable replacement bridge. Additional *floodplain drainage*, using culverts set at the floodplain elevation under the north bridge approach, may help mitigate this problem.

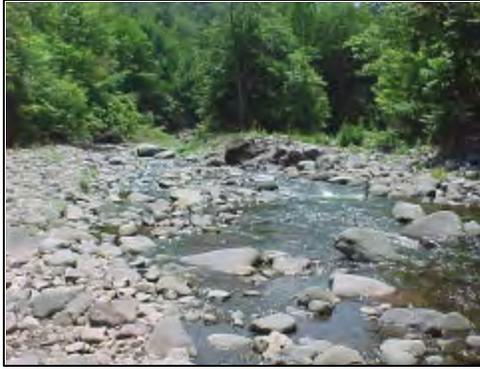
**Figure 26 Cross-section 88  
Stream Type F3b**

As the stream widens significantly, becomes entrenched and slope increases to 2.4%, stream type changes to F3b (Fig. 26). At the top of this 116 ft. reach, bank erosion monitoring site #10 begins (Inset A). The thalweg moves against the right bank, and high *shear stress* exerted on the outside of the meander bend has caused a 130 ft. long bank failure. The owner of this property has recently installed rip-rap on the bank for protection. Adding vegetation to this site would greatly improve site stability and longevity.

The BEHI score of site #10 is ranked “Moderate”, the third lowest prioritization category in terms of its vulnerability to erosion. This bank erosion site is considered a low priority for restoration due to its small eroding area (888 ft<sup>2</sup>) and its low threat to infrastructure or water quality.

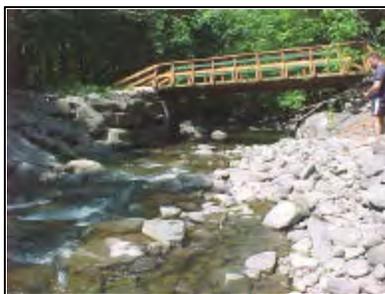
**Figure 28 Cross-section 90  
Stream Type F3**

As the stream narrows to pass under a private bridge near the bottom of this management unit, stream type changes to F3 for the last 88 ft. of this management unit (Fig. 28). There is a large gravel deposit along the right stream bank. Inadequate sizing of bridge openings commonly causes gravel deposits upstream of bridges. An undersized bridge opening (i.e., too narrow) causes water to back up upstream of the bridge, reducing stream velocity, which results in sediment deposition. At high stage, floodwater may seek conveyance through alternative paths, forming new channels around the

bridge constriction, as appears to have happened at this site. Additional *floodplain drainage*, using culverts set at the floodplain elevation under the north bridge approach, may help mitigate this problem.

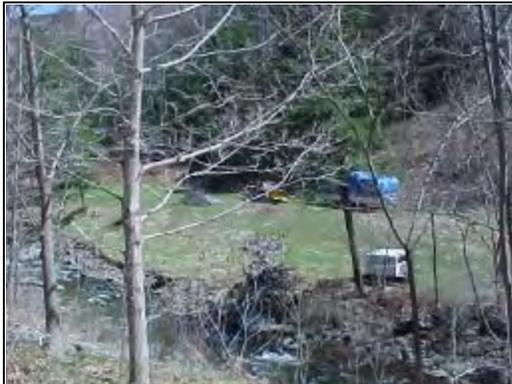
**Figure 31 Planting Site #17  
Looking upstream**

Planting site #17 is located on the left bank at residential properties upstream from Benjamin Rd. Bridge (Fig. 31). This property has a large mowed lawn area, which extends to the edge of the stream bank. The left stream bank is experiencing minor erosion. To successfully prevent further erosion of this stream bank, stream banks should be planted with native trees and shrubs. To further increase stability of this site a buffer should be established on the grass area at the greatest width agreeable to the landowner.

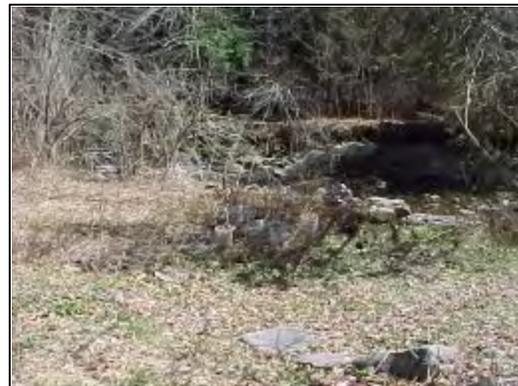
**Figure 32 Planting Site #18**

Planting site #18 is located at a private residence (fire#2124) on NYS Route 214 (Fig. 32). There is a low bench on the right stream bank with scattered shrubs and grass. This site should be monitored to assure vegetation continues to establish. If establishment does not continue, additional native tree and shrub plantings are recommended to increase the density of the upland stream buffer.

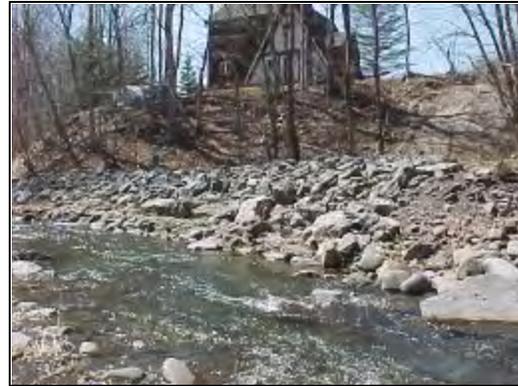
Figure 33 Planting Site #19

Planting site #19 is located at a residence (fire#2108) on NYS Route 214 (Fig. 33). At this site there is a steep bank, which is mostly covered with trees, below which is a small flat grass area, and the stream bank is armored with rip-rap. Inserting plant materials into the soil between rip-rap rocks, or *joint planting*, is recommended. Joint planting will strengthen and increase the longevity of this rip-rap, while adding aesthetic and habitat value. To provide protection from scour at the toe of the stream bank, willows should be planting along the base of the stream bank. To prevent erosion from runoff, plantings of native trees is recommended on the upper section of the steep bank, which is currently bare. Due to the steepness of this bank, the use of a *geotextile* may be necessary to ensure planting success.

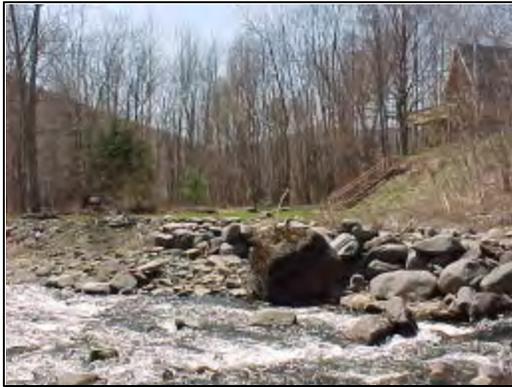
Figure 34 Planting Site #20

Planting site #20 is located at a residence (fire#2092) on NYS Route 214, directly downstream from planting site #19 (Fig. 34). A grass lawn area currently extends to the edge of the right stream bank. At one time this bank may have been completely armored with rip-rap, but now consists of large scattered cobbles and bare soil. To provide protection from scour at the toe of the stream bank, willows should be planted along the base of the stream bank. The stream bank and terrace above should also be planted with native trees and shrubs.
