Management Unit 5
Greene County - Town of Hunter
Cross Section 90 to Cross Section 107

Management Unit Description

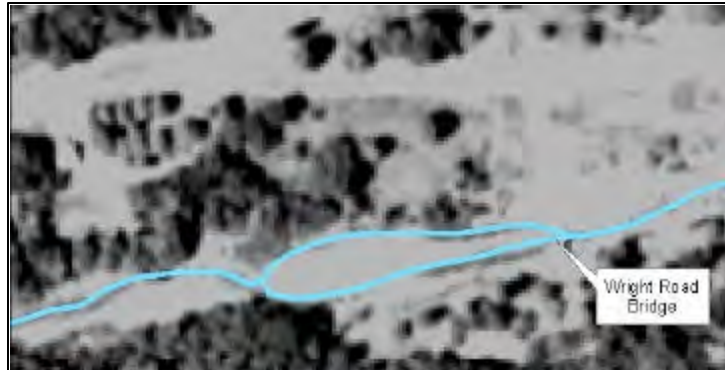
Figure 4 - 1959 aerial photograph with stream alignment

Historical stream channel alignments indicate that most of the stream channel within this management unit has remained laterally stable (Fig. 4). As revealed by this 1959 aerial photograph, the stream channel downstream from the Wright Road bridge was at one time split into two channels. The stream rejoined into one channel approximately 400 ft. downstream. This split does not appear in the next available aerial photographs taken in 1980.

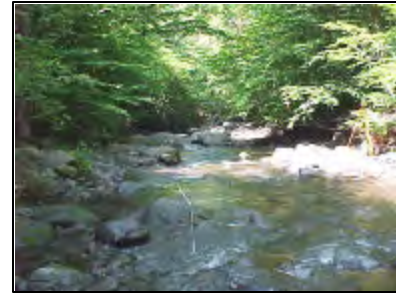
**Figure 8 Cross-section 93
Stream Type B3**

As the stream becomes moderately entrenched, limiting its ability to overspill its banks, stream type transitions into B3 for the next 155 ft. of stream (Fig. 8).

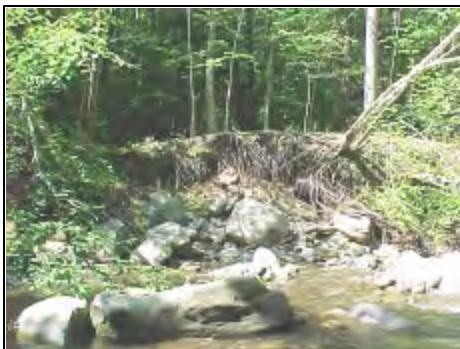
Figure 11 Bank erosion site #12

From the end of this reach to the Wright Road bridge, the stream shows indications of extreme instability. Monitoring at bank erosion monitoring site #12 (Inset H & Fig. 11) focuses on the left bank. During high flow events, this bank is subject to severe erosion due to the entrenchment of the stream channel. Adding to the instability of this reach, a *headcut* is migrating upstream between erosion sites #11 and #12, causing channel

incision. Although the top of this bank is heavily forested, the bank angle is over-steep, and vegetation appears to be disconnected from the water table. Erosion is active and numerous trees continue to be undercut. The morphology of this section is unstable and revegetation alone will not be sufficient to stabilize the bank. It is recommended that grade control be established throughout the reach to achieve more effective flood conveyance, and stream banks be graded and vegetated.

The Bank Erodibility Hazard Index (*BEHI*) score of site #12 is ranked “High”, the third highest prioritization category in terms of its vulnerability to erosion. Previous geologic mapping did not identify lodgement till or glacial lake clays at this site, and none were identified during the stream feature inventory. This bank erosion site is considered a medium priority for restoration because of its threat to infrastructure downstream but has a small eroding area (768 ft²) and does not threaten water quality.

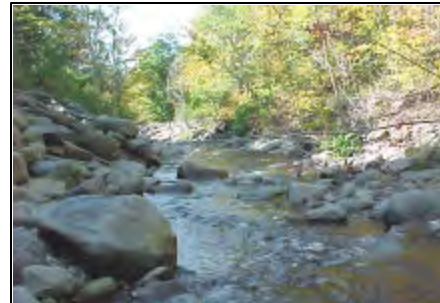
**Figure 15 Cross-section 100
Stream Type F3b**

As the channel becomes more entrenched and slope decrease to 2.3%, stream type changes into F3b for the next 350 ft. of stream (Fig. 15). This reach has high banks on both sides, and has experienced severe erosion during past flood events. In efforts to protect their homes, both stream banks have been heavily armored with rip-rap by the landowners.

As shown in the figure 15, there is 102 ft. of rip-rap on the left bank at the upstream end of this reach.

The reaches from cross-section 97 through 101 are trending toward increased instability, and without intervention, are unlikely to return to a stable form without significant consequence to adjacent residences. Access and dewatering difficulties complicate restoration efforts here. Full restoration is recommended at this site to mitigate potential flood-related erosion hazards. Restoration design should address both grade control and bank stability issues.

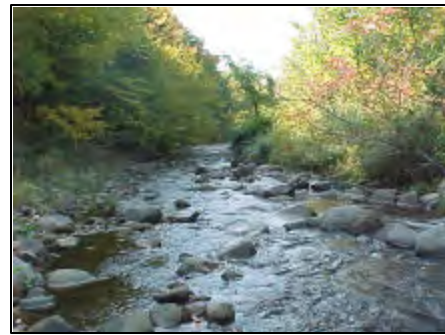
Figure 17 Cross-section 105 Stream Type B3

Proceeding downstream, the channel becomes moderately entrenched and slope increases slightly to 2.1% for a short 134 ft. reach of B3 stream type (Fig. 17).

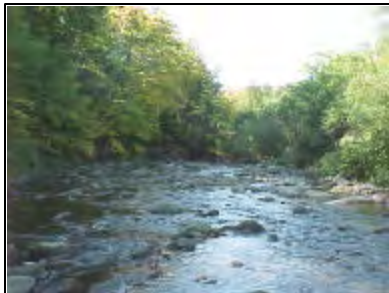
Figure 18 Cross-section 106 Stream Type F3

once again becomes entrenched and the slope decreases to 1.7% (Fig. 18). This 467 ft. reach has an overwide channel and is shallow. Overwide channels are considered unstable because they often *aggrade*, which eventually causes bank erosion by increasing stream velocity against the stream bank. Overwide channels also provide poor fish habitat due to filling of deep pools and warmer water temperatures.

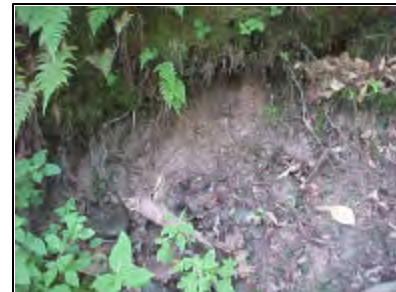
At the top of this reach, on the left bank, is a clay exposure, confirming Rubin's 1996 geologic mapping of lodgement till here (Fig. 19). Clay inputs into a stream are of serious water quality concern because they can increase *turbidity*, degrade fish habitat, and act as a carrier for other pollutants and pathogens.

Figure 19 Clay Exposure

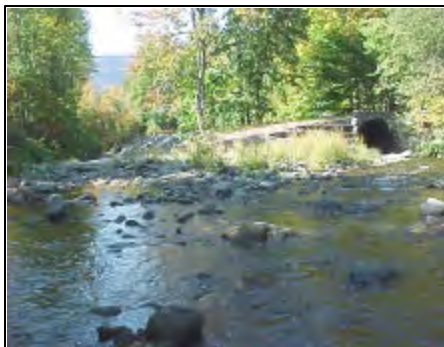
Figure 20 Cross-section 107 Stream Type C3

As the channel reconnects with its floodplain, stream type changes to C3 for the last 184 ft. reach in this management unit (Fig. 20). The channel begins to narrow and the slope remains consistent at 1.8%. At the top of this reach, there is another clay exposure located on the left bank.
