Management Unit 9
Greene County - Town of Hunter
Cross Section 131 to Cross Section 135

Management Unit Description

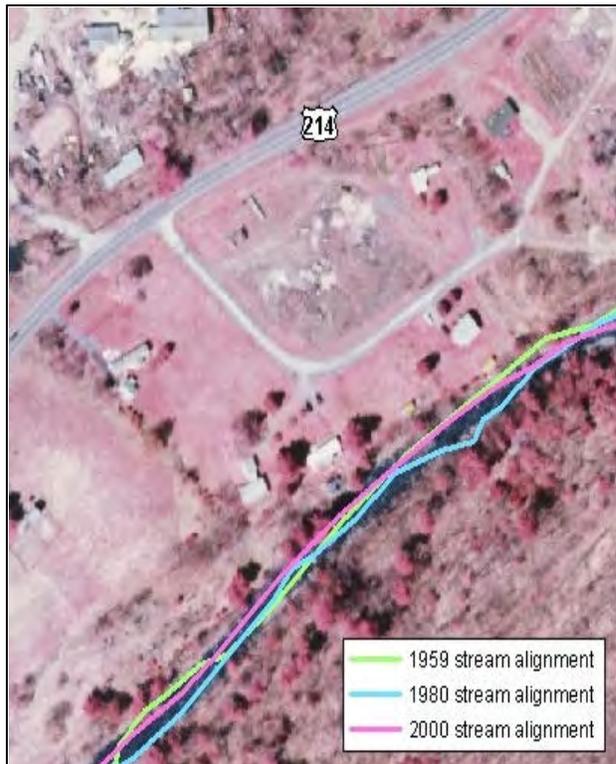
Figure 2 Historical stream channel alignments of Management Unit 9

As seen from the historical stream alignments, channel in this management unit has not exhibited significant lateral shifting in the period since 1959 (Fig. 2). There is some evidence of channel *incision*, or downcutting, in this part of the stream, however, with the elevation of the

stream channel is considerably lower than the adjacent terrace to the right.

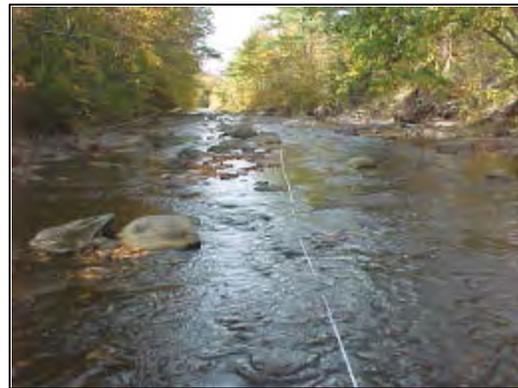
**Figure 4 Cross-section 132
Stream Type B3**

As channel entrenchment moderates, stream type changes to B3 for another short reach totaling 73 ft. in length. The slope of this reach increases significantly to 2.8%.

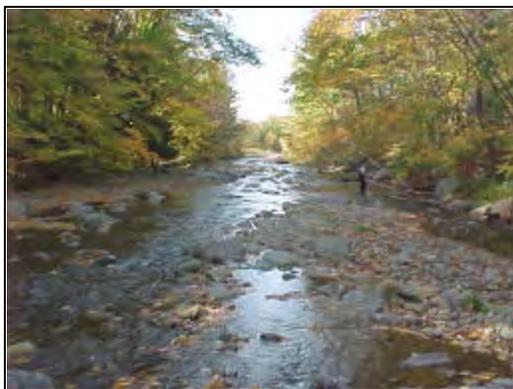
**Figure 5 Cross-section 133
Stream Type F3**

Continuing downstream, the channel once again becomes entrenched as it transitions back into a F3 stream type for the remaining 975 ft. of this management unit. The channel is overwide, shallow, and flat with a slope of 1.3%.

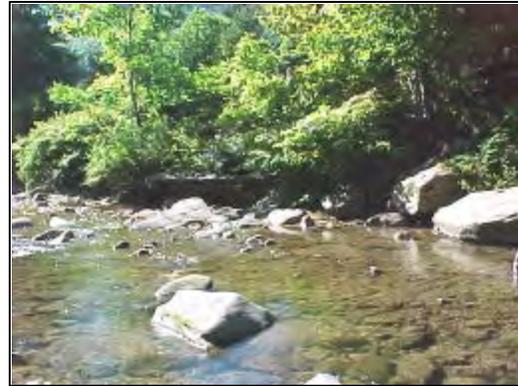
Figure 6 Cribwall

At the top of this reach, approximately 110 ft. of rip-rap has been installed along the right stream bank (Inset D). In the middle of this rip-rap is a cable suspended foot bridge used to access the land on the opposite side of the creek. At the top of right stream bank is a residence with mowed lawn to the stream's edge and a shed which is extremely close to the edge of the bank. At the toe of the right stream bank below this shed, the landowner has installed a wooden cribwall to protect the bank from erosion (Fig. 6).

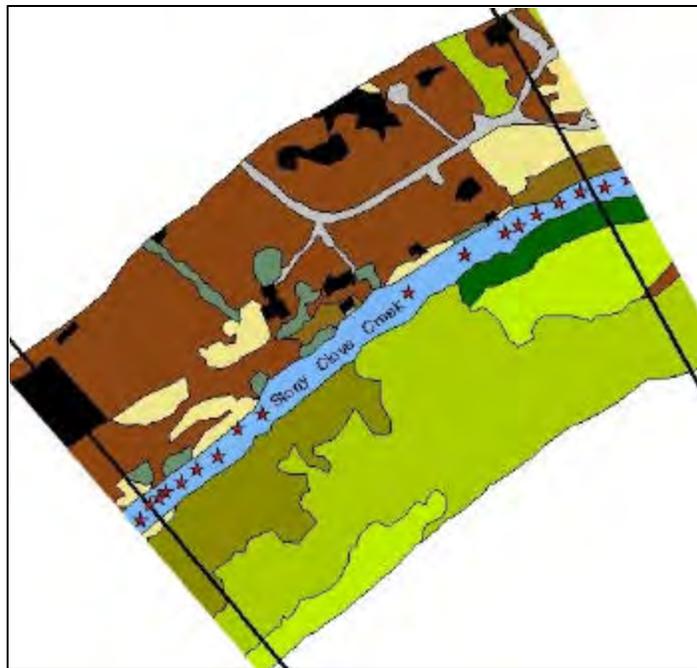
Figure 7 Riparian vegetation map for Management Unit 9

The predominant vegetation type within the 300 ft. riparian buffer is forested (53%) followed by herbaceous (34%). Areas of herbaceous (non-woody) cover present opportunities to improve the riparian buffer with plantings of more flood-resistant species. *Impervious* area (4%) within this unit's buffer is primarily the NYS Route 214 roadway and private residences.

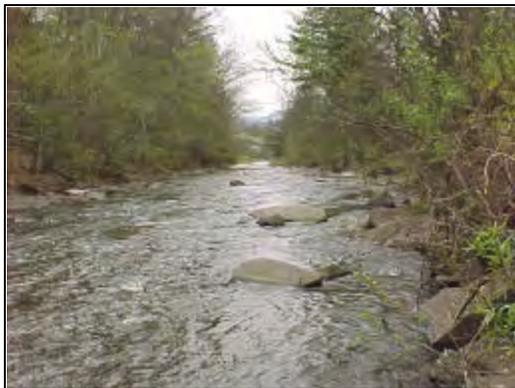
Figure 9 Planting Site #33

Planting site #33 is located on six separate residential properties on the right stream bank, beginning along Stony Road (Fig. 9). Presently there is scattered vegetation along the stream and upland grass lawn areas on these properties. It is recommended to plant native tree and shrub species along the stream bank to increase the density of vegetation. It is also recommended to increase the upland buffer width as much as possible. This will increase the buffer functionality and improve stream bank stability while still allowing a lawn area.

Along the stream bank of the first property, approximately 110 ft. of rip-rap has been installed (Inset D). Inserting plant materials into the soil between rip-rap rocks, or *joint planting*, is recommended. Joint planting will strengthen and increase the longevity of this wall. These plantings will also improve the aquatic habitat by providing shade, thereby cooling water temperatures.

The stream channel along this reach is overwide. Planting native willow and sedge species along both sides of the stream is recommended. These plantings will encourage the stream channel to narrow, improving stream habitat and function.

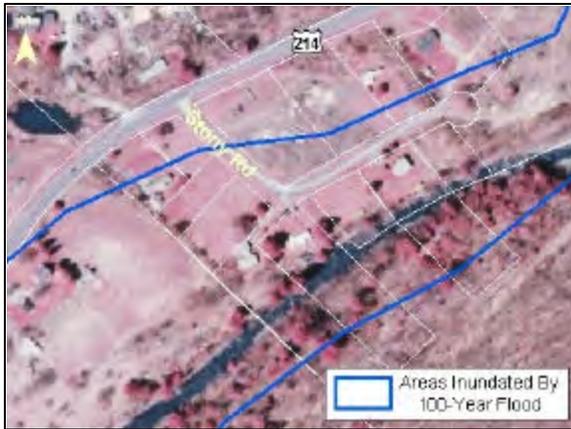
Figure 10 100-year floodplain boundary in Management Unit 9

floodplain boundary in this management unit (Fig. 10). The current NFIP maps are available for review at the Greene and Ulster County Soil & Water Conservation District offices.

According to NFIP maps, there are seven houses located within the 100-year
