Management Unit 10
 Greene County - Town of Hunter
 Cross Section 135 to Bank Erosion Monitoring Site #18

Management Unit Description

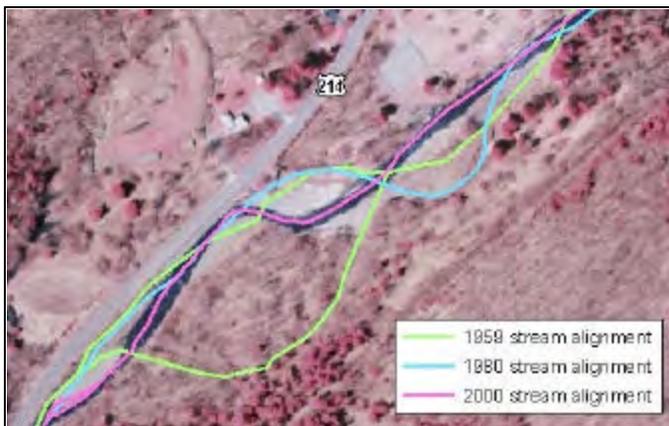
Figure 3 Historical stream channel alignments of Management Unit 10

As seen from the historical stream alignments, this management has experienced significant lateral channel migration since 1959 (Fig. 3). In that year, the stream channel split into two channels near the middle of the management unit. By 1980 the channel to the far left was abandoned in favor of the stream channel which flows closer to NYS Route 214. This channel migration has caused a serious threat to this roadway.

After the January 1996 flood, the roadway was undermined, requiring significant repair. By 2000, the stream channel became less *sinuous* and currently flows at the toe of the NYS Route 214 road embankment in the lower half of the management unit.

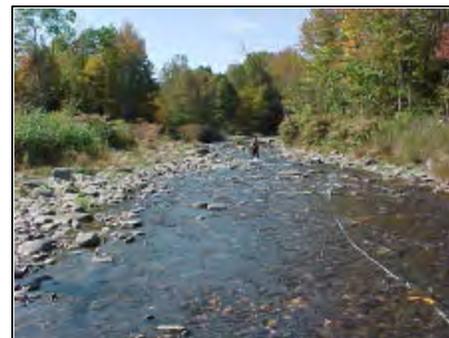
Figure 5 Cross-section 135 Stream Type F3

Management unit #10 begins slightly up stream from cross section 135, with a 171 ft. reach of F3 stream type (Fig. 5 & Inset D). This reach is *entrenched*, or confined within the stream banks during high flow events. Channel slope is fairly flat at 1.4%, and the dominant bed material is cobble. The channel is wide, shallow and straight. Despite entrenched conditions, the toe of the stream banks remains fairly

stable as a result of the presence of densely-rooted native sedges (*Carex torta*).

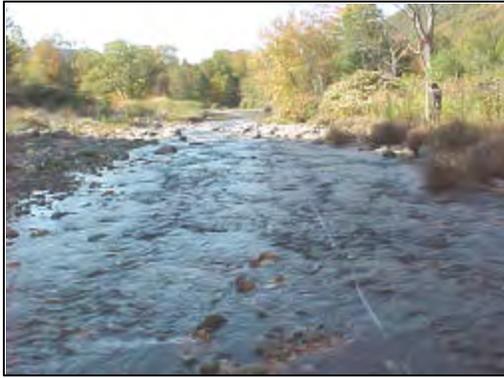
**Figure 6 Cross-section 136
Stream Type B3c**

Continuing downstream, channel slope flattens to 0.9%, as stream type transitions to B3c for the next 410 ft. of stream (Fig. 6). This stream reach remains wide, shallow and straight but does gain limited access to its floodplain on the left.

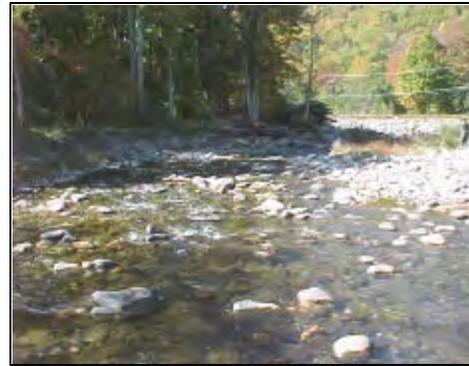
**Figure 7 Cross-section 137
Stream Type C3**

For the last 1,374 ft. of channel in this management unit, stream type changes to C3, becoming fully connected with its floodplain (Fig. 7). The channel begins to meander and slope increases to 1.4%.

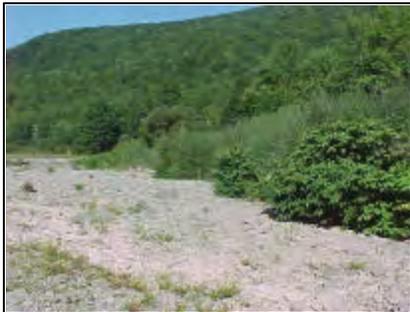
Figure 8 Gravel Bar

On the right stream bank, a large gravel bar has formed. Gravel is often deposited on the inside of meander bends, where flow velocities are lower. Gravel bars help maintain channel stability during flood events. In stable streams, the bars will erode away while the channel is in flood stage. The bars then are rebuilt as flow decreases, helping the stream maintain its stability by reestablishing its pools and riffles. If gravel bars are removed, these processes do not occur and instead, the stream often dissipates its energy by eroding banks and scouring its bed.

In 2000, Trout Unlimited participated in a project to plant willows on this gravel bar. Vegetation encourages deposition of sediment leading to the rebuilding of the stream's floodplain. These willows are currently thriving and spreading, contributing to the stability of this gravel bar.

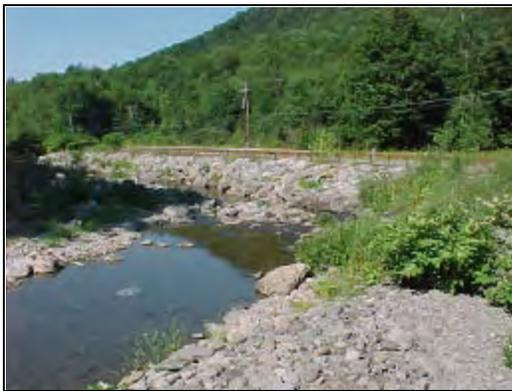
Figure 10 Rip-rap along NYS Route 214

As the stream flows directly towards NYS Route 214, there is a significant *headcut*. As the stream comes out of the headcut, it drops into a deep pool and turns sharply to the left. The stream then flows along the toe of the road embankment. In efforts to protect this embankment, the NYS Department of Transportation (DOT) installed 305 ft. of rip-rap on the right stream bank following the

January 1996 flood (Fig. 10 & Inset B). On the left stream bank, approximately 268 ft. of rip-rap has been installed (Inset A). A smaller gravel bar has formed at the toe of the rip-rap along the inside of this meander bend (Fig. 11). At the downstream end of this gravel bar, the stream channel widens significantly for approximately 300 ft..

There is one section of rip-rap in this management unit which is protecting NYS Route 214 road embankment (Inset B). While rip-rap and other hard controls may provide temporary relief from erosion, they are expensive to install, degrade habitat, and require ongoing maintenance or transfer erosion problems to upstream or downstream areas. *Joint planting*, as recommended for planting site #34, will strengthen and increase the longevity of this rip-rap, reducing long-term maintenance costs.

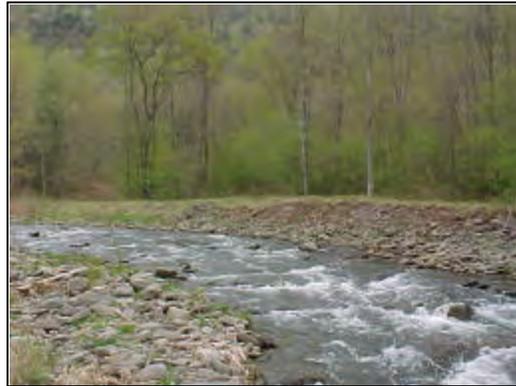
Figure 14 Left stream bank at middle of planting site #34, looking upstream

Planting site #34 is also located on the Ruoff property, across road from The Stony Clove Rod & Gun Club (Fig. 14 & 15). The left stream bank has experienced some minor erosion, leaving either grass or exposed soil on the stream bank. The top of this bank is covered with a mix of cobble and herbaceous vegetation. In the downstream half of this planting site there are two gravel bars and a two reaches of rip-rap (Inset A&B).

Existing willows should be augmented with native sedges here with additional plantings along the left stream bank. These plantings will help to stabilize this stream bank, and improve aquatic habitat function. To improve the upland buffer function, trees and shrubs should be planted. Willow and sedge species should also be considered for gravel bar plantings throughout the unit.
