**Management Unit 15**  
 Ulster County - Town of Shandaken  
 Weiss Road Bridge to Warner Creek Confluence

**Management Unit Description**

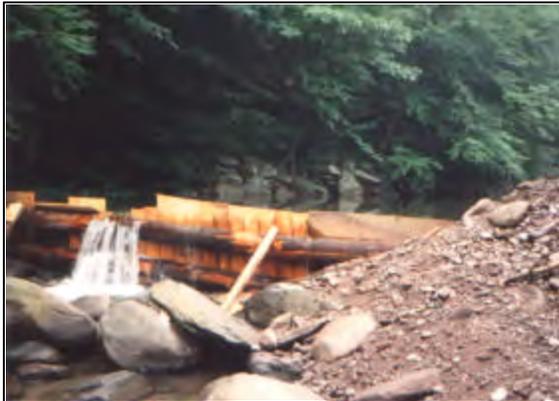
**Figure 3 Temporary Pool Digger**

Permits were issued in 1993, 1997, 1999, 2000, and 2001 to repair this pool digger by repositioning stream boulders that had been moved by high flow events (Fig. 3).

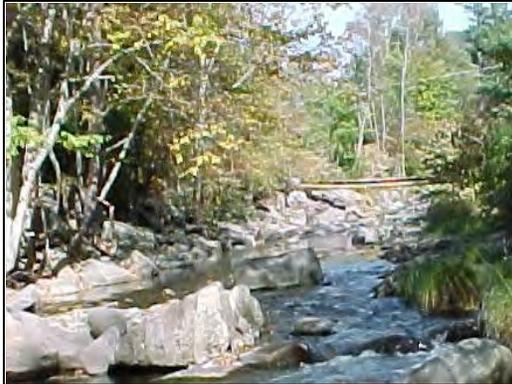
**Figure 6 Rip-rap on right bank  
looking upstream**

Rip-rap has been installed on the first 50 ft. of the right stream bank downstream of the Weiss Rd. Bridge (Fig. 6). Located along this rip-rap is a small stormwater culvert (Inset D). The culvert outfall, lined with large rock material, is set back from the active stream channel, and enters the stream at a low angle. All of these culvert conditions reduce the risk of erosion from stormwater runoff.

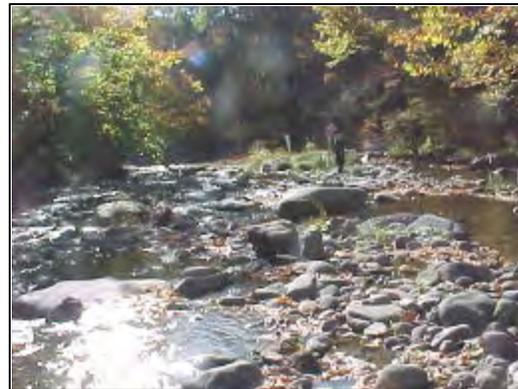
**Figure 7 Cross-section 159  
Stream Type B3c**

As the channel begins to widen and becomes more entrenched, stream type transitions to a B3c (Fig. 7). This 310 ft. reach becomes steeper, with a 1.6% slope.

This stream reach is overwide. Deposition of bed materials is common in overwide channels because they lose their ability to transport the stream's *bedload*. Under these conditions, streams often *aggrade*, or rise in stream bed elevation, due to excessive deposition. As seen in the Figure 7, aggradation in this reach is causing the stream to become divided into multiple threads. Aggradation also steepens stream channel gradient downstream of the deposition site, by raising the elevation of the channel.

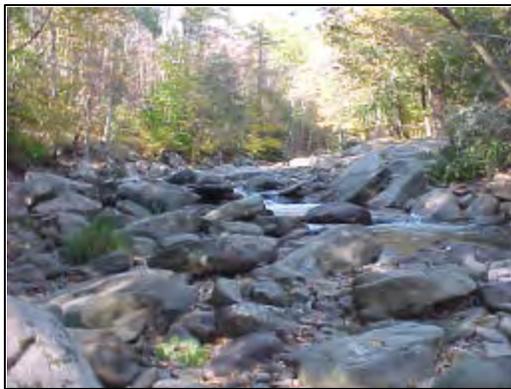
**Figure 9 Cross-section 160 Stream Type F3b looking upstream**

As the stream turns to the left, the channel begins to narrow, the stream type changes to F3b (Fig. 9). This 233 ft. reach becomes *entrenched*, or confined within the stream banks during high flow events. This reach steepens to a 2.8% slope. Although there is an abundance of boulders in this reach, dominant bed material is cobble.

The *thalweg*, or deepest part of the channel, is pushed against the outside of the meander bend, on the right stream bank. Stream bank erosion often occurs on the outside of meander bends where the stream velocity is greatest during high flows.

To protect this stream bank from erosion, rip-rap has been installed on 141 ft. of the bank (Inset C). NYS Route 214, located at the top of this high stream bank, could become undermined if this stream bank were exposed to severe erosion.

There were no serious threats to infrastructure identified in this management unit at the time of the stream feature inventory. However, NYS Route 214 is perched high upon the right stream bank near The Chichester Country Club (Inset C). Currently showing signs of minor disturbance, this bank should be monitored for erosion. If the toe of this bank were further compromised, catastrophic failure of NYS Route 214 could result.

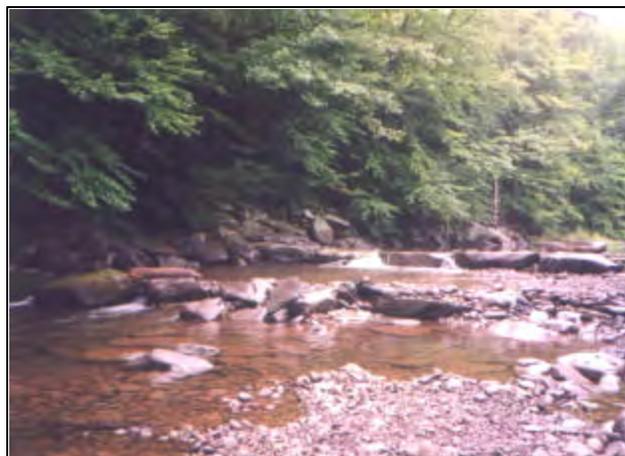
**Figure 10 Pool Digger August 18, 1992**

In 1991, The Association installed a temporary pool digger to create a swimming area at the club (Fig. 10). After a large deep pool was created, stream boulders were placed across the

stream to hold the grade and maintain the pool (Inset B). As detailed in the stream disturbance permit section, many permits have been issued over the years to reposition the stream boulders, which have been moved during high flow events. These stream maintenance activities do not appear to have significantly disturbed the reach.

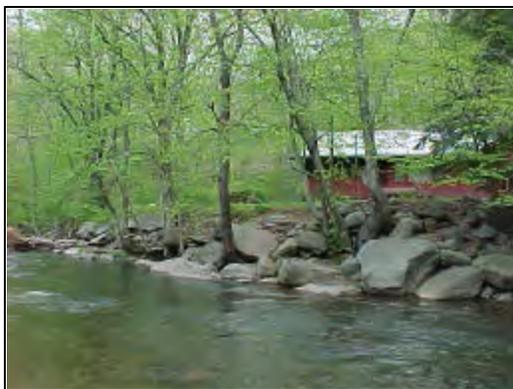
**Figure 15** Planting Site #43

Planting site #43 is located on the right stream bank, at the first residence downstream from the Weiss Rd. bridge (Fig. 15). Rip-rap, which has a few mature trees growing through it, has been installed along the stream bank. At the top of the bank is a residence whose grass lawn extends to the edge of the bank.

Recommendations for this site include *joint planting* the existing rip-rap, by inserting plantings into the soil between the rip-rap rocks. Joint planting will strengthen and increase the longevity of this rip-rap. Upland plantings of native trees and shrubs in the grass area should be installed to improve bank stability and buffer functionality.

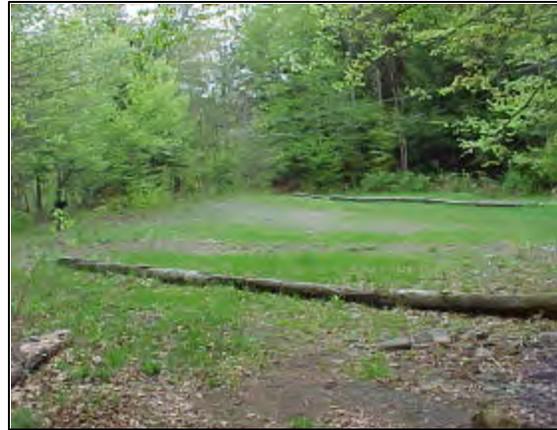
**Figure 16 Planting Site #44**

Planting site #44 is located on the left bank at The Chichester Country Club (Fig. 16). This upland area is maintained as a grass parking area, with only a few trees along the edge of the stream bank. As the reach of stream adjacent to the parking area appears

aggradational, bank stability is a primary concern at this site. Healthy stream side vegetation helps bind soils in the bank, increasing its resistance to erosion. Recommendations for this site include planting native trees and shrubs along the stream bank in the upland grass area. Increasing the streamside buffer by at least 20 ft. could reduce the risk of erosion to the parking facilities, while improving buffer functionality.

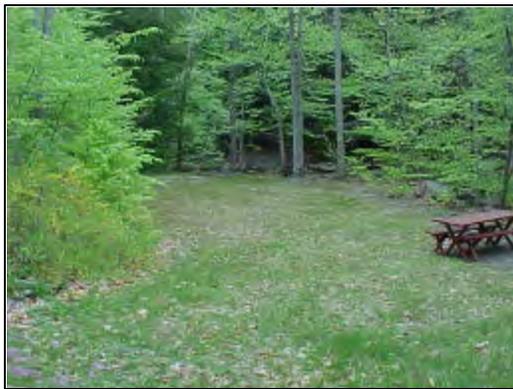
**Figure 17 Planting Site #45**

Planting site #45 is located on right stream bank at the residence near the end of this management unit (Fig. 17). This upland area is maintained as grass with a few trees along the edge of the stream bank.

Plantings of native trees and shrubs within the upland grass area is recommended at this site. Increasing the buffer width by at least 20 ft. could improve buffer functionality and stream bank stability while still allowing a significant lawn area.
