Management Unit 17
 Ulster County Town of Shandaken
 Silver Hollow Road Bridge to between XS 172 and XS 173

Management Unit Description

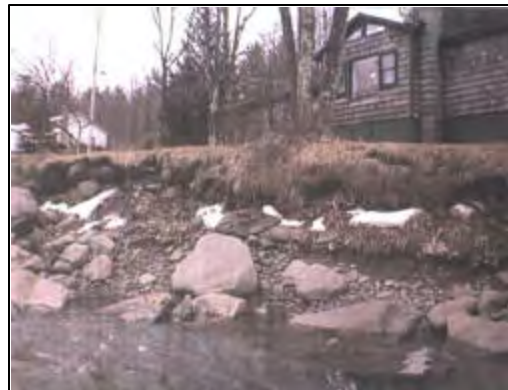
Figure 8 1996 flood damage at Hoffman property

At the Hoffman residential property located on the left stream bank just below Silver Hollow Bridge, severe stream bank erosion occurred during the 1996 flood event (Fig. 8). In efforts to protect the house and property, the landowner installed a 220 ft. long stacked rock wall.

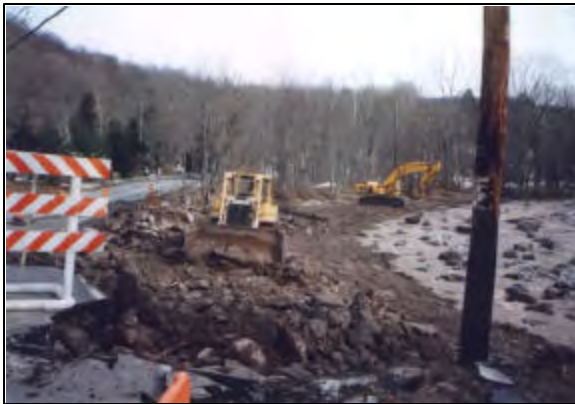
Figure 10 NYS Route 214 washout from 1996 flood

During the January 1996 flood event, floodwaters damaged the road embankment along NYS Rt. 214 and caused serious stream bank erosion (Fig. 10). After this flood event, rip-rap was installed by the NYS Department of Transportation (DOT) to stabilize the stream bank.

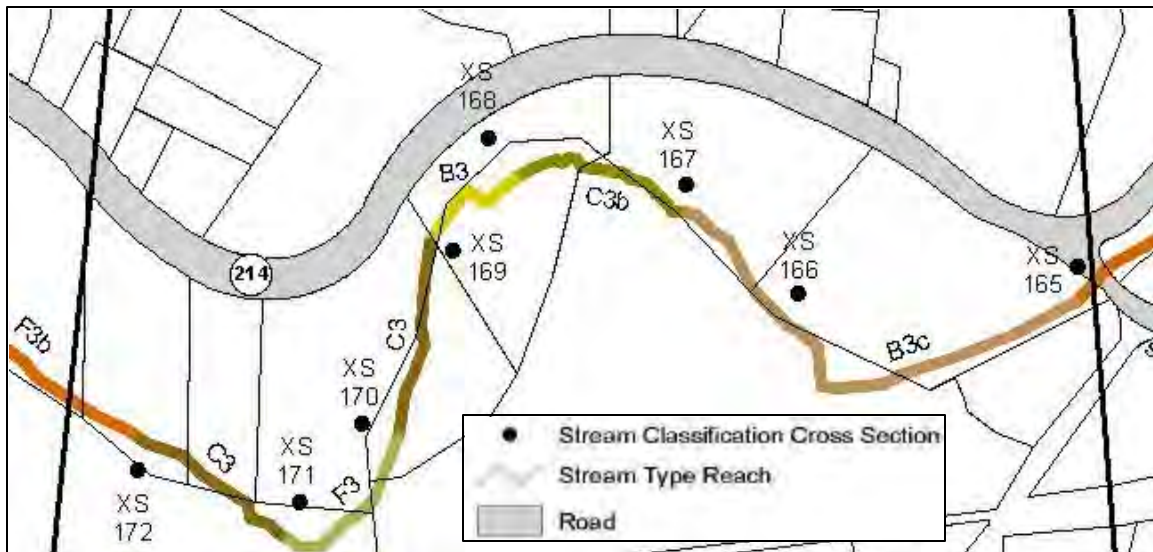
Figure 11 Cross-sections and Rosgen stream types for Management Unit 17

Stream *morphology*, or shape (i.e., slope, width and depth) changes several times in this unit (Fig. 11), creating small reaches with differing morphologic characteristics, which are classified as different *stream types* (See Section 3.1 for stream type descriptions).

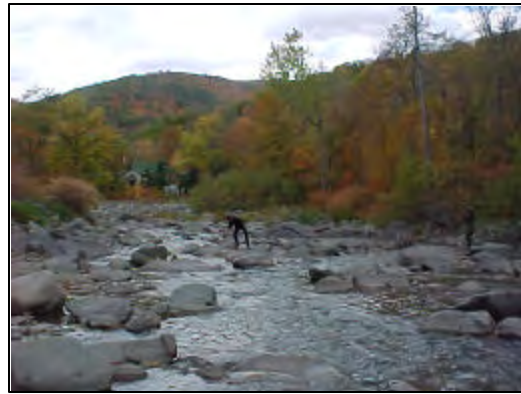
**Figure 12 Cross-section 167
Stream type B3c**

As entrenchment moderates and slope decreases to 1.3%, stream type changes to B3c for the next 752 ft (Fig. 12). Approximately 300 ft. into this stream section, the valley wall forces the stream to bend sharply to the right, as the *thalweg*, or deepest part of the stream channel, flows into a deep, clay-bottomed pool directly against the left stream bank (Inset C).

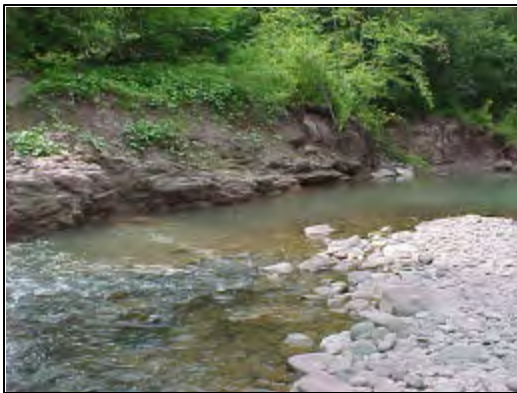
Figure 13 Bank Erosion Site 23

Bank erosion monitoring site #23 is located along this eroding bank, and is approximately 332 ft. long, with a total area of 18,858 ft.². qualifying it as the third largest eroding area along the Stony Clove Creek (Fig.13).

The Bank Erodibility Hazard Index (*BEHI*) score for this site is ranked “Very High”, the second highest prioritization category in terms of its vulnerability to erosion due to the threat to water quality.

Large sections of the hillside have no vegetation, and several severe *scarps* provide evidence of extensive *rotational failure planes* on the hillslope above the channel (Inset G). During high flows, the channel morphology and clay-rich bed and banks set up the conditions for severe *toe erosion* along this stream bank (Inset C). As the toe of the left bank is scoured down through clay lenses, the hillslope slips along the failure planes. Consequently, at high flows large amounts of clay are introduced into the stream as *suspended sediment*. Just below the pool at this bank failure there is a 2 ft. high *headcut* (downstream of cross-section 166) which, if allowed to migrate upstream, could further destabilize the failing bank by lowering the streambed elevation and increasing the potential for additional slippage.

Restoration of the two erosion sites discussed above should be considered in the context of a larger restoration project area, to extend from the railroad bridge abutments in Management Unit #16, to the NYS Route 214 bridge at Chichester, at the downstream end of Management Unit #18. Taken as a whole, this larger project would represent the highest priority restoration in the Stony Clove Creek. Recommendations to restore the reaches in Management Unit #17 include installing a series of rock vane structures to control grade and direct erosive forces away from banks. A floodplain bench, vegetated with native tree and shrub species, should be established between the active channel and the eroding banks. In-depth survey and design would be required to plan a stream restoration project at this site, including geotechnical assessment of the rotational failures. Providing opportunities for activities such as fishing and kayaking should be considered as a secondary objective of the project.

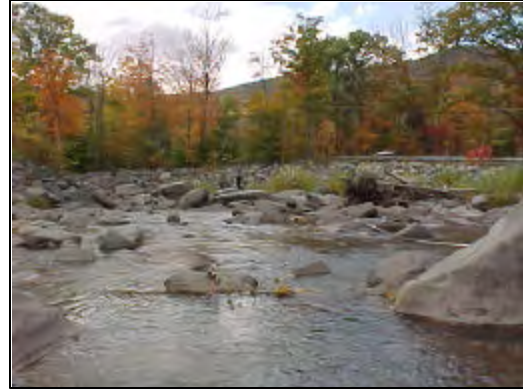
**Figure 14 Cross-section 168
Stream type C3b**

For the next 278 ft. reach the channel widens into a C3b stream type, and entrenchment decreases significantly as the channel regains connection with its floodplain (Fig.14). Floodplains provide overflow capacity for high flows. Channel slope increases to 3%, and bed material coarsens again to large cobble.

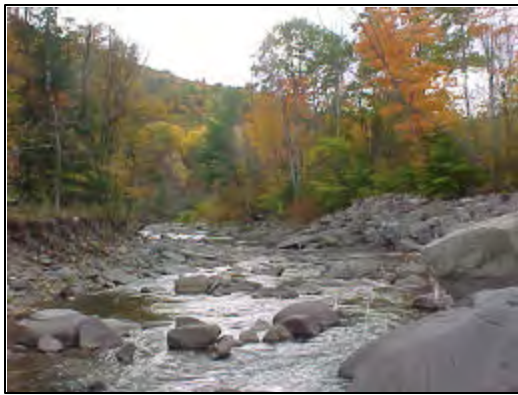
**Figure 15 Cross-section 169
Stream type B3**

Entrenchment increases as the channel turns to the left, narrowing and deepening to become a B3 stream type for the next 162 ft. reach (Fig. 15). The left stream bank is experiencing moderate erosion into exposures of clay at the toe (Inset F).

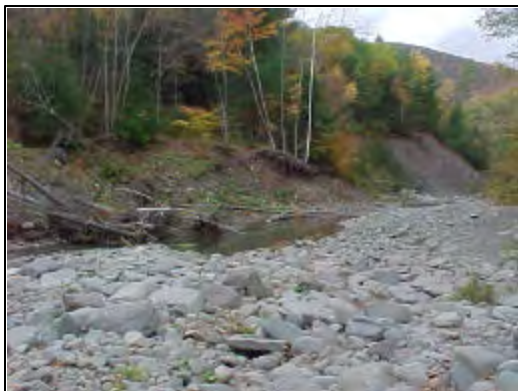
**Figure 17 Cross-section 171
Stream type F3**

Proceeding downstream, both stream banks increase in height as the stream takes another sharp bend to the right, turned by the valley wall beyond the left stream bank. This 250 ft. reach is an F3 stream type (Fig.17). The stream

widens significantly, steepens slightly to 1.9% slope and the bed material becomes finer. The thalweg flows against a failing high left stream bank.

Like the previous erosion site, this hillslope is being undermined by toe erosion and exhibits several failure plane scarps, with mass wasting of large volumes of glacial till accompanied by mature trees and shrubs. As this large woody material is mobilized, it poses a threat to infrastructure downstream. The soil has a high silt and clay content, and the site contributes significantly to suspended sediment loading.

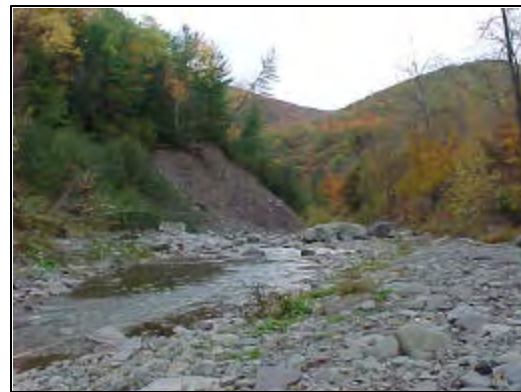
**Figure 18 Cross-section 172
Stream type C3**

Narrowing and deepening as it comes out of the turn, the stream drops over a 3 ft. high headcut. As the channel straightens and entrenchment moderates, stream type changes to C3 for the next 257 ft. reach (Fig.18). An abandoned channel, still evident in the floodplain on the right, carries water during flood flows.

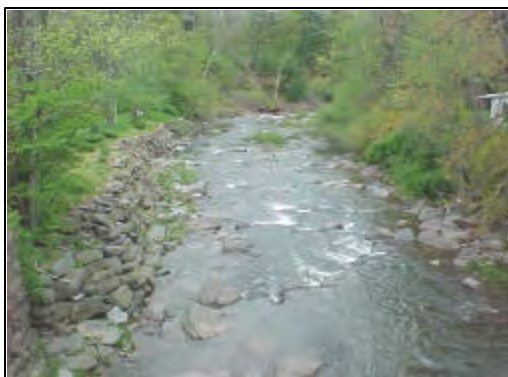
Figure 21 Planting Site #46

Planting site #46 is located on the left stream bank just downstream from the Silver Hollow bridge on the Hoffman property (Fig. 21). On this site there is a stacked rock wall, with several shrubs and mowed grass to the edge of the stream bank.

To increase stream buffer functionality, additional plantings of native trees and shrubs along the stream bank and upland area are recommended. Increasing the stream buffer width by at least 20 feet will improve stream

bank stability while still allowing for a lawn area. It is also recommended to interplant native willow and sedge species through the stacked rock and along the toe of this stream bank. This planting will help to strengthen the revetment, while enhancing aquatic habitat.

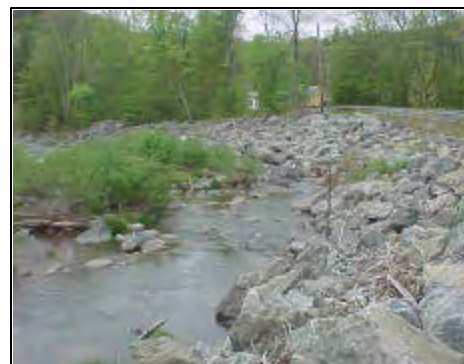
Figure 22 Planting Site #47

Planting site #47 is located on the right stream bank along the rip-rap on NYS Route 214 (Inset B).

Inserting plant materials into the soil between rip-rap rocks, or *joint planting*, is recommended (Fig. 22). Joint planting will strengthen and increase the longevity of this rip-rap, while adding aesthetic and habitat value. The planting of the rip-rap here would require coordination with the NYS DOT, as they are responsible for the maintenance of the rip-rap.
