FARBER FARM STREAM RESTORATION PROJECT - EAST KILL -

IMPLEMENTATION & MONITORING REPORT

UPDATED
MAY 2006
and November, 2009

F.7 Project Status: 2009 Inspection - Survey

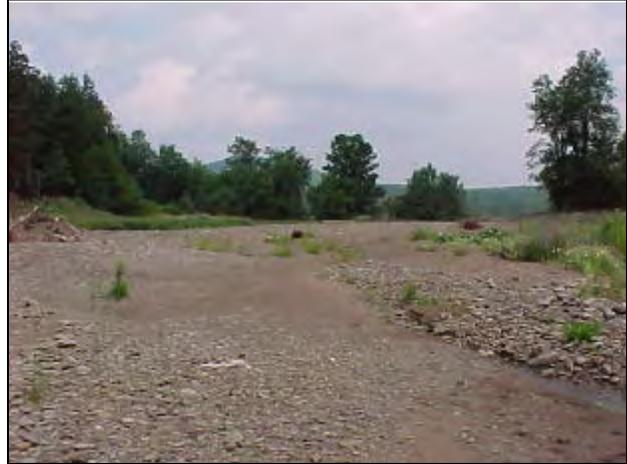
Image of subsurface stream flow condition during summer base flow.

Inventories during low flow conditions documented subsurface flows during the summer thus limiting aquatic habitat. The existing channel did not exhibit the bed diversity that is typical of a natural riffle/pool sequenced stream channel.

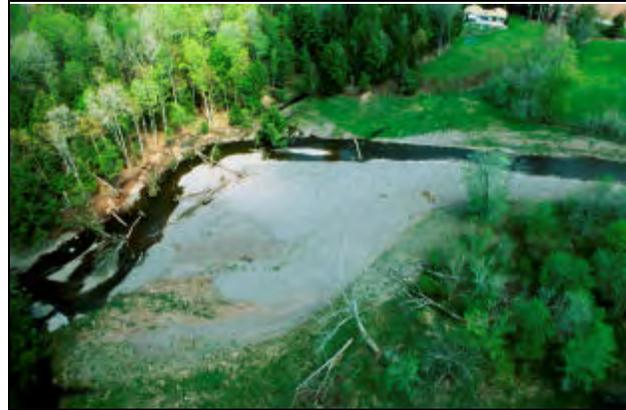
Image of excessive deposition and bar formation at the bottom of project reach.

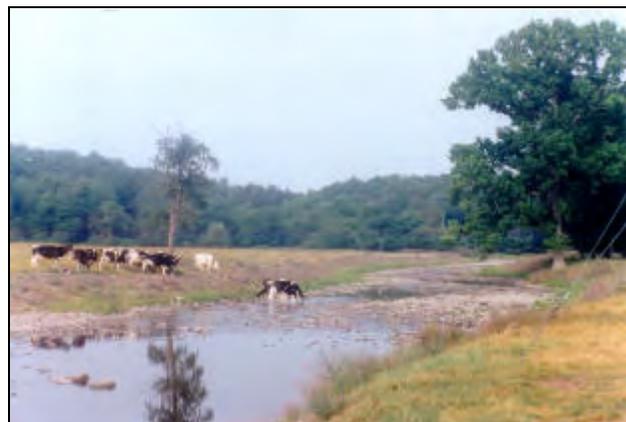
Image of livestock in channel and grazing on streambank vegetation.

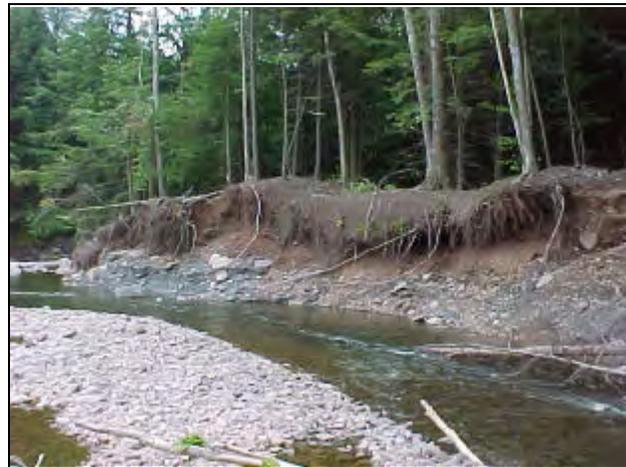
Several areas of the project reach exhibited evidence of streambank erosion. Historic aerial photography depicted excessive channel lateral migration in the lower portion of the reach near the confluence with an unnamed tributary. The migration and existing eroded streambank were suspected to be negatively affecting water quality, which may have been further amplified by excessive sedimentation and point bar development. The most significant bank erosion located in the middle of the channelized portion of the project reach and was characterized by several hundred feet of exposed bank.

Image of stream bank erosion near bottom of project reach.

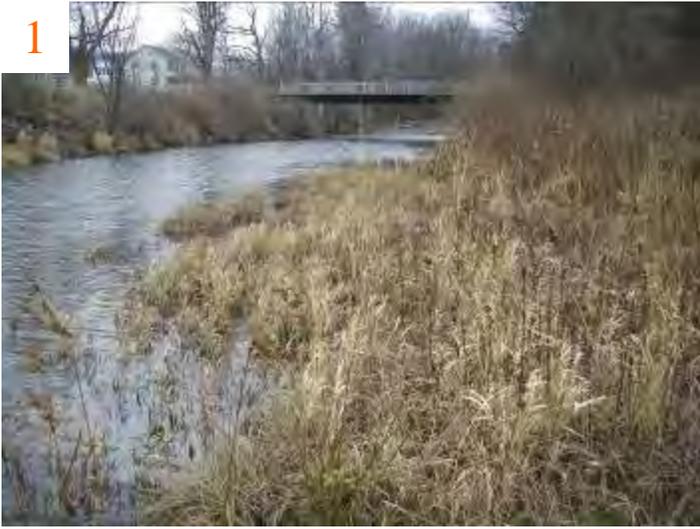
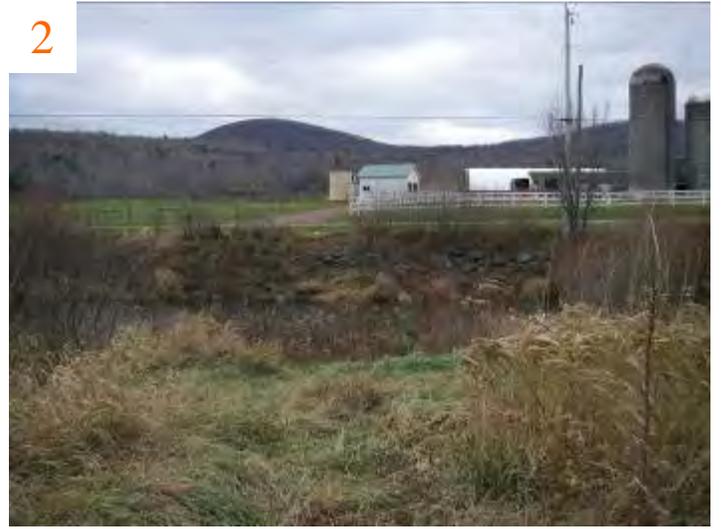
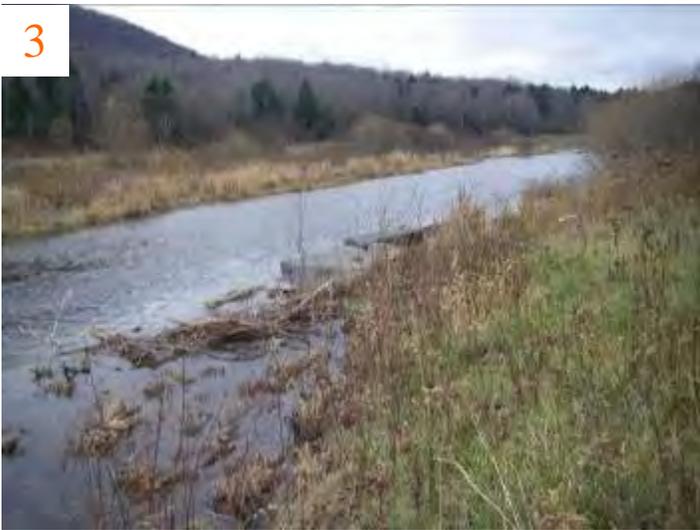
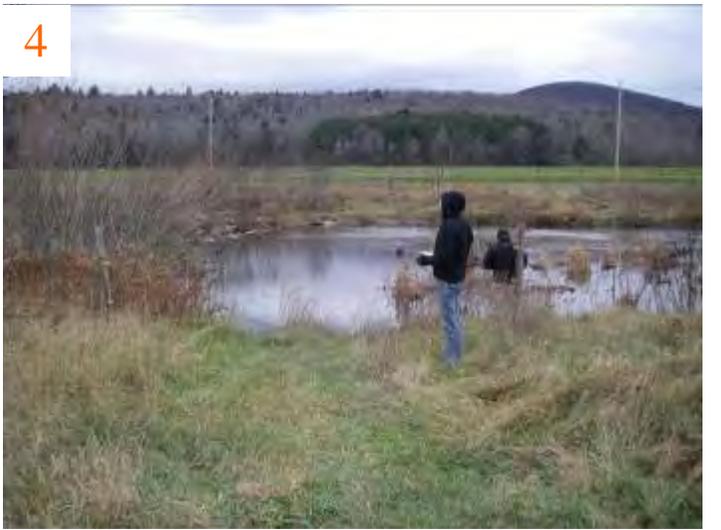
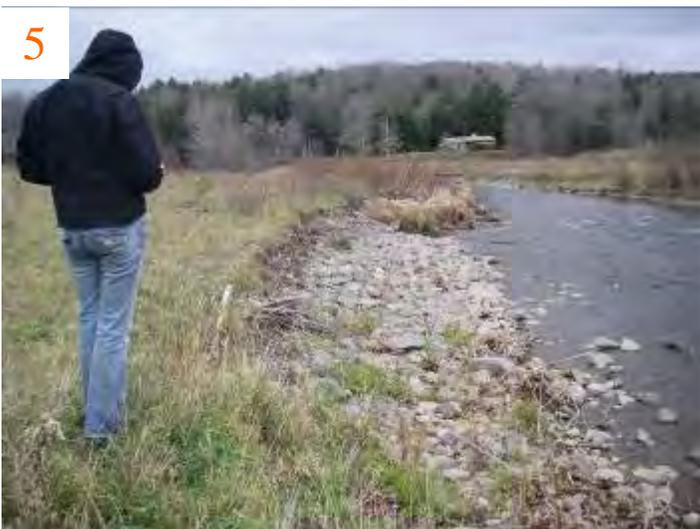
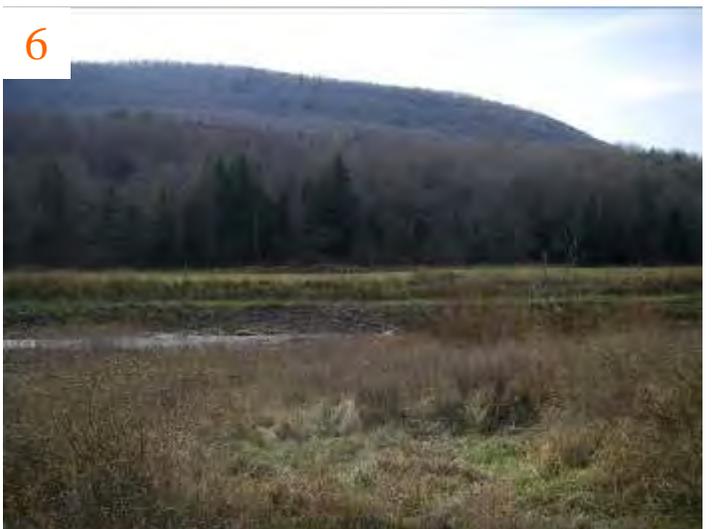
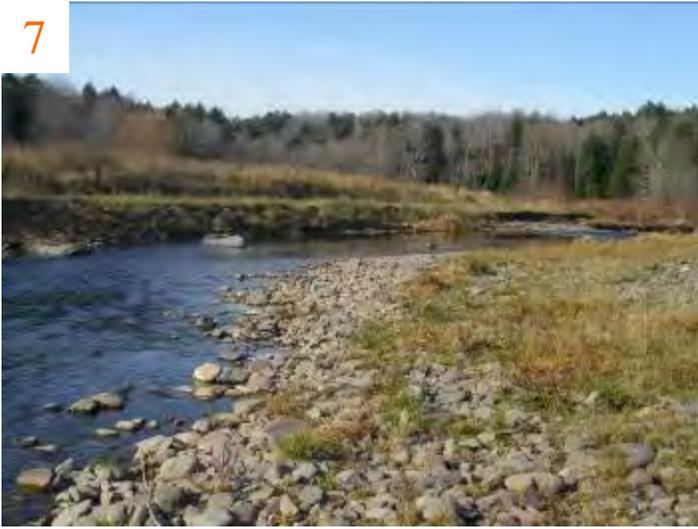
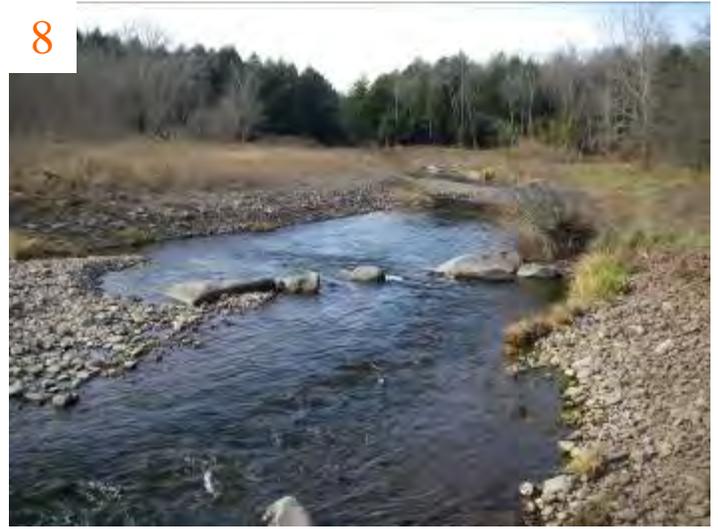
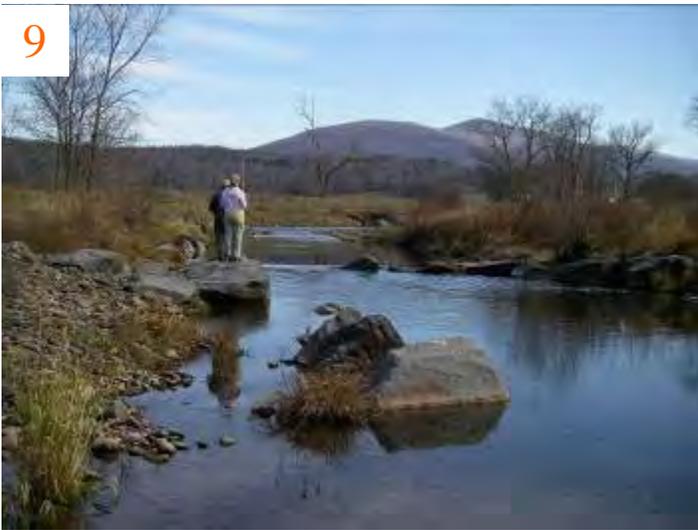
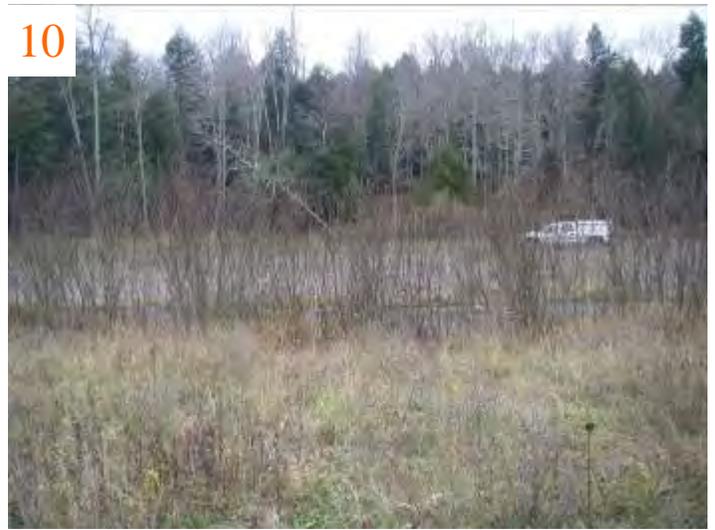
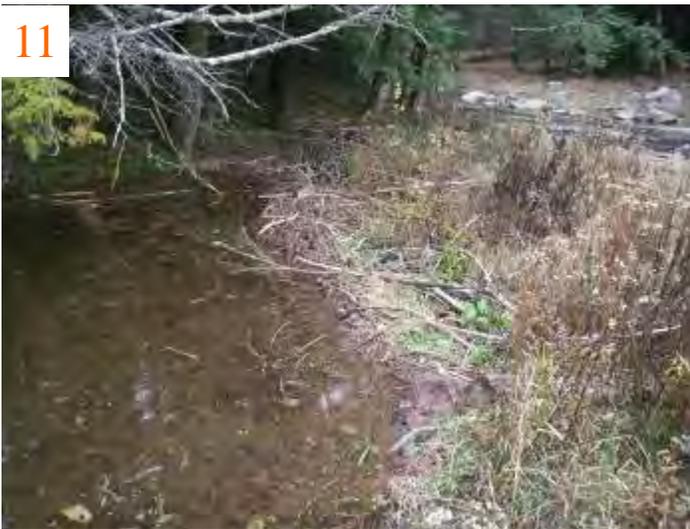
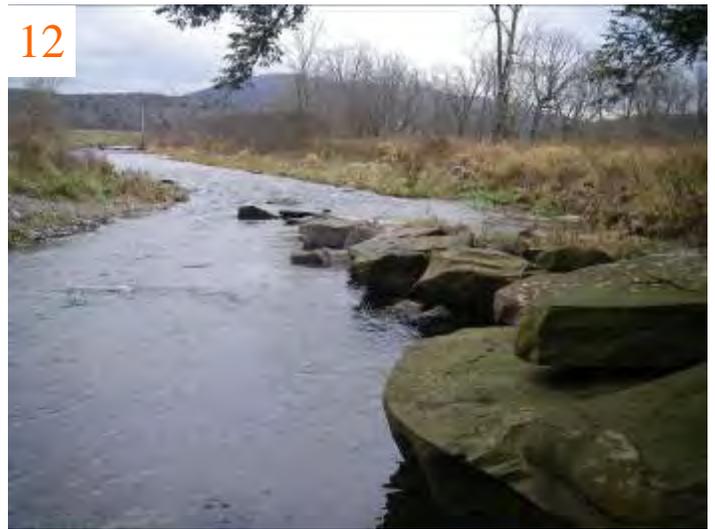
- Photograph 1: Bridge at top of project reach.
- Photograph 2: View across stream from left bank at cross section 1.
- Photograph 3: Cross vane looking upstream near cross section 3.
- Photograph 4: Low level crossing shown from left bank upstream of cross section 3.
- Photograph 5: Erosion along left bank downstream of cross section 3.
- Photograph 6: View across stream from right bank at cross section 4.
- Photograph 7: View across stream of location of former center bar near cross section 5.
- Photograph 8: Minor bank erosion and rock vane located upstream of cross section 6.
- Photograph 9: Cross vane upstream of cross section 7.
- Photograph 10: View from left bank across stream at cross section 7.
- Photograph 11: Small tributary with a beaver dam on it entering left side of stream near cross section 8.
- Photograph 12: Rock vane at downstream end of project reach.
