Reach 1d (Peck Road Bridge to C.D. Lane Park)

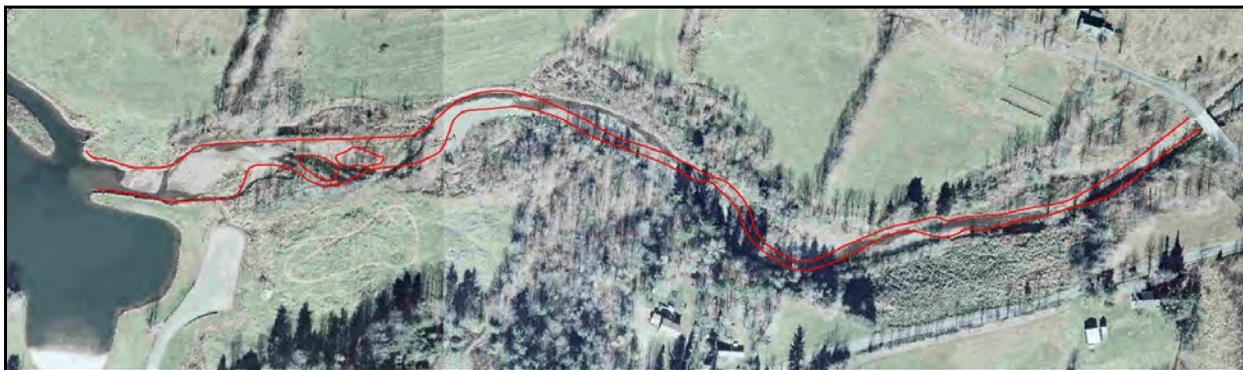
Figure VI-17: Comparison of 1995 (red) and 2000 (photo) stream Planform in management segment 1d.

Analysis performed on the 1995 and 2000 aerial photographs (**Figure VI-17**) revealed only minimal planform change through the majority of the reach, with the exception of two isolated areas. The first area is located along one meander, half way down the reach, that has migrated north nearly 50 feet in the 5 year period. The second area is near the bottom of the reach at the confluence of the stream and the flood retention pool. Historic aerial photograph interpretation of stream channel shifts through this reach is limited by the availability of photographs after construction of the flood control structure.

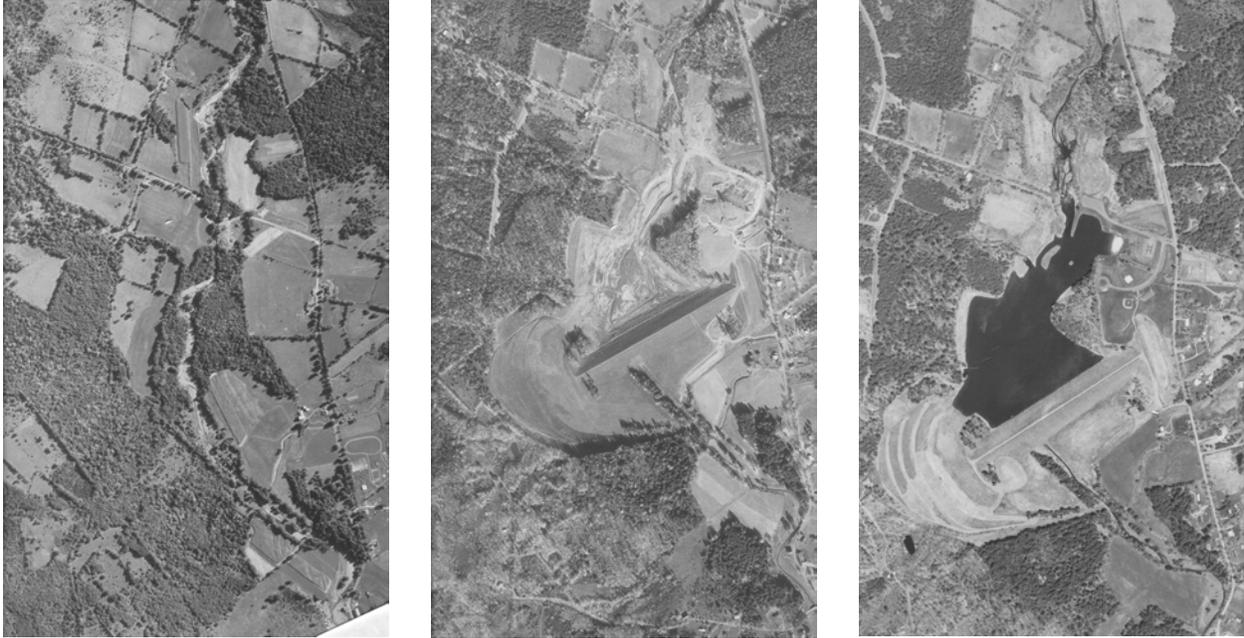
Figure VI-18: Aerial progression from 1959, 1980 and 1995 indicates reach 1d has exhibited poor riparian conditions for over 40 years. Note that the C.D.Lane lake is empty in the center photo.

The riparian buffer in reach 1d is variable. The majority of the reach is in relatively good condition, but several sections require attention. Comparison of aerial photographs from 1959 to 2000 (**Figure VI-18**) indicate that there has been relatively minimal change in the riparian zone over the past 41 years. Prior to the construction of the flood control dam, the reach had several active farms along its length, with pen fields bordered by thin woody buffers. Currently, the right bank has a good buffer condition with the exception of a short section at the bottom of the reach. The left bank has a good buffer at the top and bottom of the reach, but the middle of the reach exhibits poor conditions. Active erosion in this area has removed critical deep rooted vegetation. It is interesting to note the changes in **Figure VI-18** as the C.D.Lane flood control structure is constructed.

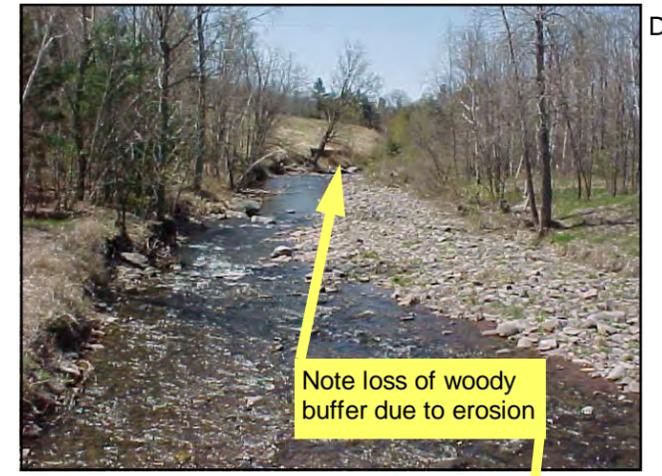
D

Note loss of woody buffer due to erosion

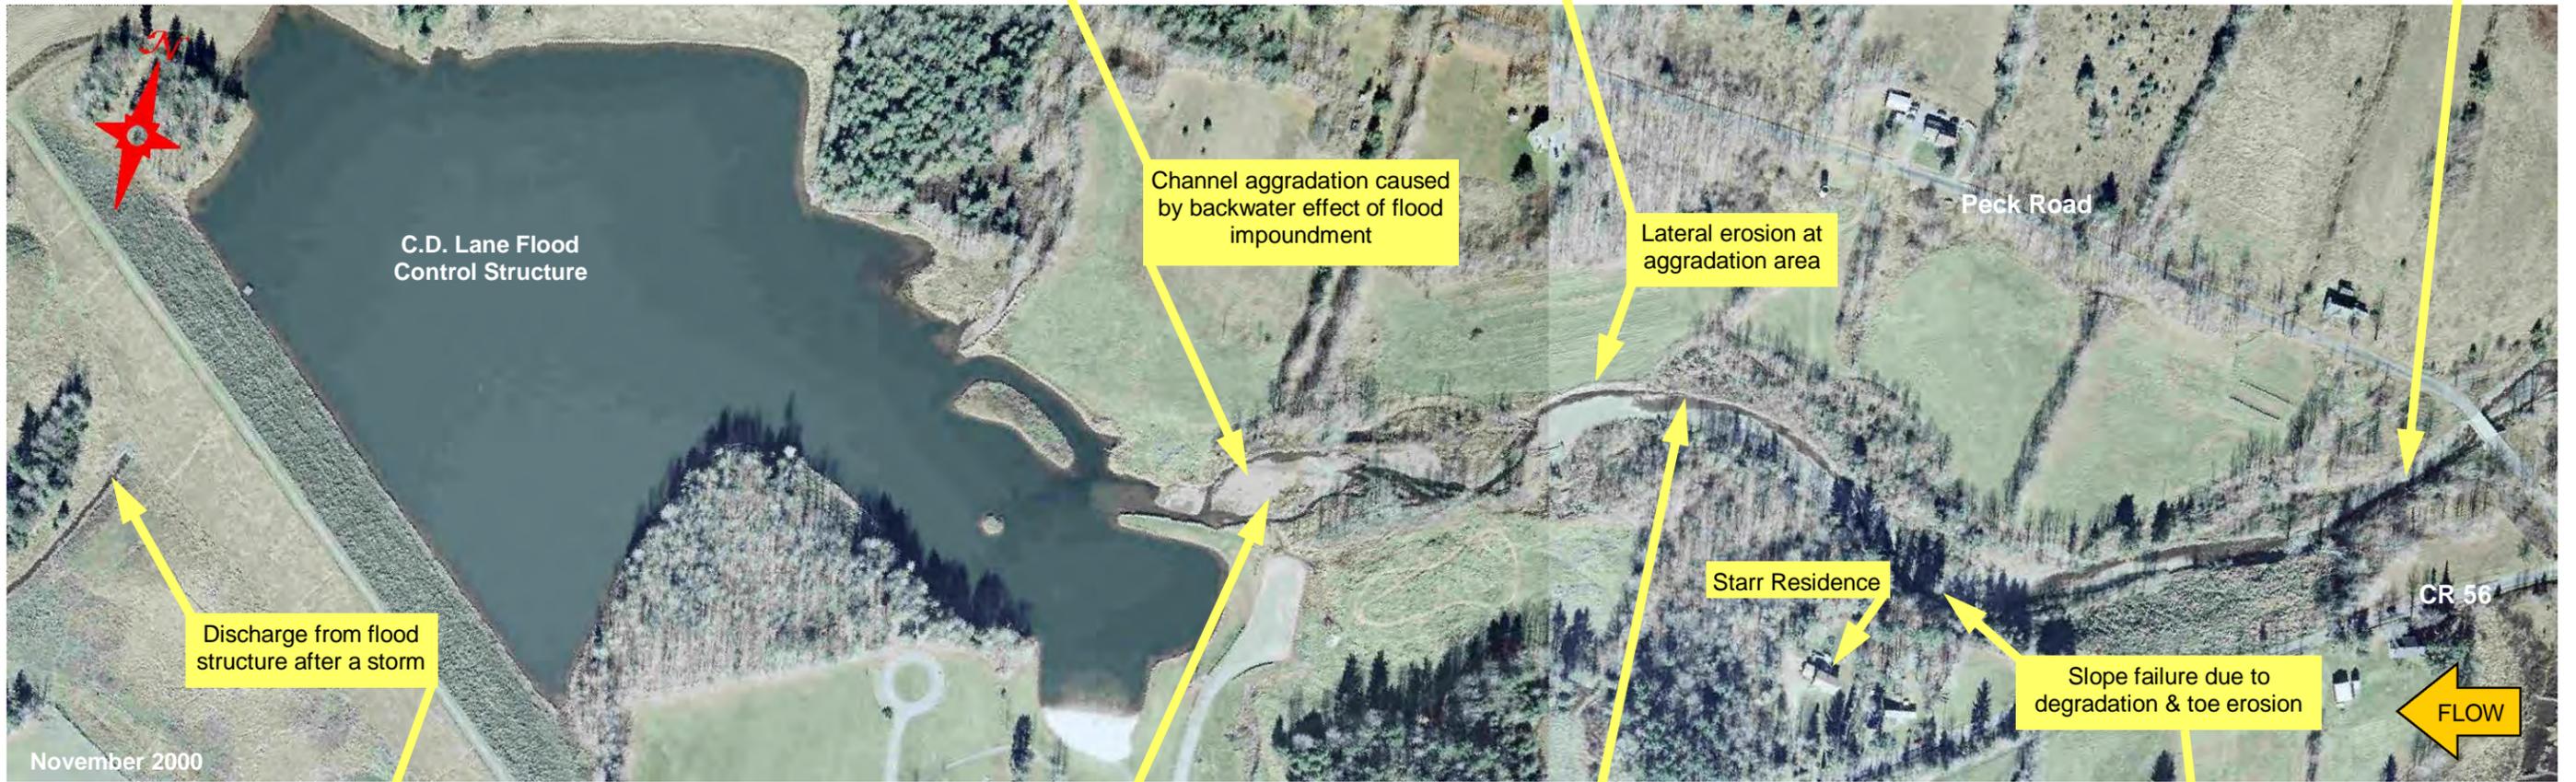
Channel aggradation caused by backwater effect of flood impoundment

Lateral erosion at aggradation area

Slope failure due to degradation & toe erosion

Discharge from flood structure after a storm
