## **Reach 4e** (Maier Farm Bridge - Tompkin's Quarry Bridge)

**Table VI-15: Management Recommendations Reach 4e.**

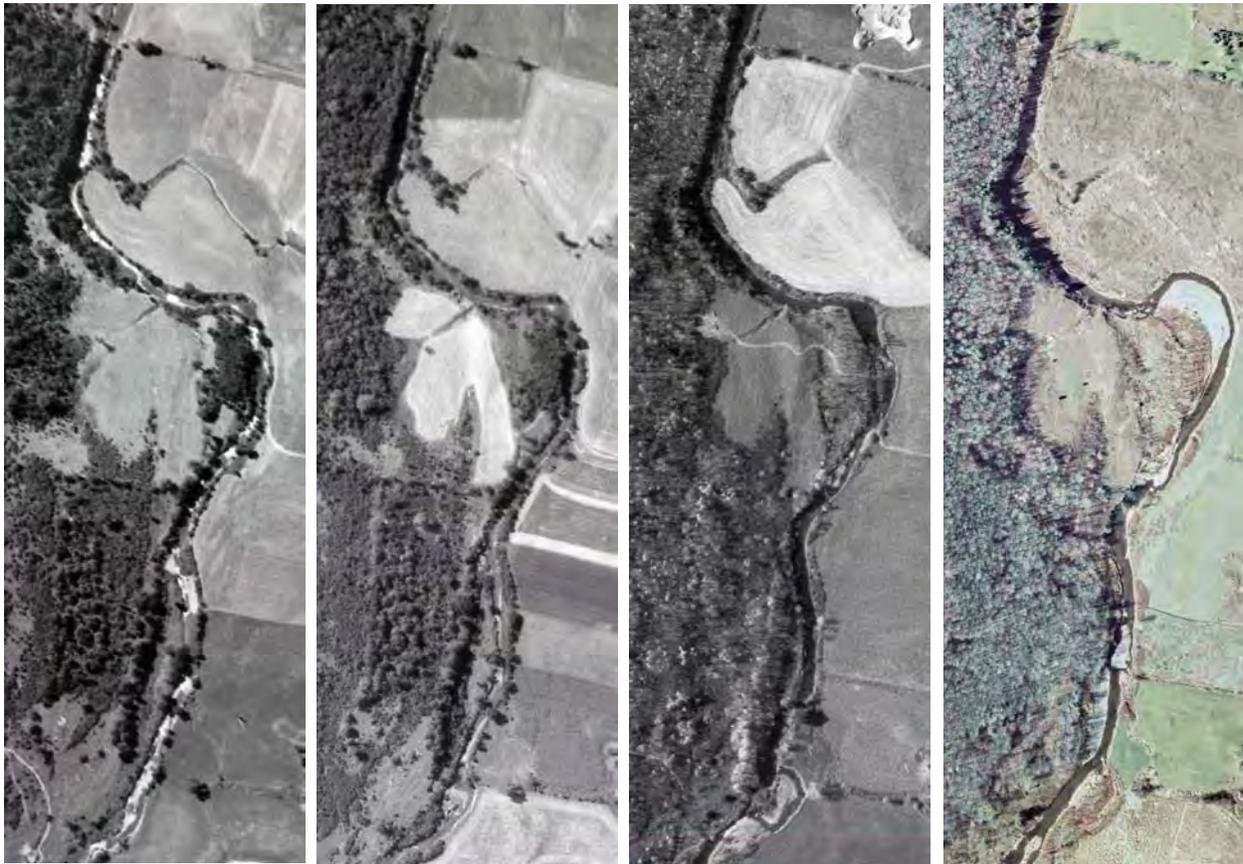
**Figure VI-62:** Comparison of aerial photos of reach 4e from 1959, 1967, 1980 and 1995 (left to right)

After the Phase I assessment, the GCSWCD conducted an analysis of historical aerial photographs to determine for what length of time the instability had been present. Based on a review of photographs from 1959 to 2000, an active meander migration in the upper

section of the reach was evident (**Figure VI-62**). The meander clearly had been moving laterally, as well as in a downstream direction for over 40 years. Additionally, small segments above and below the active meander also indicated signs of long term accelerated migration. In the lower end of the reach, the historical aerials did not indicate any significant changes in planform over the period of available record. This is not unexpected considering that the presence of the hamlet has most likely resulted in active maintenance of the channel over the years.

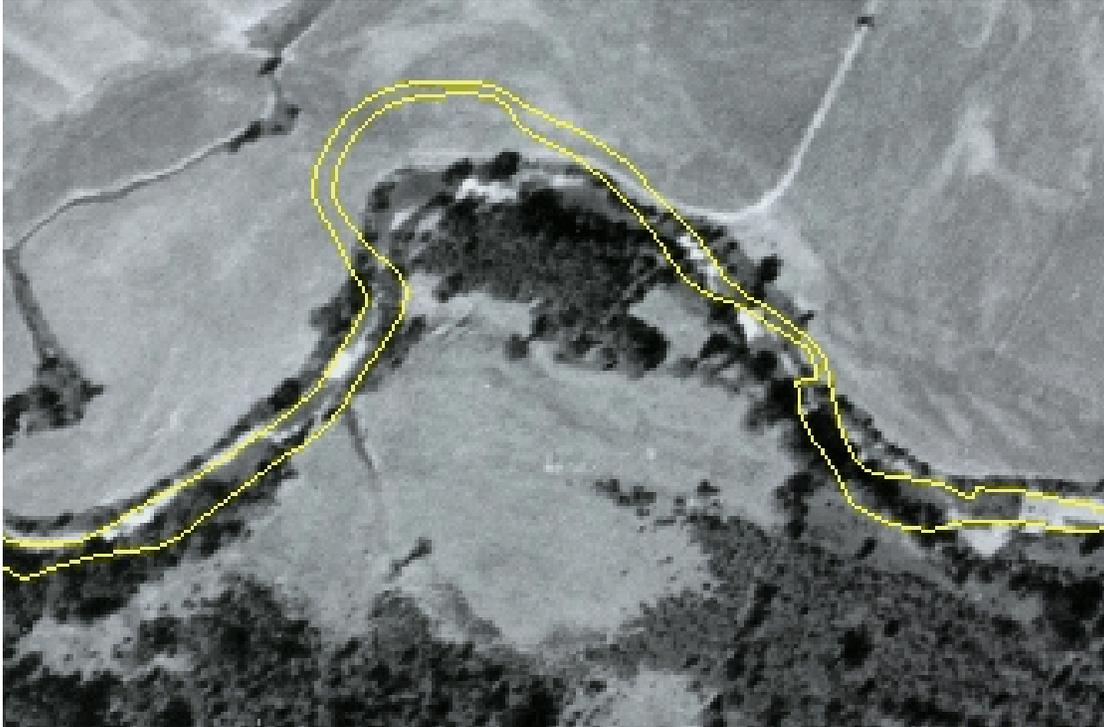
**Figure VI-63:** Aerial Overlay - Kastanis

When the aerial photos from 1959, 1968 and 1980 are adjusted to match the 1995 digital ortho-photo series, the GCSWCD can overlay channel planform from various time periods, and measure the impact of channel migration. When this was completed for the Kastanis site (**Figure VI-63**), the GCSWCD found that the channel had migrated approximately 120 feet in a northwest direction during the period of record. The rate of channel migration appears to significantly increase between 1980 and 2000. Based on the aerial overlays, the channel has migrated an average of 6 feet per year at the apex of the meander bend. Between 1980 and 2000, the estimated area of bank loss is 61,350 ft<sup>2</sup>. Applying an average bank height of 9.2 feet yields an estimated volume loss of 20,900 cubic yards, which equates to an average of over 1,000 cubic yards annually from one meander bend.

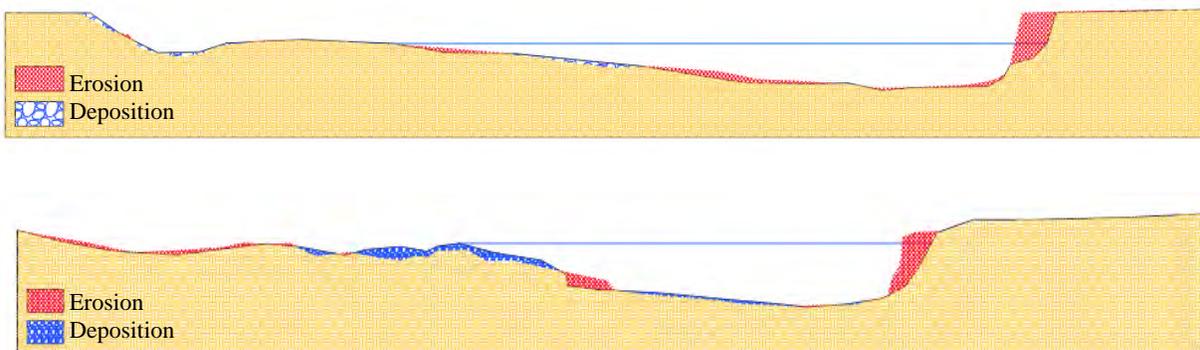
**Figure VI-64:** Overlay of cross section #1 (top) and #3 at the Kastanis Site, 1998 - 2000.

Cross sections #1 and #3, (**Figure VI-64**) located near the top of the reach, indicated active lateral erosion on the north bank. While cross section #1 indicated a trend toward an overwidened condition, with an increased width to depth ratio, cross section #3 was characterized by a greater amount of deposition on the opposite bank. At cross section #2, stream process appears to be attempting to balance erosion and deposition, with erosion on the north bank being fairly closely matched by deposition on the opposite bank resulting in no significant shift in width to depth ratio.

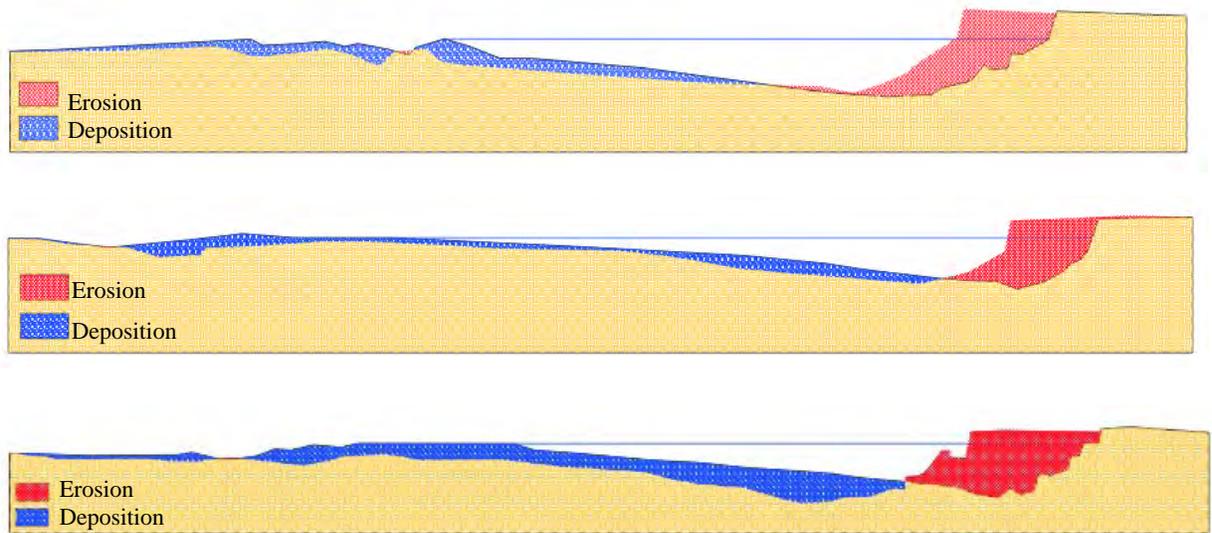
**Figure VI-65:** Overlay of cross sections #6 (top), #7 (middle) and #9 (bottom) at the Kastanis Site, 1998 - 2000.

Cross sections #6, #7, and #9 (**Figure VI-65**) represent three of the four cross sections located on the highly active meander bend discussed previously. Cross section #6 is positioned along the upstream portion of the meander, and has documented 13.8 feet of lateral erosion during the monitoring period. The area eroded along the right bank exceeded 130ft<sup>2</sup> over the two year monitoring period, with 51ft<sup>2</sup> of this erosion occurring during the September 1999 flood event. Cross section #7 is located slightly downstream on the meander bend, and during the monitoring period measurements revealed 14.5 feet of lateral erosion with 123ft<sup>2</sup> of area eroded along the right bank. The September 1999 flood was responsible for 60ft<sup>2</sup> of the total erosion at the cross section. Cross section #8, not shown, is similar to cross section #7 with 15.4 feet of lateral erosion with 123 ft<sup>2</sup> of eroded area. Cross section #9 is located on the downstream portion of the meander bend, and during the monitoring period 23.6 feet of lateral erosion was documented. The area eroded on the right bank equals 205ft<sup>2</sup> with 120ft<sup>2</sup> occurring during the flood event.

While an initial review of the cross section overlays may appear to indicate minor channel degradation, what is being represented is the evolution of the stream channel dimension as the meander migration moves through the fixed ends of the cross section. For example, while cross section #6 appears to show some downcutting, the cross sections have actually captured the process of the stream profile transition from a riffle or run feature to a pool feature. As the meander migrates down valley, the cross section dimensions will change as their position in relation to the meander features changes .

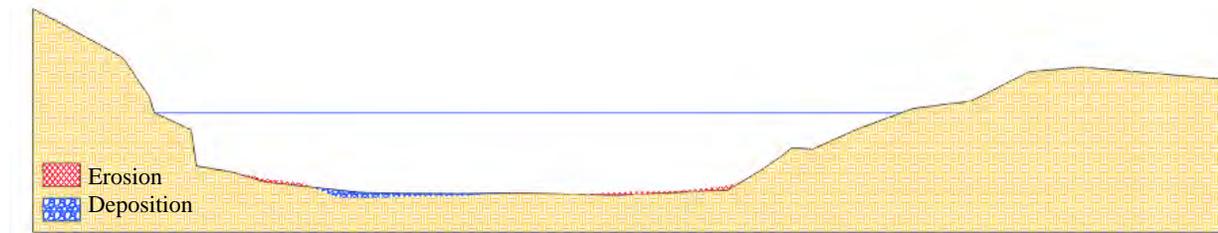
**Figure VI-66:** Overlay of cross section #13 at Kastanis Site 1998 - 2000. Note presence of terraces and increased entrenchment in this section of the reach

Moving down the reach, the stream corridor begins to transition to a more entrenched condition (**Figure VI-68a photo A,E,F**). The floodplain narrows, and terraces/steep slopes on both sides of the stream result in a constriction in valley morphology (**Figure IV-66**). Between cross section #9 and #15 (**Map VI-5**), the stream type transitions from a C4 to F4 stream type. The lower end of the Kastanis site exhibits a variable entrenchment ratio, ranging from 3.3 to 1.3. Slight changes in bankfull stage, as little as 0.2 feet, can dramatically increase or decrease the degree to which the stream channel is confined at the bankfull stage. The transition between stream types occurs gradually over

approximately 1,250 feet of channel length, before a complete transition into an F4 channel at cross sections #15 and #16 where the average entrenchment ratio is 1.3.

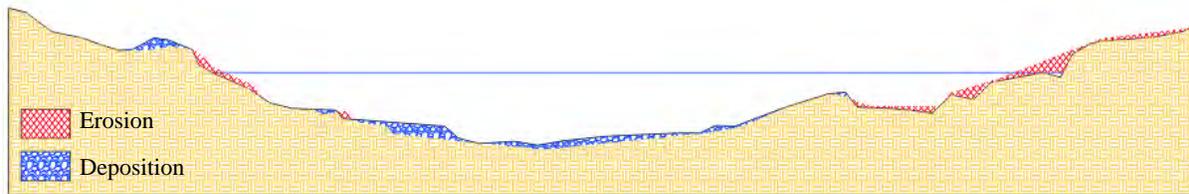
**Figure VI-67:** Overlay of cross section in Ashland Hamlet, lower reach 4e, 1998 and 2000.

The single monitored cross section is located near the bottom of the reach, at a point where NYS Route 23 is located close to the stream. The GCSWCD monitored the cross section in both 1998 and 2000 (**Figure VI-67**), as well as several hundred feet of streambed profile. The Phase III/IV monitoring also included an analysis of streambed sediment size, with small cobble dominating the channel materials. Analysis of the cross section indicates a C3 stream type, with only minimal bank erosion and channel aggradation noted during the monitoring program. The monitoring program included the large flood event in September 1999, and any measured erosion was minimal considering the magnitude of the flood.

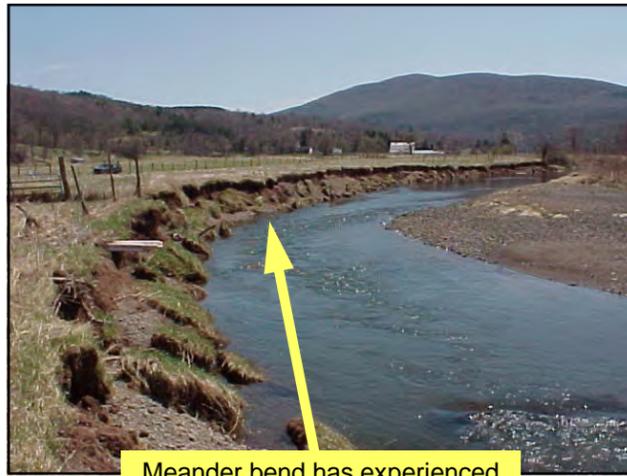
B

The initial visual inventory, performed during the Phase I Inventory and Assessment in 1997, noted large areas of streambank erosion within reach 4e. At that time, the upper portion of the reach (**Figure VI-68a photo B,C,D,F**) was experiencing the greatest amount of instability, but eroded banks and channel problems had been noted throughout the reach. The Phase I inventory found that 4,220 feet of streambank within the reach was experiencing active erosion, with 57% of the total streambank length impacted. The scale of the erosion was estimated at nearly 5.3ft<sup>2</sup> of exposed streambank per linear foot of stream channel, with the majority of this occurring in the upper 3,300 feet of the reach. When compared to the erosion rates in other management segments, reach 4e exhibited the second highest rate in the watershed.

Analysis of the cross section data from the upper reach indicates that stream classification has shown little change over the three years of data collection. The upper limits of the site classify as a C4 stream type (Rosgen 1995), which extends from cross section #1 through section #9. Along this section of the reach, the north bank has been experiencing lateral migration as discussed previously in this section **(Figure VI-68a, photo B,C,D,G)**. The

north bank ranges from 7.5 - 10.5 feet in height, and the primary failure method appears to be related to undermining of the streambank toe and mechanical slab failure of the upper banks. Representative samples of cross sections in the highly unstable area are discussed below. Cross sections #1 through #9 represent a portion of the cross sections located on the upper 2,780 feet of the reach (**Map VI-5**).

In general, the riparian condition in reach 4e is similar to most areas along the lower Batavia Kill: poor. Riparian buffers, when present at all, are limited in width and provide minimal benefits. In those areas where the stream borders steep upland slopes, such as along much of the right bank through reach 4e, dense wooded buffer is common (**Figure VI-68a photo A**). The presence of these buffers can be attributed to the slopes being too steep for farming or development. In the areas where agriculture has been active during the last 40 years or more, riparian vegetation is pretty much limited to grasses, with narrow, intermittent bands of woody material. A review of the historic aerial photographs from 1959 to 2000, shows that the riparian area has been severely limited by agricultural practices in the adjacent fields (**Figure VI-62**). The lack of any deeply rooted vegetation is a primary factor in the high rates of erosion that have been observed in the upper section of the reach (**Figure VI-61a photo B**). Almost the entire upper half of the reach is characterized by little

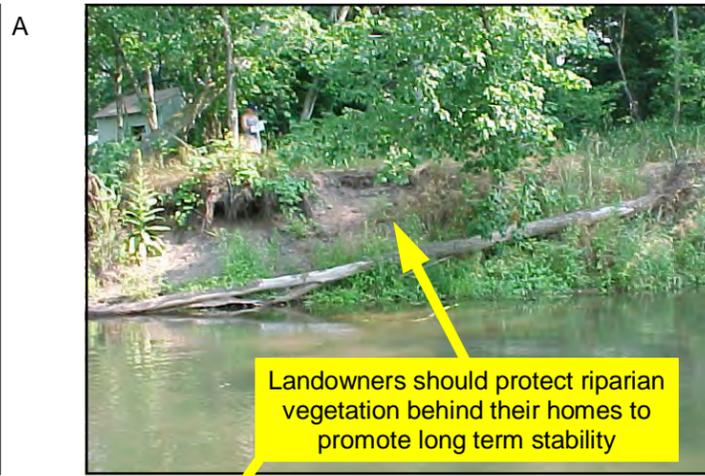
Landowners should protect riparian vegetation behind their homes to promote long term stability

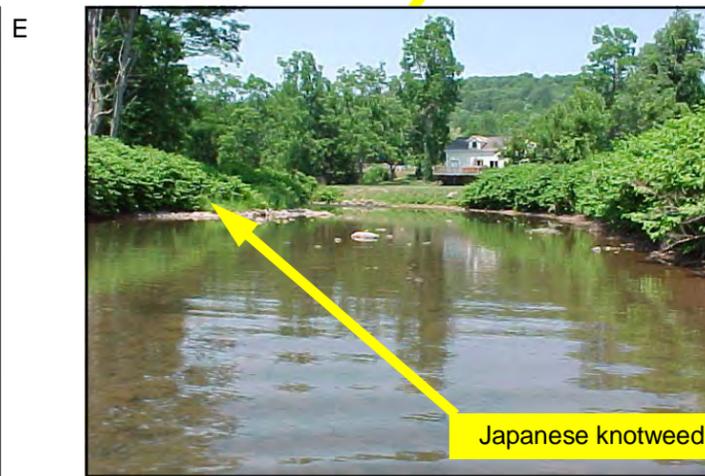
In the lower half of the reach, while there is some tree/shrub community along most of the channel, the riparian zone averages less than 50 feet in width and is in poor condition. The presence of a narrow band of larger hardwood trees, as well as some willow and other shrub growth along the channel, are helping maintain channel stability, but is not adequate to provide water quality benefits. Reach 4e also contains significant areas of the riparian zone that is impacted by Japanese knotweed.

Japanese knotweed is found in many locations through Reach 4e. Knotweed crowds out more desirable vegetation
