Reach 4f (Tompkin's Quarry to Holden Property)

Reach 4f Summary

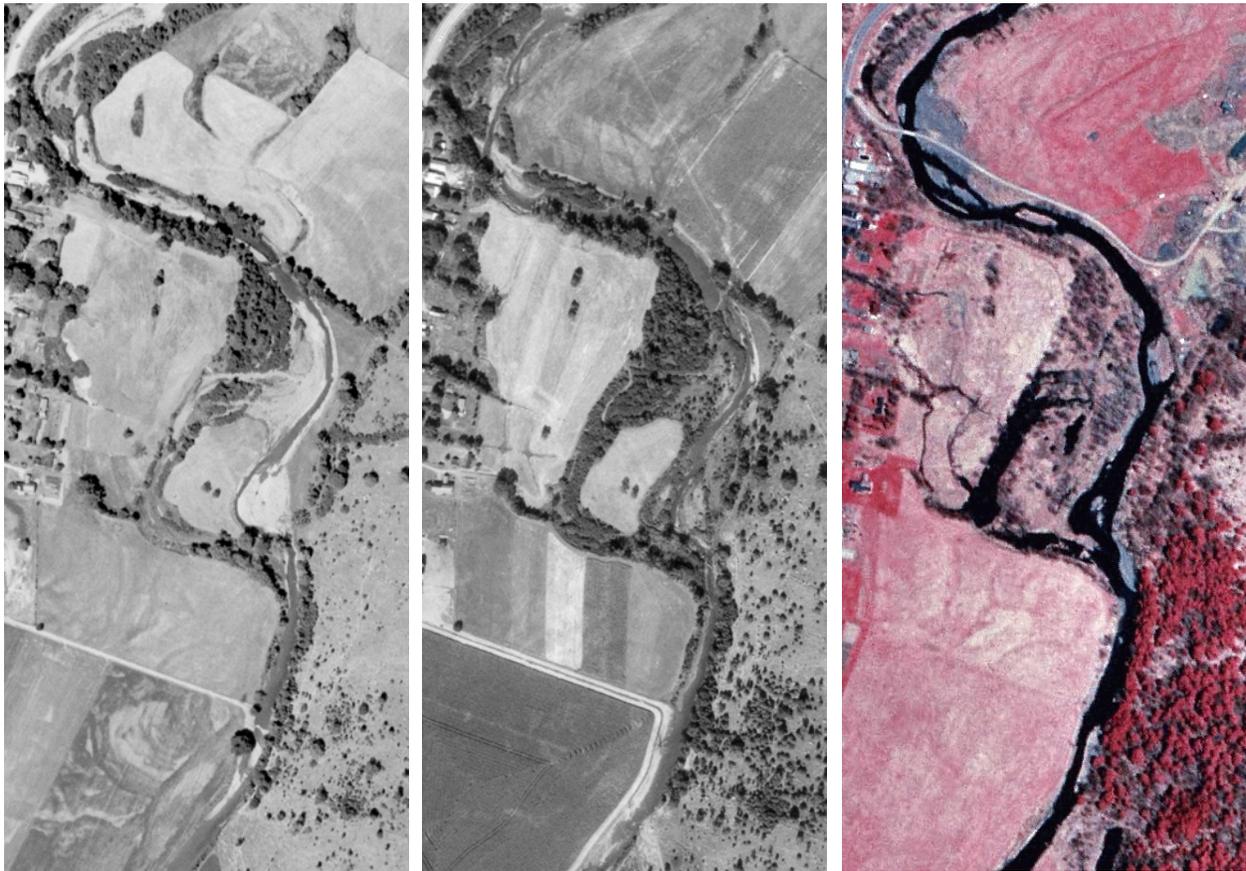
Figure VI-69: Review of aerial photos from reach 4f from 1959 (left), 1980 (center) and 1995 (right). Note development of center bars and the loss of active farming on the floodplain.

To evaluate long term changes in the reach, the GCSWCD reviewed historical aerial photographs from 1959 to 1995 (**Figure VI-69**). By reviewing stream conditions between 1959 and 1995, the GCSWCD noted minor changes in channel planform, as well as changes in sediment storage within the reach. The aerial images do clearly indicate historic channel meanders which pre-date 1959, but are generally not very old. These are primarily located at the very bottom of the reach.

The changes to channel planform between 1959 and 1995 were somewhat localized, with some active movement of the channel seen at the top and bottom of the reach. The aerial photos also revealed changes in sediment storage within the reach. In 1959 (**Figure VI-69, left**) the channel does not appear to exhibit significant deposition. By 1980 (center) and 1995, the aeriels show increasing deposition of sediment, with the 1995 photo showing distinct signs that central bars are developing throughout the reach. The formation of center bars is typical in those situations where the stream channel has become wider and the width to depth ratio has been increasing. As seen in **Figure VI-71, photo J**, the center

bars have started to become vegetated, which is further evidence of reduced shear stress and loss of sediment transport competence in the reach.

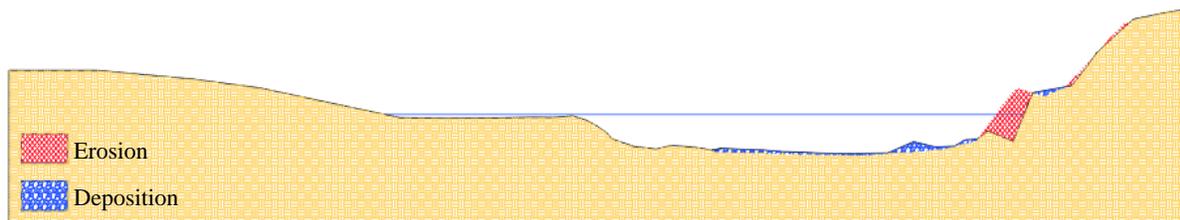
Figure VI-70: Overlay of monitored cross section in reach 4f, 1998 and 2000 surveys shown.

The cross section was surveyed again in 2000 to measure any changes that may have occurred at the cross section (**Figure VI-69**). A comparison of the cross section in 1988 and 2000 revealed some lateral erosion on the right bank, with a small amount of aggradation. No degradation was noted at the cross section. Between 1998 and 2000 the

channel appeared to have been widening, with its width to depth ratio increasing. The finding that some aggradation had occurred at the cross section was not unexpected as it is a typical response to channel widening. Considering the magnitude of the flood event that occurred between the two surveys (September 1999), the changes seen at the cross section were not a major concern, but the reach should continue to be monitored for signs of increasing instability.

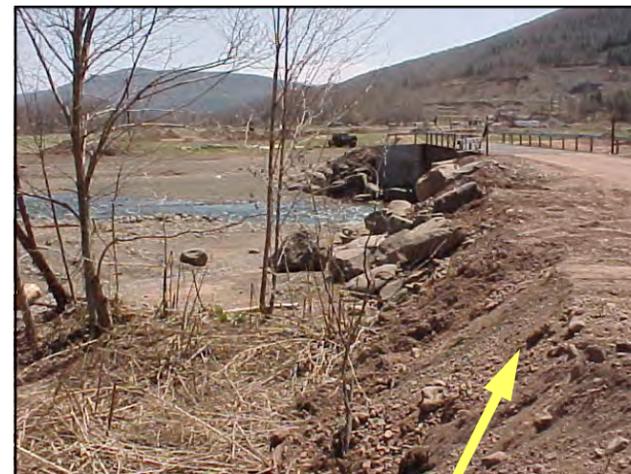
D

Overwiden channel below bridge is promoting active aggradation

Floodplain fills increase channel entrenchment and divert floodway forces

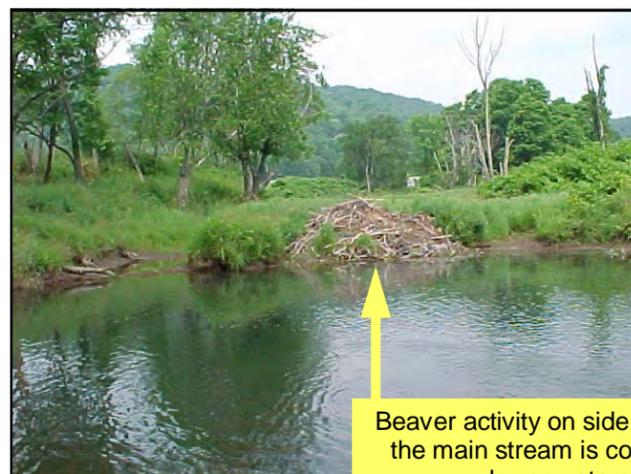
E

Beaver activity on side channels and the main stream is common in the lower watershed

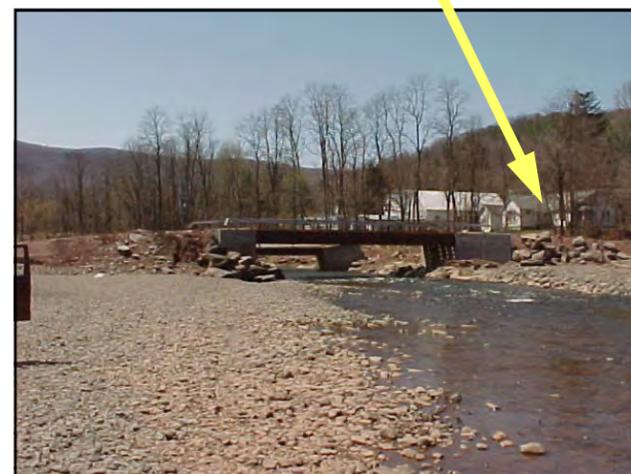
F

Central bar formation is typical when the stream channel is over widened

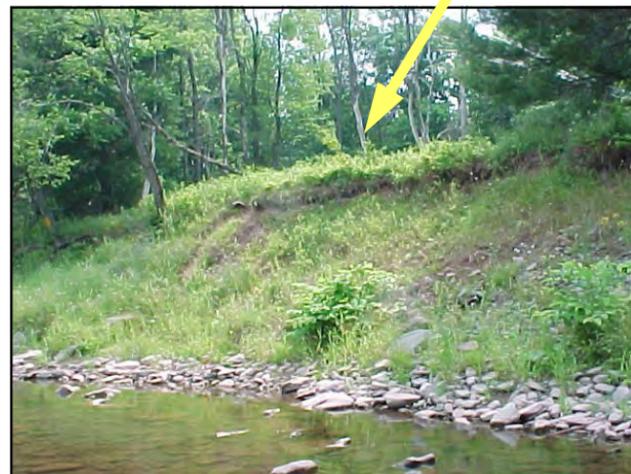
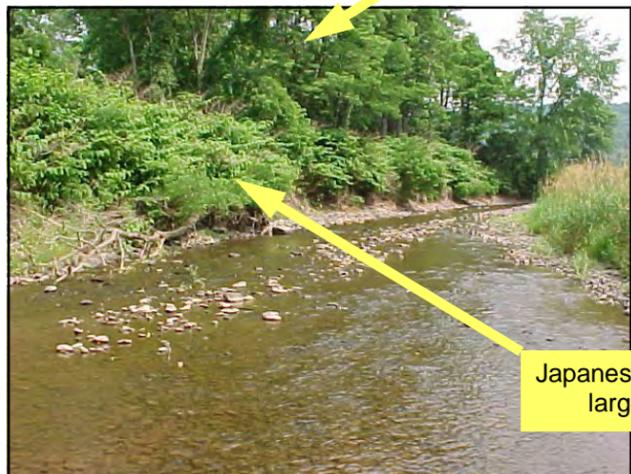
The majority of the left bank, where the quarry access road is located is void of any woody vegetation, and the thin zone of grasses is less than adequate to provide any real benefit to water quality, habitat or bank stability. While some woody vegetation is present in the riparian buffer on the lower end of the reach on the left bank, but as seen in **Figure VI-68 photo G&H**, the lower banks are not provided adequate protection from erosion.

Riparian vegetation requires additional woody shrubs and deep rooted sedges on lower slopes

Riparian buffer require woody trees & shrubs for deep rooting and shading

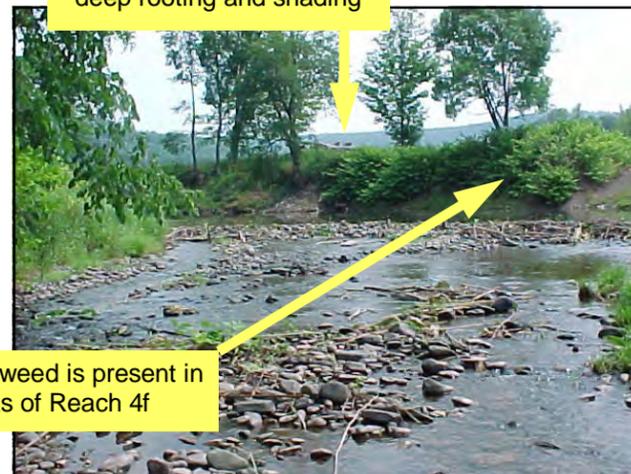
I

Japanese knotweed is present in large areas of Reach 4f
