Broadstreet Hollow Management Unit 1

General Description:

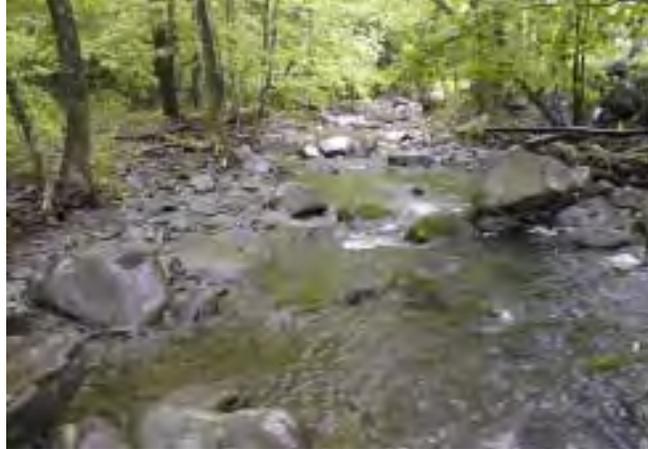
This unit is approximately 2,420 feet long, beginning at the upper end of Broadstreet Hollow Road, approximately 100 feet into New York State Department of Environmental Conservation (NYS DEC) land (Photo 1). This unit is in good condition (relatively *stable*), with some stream bank alteration along the roadside, and no development (houses or other structures) between the road and the stream.

Photo 1. Looking downstream from the top of MU1.

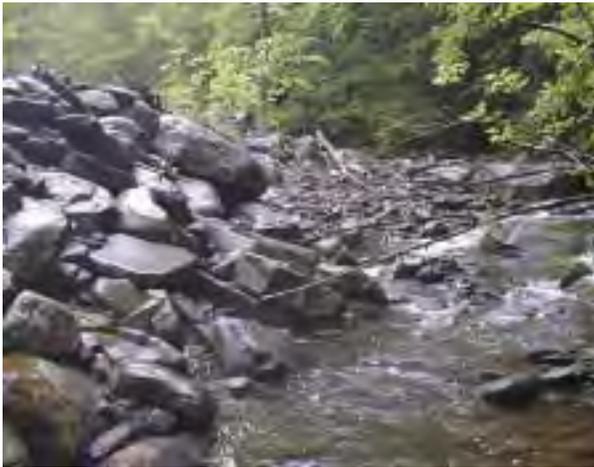
Photo 2. Looking upstream at un-vegetated boulder rip-rap.

The upper rip-rap section, extending just downstream of DEC land along the right bank of the stream (looking downstream), is older (actual age unknown), primarily un-vegetated, and consists of large boulders, either *non-quarried natural boulders* from outside the stream, or local, or *native*, material from the stream channel itself (Photo 2)
3&7

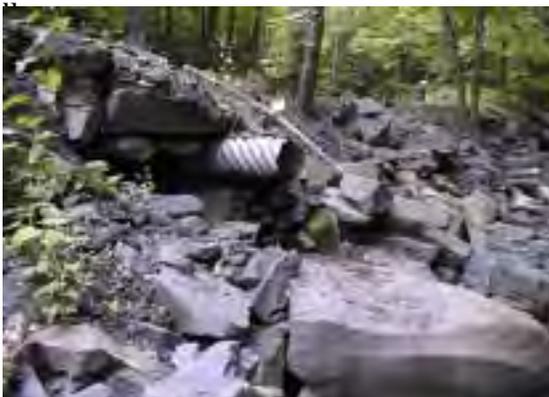
Photo 4. Culvert in lower rip-rap section, right bank, MU1.

no recent stream bank work and continues to experience stream instability and stream bank erosion (Photos 3 and 4). Rip-rap in

This rip-rapped section appears to represent the greatest potential for stream instability in MU1. The angle of the stream bank is steep, there is very little vegetation to hold bank materials in place, and both the stream and the valley are particularly narrow and steep. This

section of stream is primarily comprised of *entrenched* stream types (i.e., no discontinuous floodplain benches and close valley walls), some with greater than 5% slope. There is a small reach of especially narrow and highly entrenched stream type with approximately 2.5% local slope. This narrow reach has some bank erosion on the left bank (see Photo 5 and discussion below), opposite the rip-rap, and two culverts entering the stream channel well above the stream bed (see Photos 3 and 4, and discussion below).³

The two culverts in MU1 in the lower rip-rapped section (see Photos 3 and 4, above) currently enter the stream from a steep angle. Hence, the water falling into the stream has greater erosive potential as it falls and hits the stream bank below. In addition, the water runs over a distance of bare rock before entering the stream, potentially heating the water and increasing stream temperature³. Where possible, the outlets to these culverts should be reconfigured to allow water to directly enter the stream, at a low angle to minimize

erosion, or splash rocks, possibly with vegetation, installed or adjusted to dissipate the energy of the falling water.

Adding woody vegetation (trees, shrubs) at and opposite culvert outlets, with a mixture of native riparian species, can improve shade and cover conditions for aquatic habitat, as well as reducing water heating. This can also improve bank stability and reduce the need for bank stabilization work that potentially causes stream ecosystem disturbances⁷.

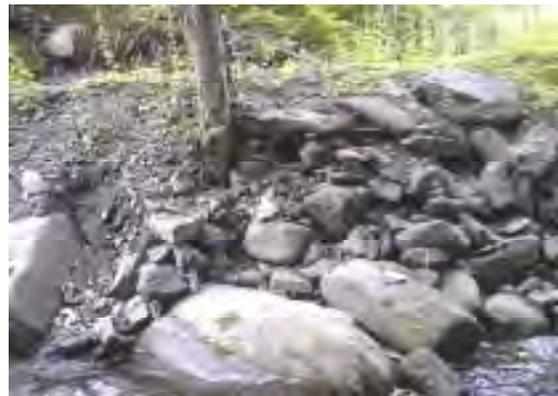
Photo 3. Culvert in lower rip-rap section, right bank, MU1.

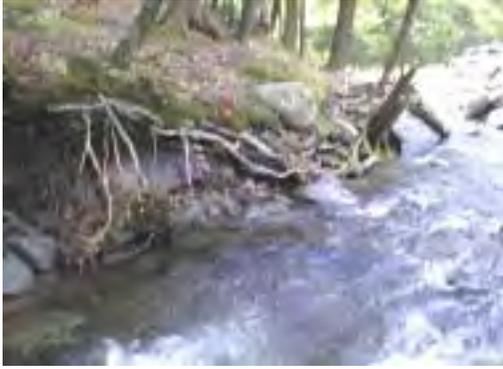
Photo 5. Minor bank erosion, across from lower rip-rap section, MU1.

Stream assessment conducted in 2001 did not reveal any significant eroding or exposed banks that currently warrant intensive stabilization or monitoring. Two areas of minor bank erosion were noted¹ but do not currently threaten the road or any other structures (Photos 5 and 6). Road fill at the turnaround area at the top of Broadstreet Hollow Road is eroding (see Photo 5) but does not appear to impact the parking area, or stream reach stability in this area.

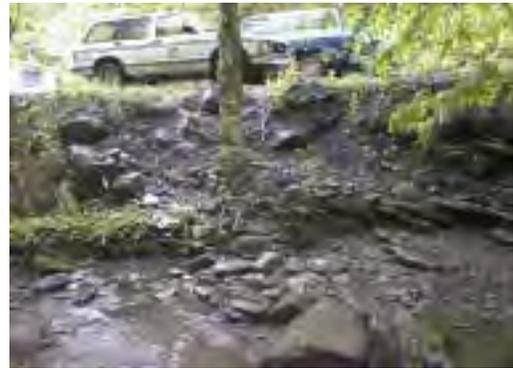
Minor bank erosion at the left bank across from the lower section of rip-rap, with the road and two culverts opposite, does not threaten any structures or the road, though this section may represent a potential future risk to stream stability and clearly indicates an imbalance in this reach (see Photo 6)^{3&8}.

Photo 6. Minor bank erosion, NYSDEC turnout, MU1.

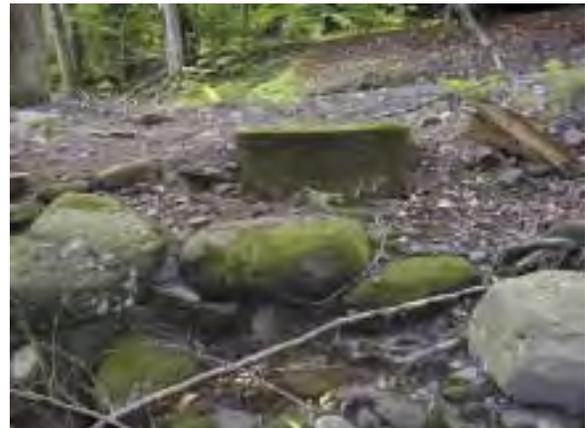
Photo 7. Shallow water supply well, right bank, MU1.

One shallow-water well was noted during the stream assessment survey conducted in 2001 that serves a property on the opposite side of the road from the stream (Photo 7). This type of well, typically less than ten feet deep, could be subject to road runoff and suspended sediments.
