## Broadstreet Hollow Management Unit 2

# Broadstreet Hollow Management Unit 2

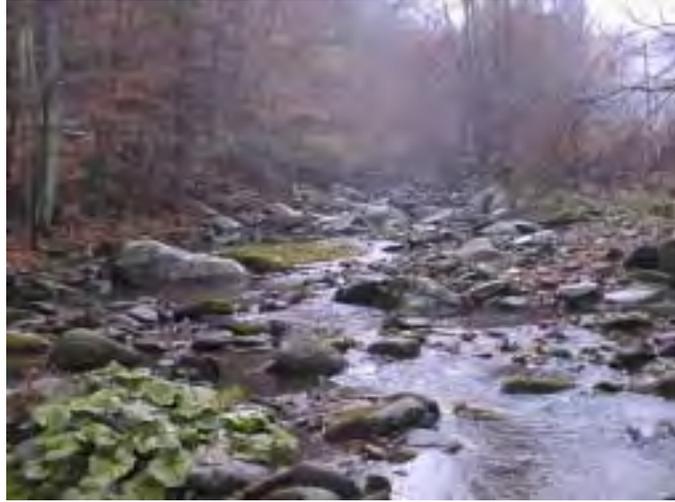
Management Unit 2 (MU2) is located in Greene County, NY<sup>1&2</sup>. The top of MU2 begins at a section of failing log crib wall where the road begins to run very close to the stream, approximately 2,400 feet from the top of Broadstreet Hollow Road (Photos 1 and 2). The Unit extends downstream approximately 1,480 feet to the outlet of the new County Bridge just below where Regina's Way intersects Broadstreet Hollow Road.

Photo 1. Looking upstream near the top of MU2, road at left at the top of the bank

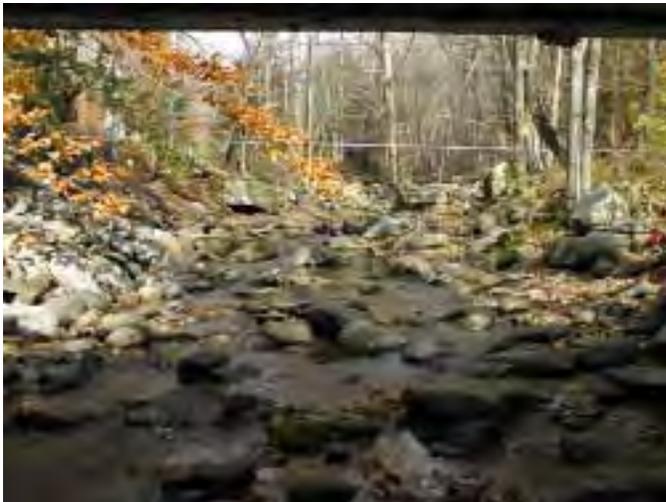
Photo 2. Looking upstream from bridge in the middle of MU2, road at left at the top of the bank

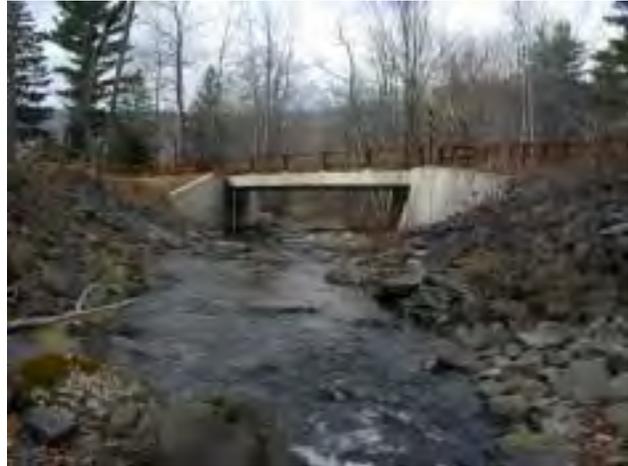
Photo 3. Looking upstream at bridge on Broadstreet Hollow Road, just below Regina's Way intersection (BIN 3201230).

One County maintained bridge crosses the stream in MU2 on Broadstreet Hollow Road, just below the intersection with Regina's Way (Photo 3). This bridge was replaced following the flood of 1996, and is wide enough to accommodate both a low flow stream channel and to allow the stream to maintain a generally natural shape consistent with dimensions upstream and downstream.

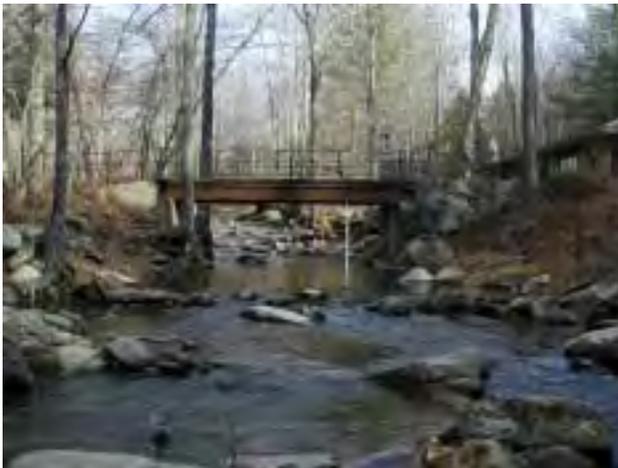
Photo 4. Looking upstream at private crossing.

Two private properties each have privately maintained bridge crossings (Photos 4 and 5). For the purposes of stream assessment, bridge width is defined by the length of the span over the stream from bank to bank, or abutment to abutment. These bridges are both constructed more narrowly than the natural stream both upstream and downstream from the bridge location.

A bridge that is too narrow can result in maintenance problems, both of the bridge itself as well as the stream channel or banks both upstream and downstream of the bridge. The constriction at the bridge can cause water to back up during floods, which can lead to increased erosion both upstream of the bridge as the water eddies behind it, and downstream as the water rushes through and eddies around the banks just downstream. Both of these bridges show evidence of such bank erosion both upstream and downstream of the bridge structure.

Landowners have reported property loss on both sides of the stream and many costly repairs. Both bridges will likely have maintenance problems over time, unless they are reconstructed to accommodate the natural width of the stream.

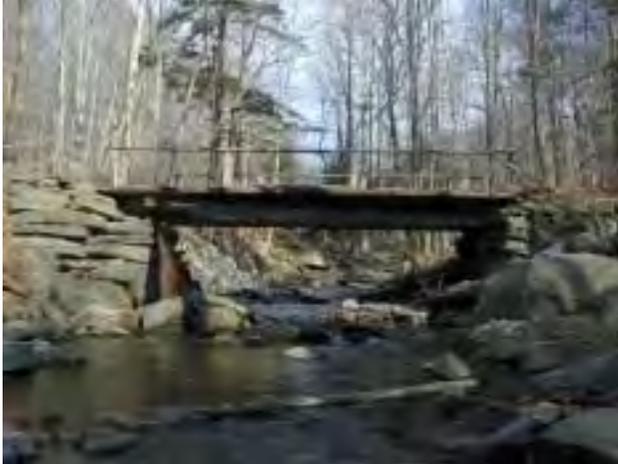
Photo 5. Looking upstream, private crossing at Shinbach property.

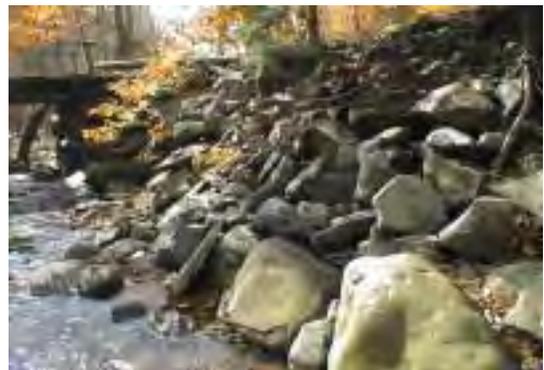
Approximately 800 feet, or 25%, of the stream banks in MU2 have been altered or hardened (Table 1)<sup>3</sup>. Dumped rock fill comprises the greatest length of revetment used in the unit (Photos 6 and 7), much of which continues to wash or fall into the stream during and following flood events and remains an ongoing maintenance problem for Town and County Highway Departments.

Photo 6. Dumped rock fill upstream of Shinbach's bridge, right bank.

Broadstreet Hollow stream can transport very large rocks, or *sediment*, along the stream bed (sediment in transport is called *bedload*). The size of sediment in dumped rock fill is often smaller than the bedload. As a result, rocks on the bank continue to wash downstream over time, needing periodic replacement. Continuing disturbance of the bank area prevents streamside, or *riparian*, trees and other vegetation from becoming established<sup>7</sup>. Further, some riparian tree species become stressed and weakened when their

trunks are buried, so existing trees that may be providing some bank protection are eventually killed by ongoing maintenance, reducing long-term bank stability, as well as compromising other important habitat and aesthetic benefits. Alternatives to dumped rock fill should be considered, to reduce maintenance costs and preserve riparian areas<sup>3</sup>.

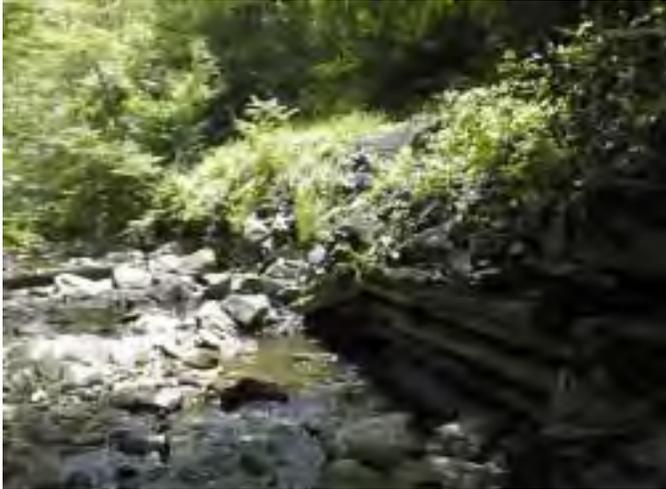
Photo 7. Failing log crib wall, with dumped rock fill, at the top of MU2.

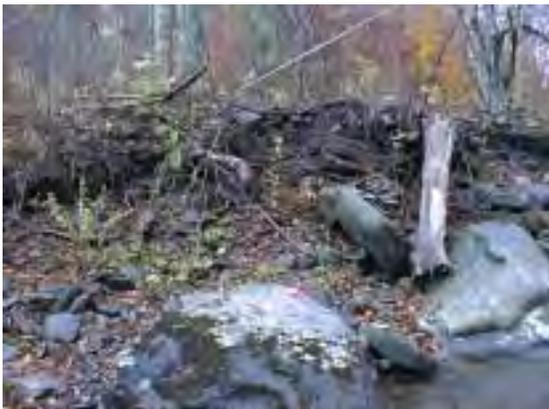
Photo 8. Eroding right bank at Broadstreet Hollow Road fill area, monitoring cross-section 22 (flow from right to left).

Four of the seven eroding banks are associated with road fill areas (see Photos 8, 10,11 and 14); one of these is also associated with eddy erosion at the outlet of the private bridge (see Photo 10). The bank at monitoring cross section 23 is associated with both a residential lawn area and the private bridge approach (see Photo 9).

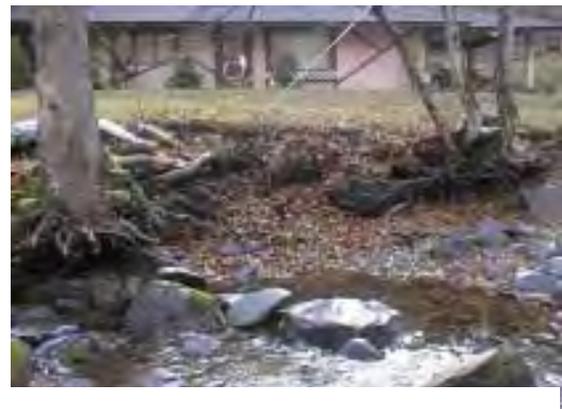
Photo 9. Eroding left bank at residential lawn, monitoring cross-section 23 (flow from left to right).

The east side of the stream, opposite the road (the left bank) contains generally healthy riparian vegetation, excepting the reach between the two private bridges (at monitoring cross-section 23). This reach would benefit from additional native trees and shrubs to protect the property and improve bank stability upstream from the lower bridge<sup>3</sup>. Additionally, the berm and rip-rap areas on the left bank at the downstream end of MU2 at the County bridge should also be vegetated to improve bank stability opposite the eroding bank (at monitoring cross-section 22) and improve shade and cover for the stream in the areas with dumped rock fill just upstream of the County bridge<sup>3</sup>.

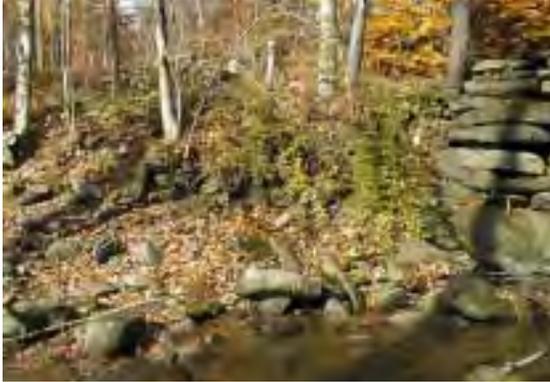
Photo 10. Eroding right bank at Broadstreet Hollow Road, and private bridge outlet, monitoring cross-section 24 (flow from right to left).

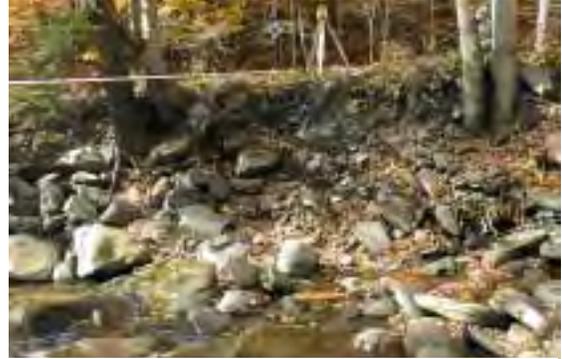
Photo 11. Eroding right bank at Broadstreet Hollow Road, monitoring cross-section 25 (flow from right to left).

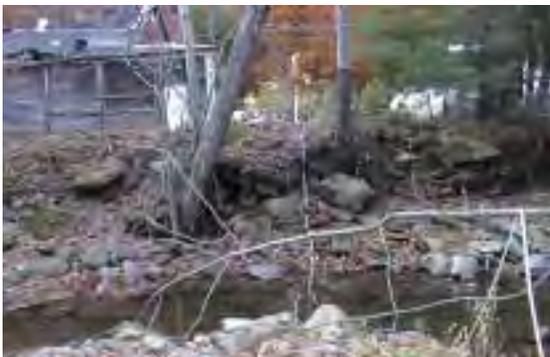
Photo 12. Eroding right bank at deteriorated house and dumping site, monitoring cross-section 26 (flow from right to left).

An old dumping site (see Photo 12) was found in this reach which has exposed the bank and has triggered ongoing bank erosion. This site poses a safety hazard from metal degradation of old concrete slab revetment and glass refuse material, in addition to the aesthetic and property value issues resulting from a dumping site.

Approximately 180 feet (6%) of MU2 was mapped as a single dumping site, the largest one documented in 2001. This area overlaps with the eroding bank (with failing concrete slab revetment) represented by monitoring cross-section 22 (see Photo 12), though extends beyond this lot and the eroding bank area. There is a deteriorated house on this

lot that coincides with the dumping area. Planning efforts to organize a cleanup endeavor at this site were initiated in 2002.

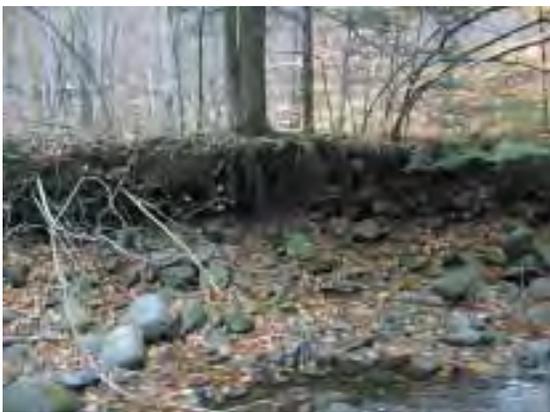
Photo 13. Eroding left bank at forested floodplain, opposite berm and fill area, monitoring cross-section 27 (flow from left to right).

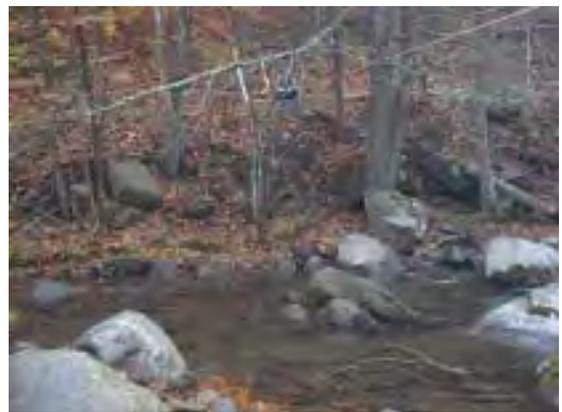
Photo 14. Eroding right bank at Broadstreet Hollow Road, monitoring cross-section 28 (flow from right to left).

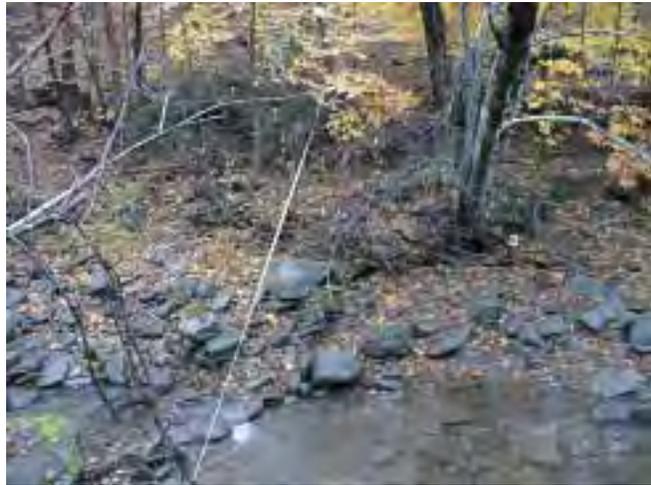
Multiple eroding banks in MU2 may cause increased turbidity in this reach from fine sediment (*silt* and *clay*) coming from stream bank and bed material. Of the approximately 475 feet of actively eroding bank documented in 2001, only one site contained an exposure of *glacial lake clay* in the stream bed (left bank Photo 15; right bank, monitoring cross-section 22, see Photo 8)<sup>10</sup>.

The berm on the left bank in this reach appears to be material pushed into that area in response to flood damages in the vicinity of the bridge just downstream (County Bridge just below Regina's Way intersection) (Photo 15)<sup>3</sup>. This practice of "cleaning" the gravel out of a stream in this way is thought to increase flood capacity by creating a larger stream channel. Unfortunately, berms such as these generally do not offer any protection from flooding, and can cause stream entrenchment and higher flood stage locally by preventing floodwaters from flowing over the floodplain, cutting off an important function of these flat areas.

Photo 15. Berm on the left bank (in the middle of the photo), at monitoring cross-section 22 location (flow from left to right).

Floodplains function to reduce flood velocity, increase absorption of floodwaters, encourage deposition of silt and fine sediments (keeping them from being washed further downstream) and decrease flood stage, or height, in downstream areas. The majority of Broadstreet Hollow stream floodplains consist of small, low, discontinuous floodplain benches that perform the important floodplain functions in small mountain streams. Because MU2 is particularly entrenched and confined, with little floodplain storage, removal or restructuring of this berm should be considered to add floodplain function to this area<sup>3</sup>.

Additionally, vegetation would help reduce bank erosion at the toe of the right bank at the erosion site, and intercept runoff from the road just beyond. In the absence of the berm, vegetation alone may be adequate to stabilize this bank.

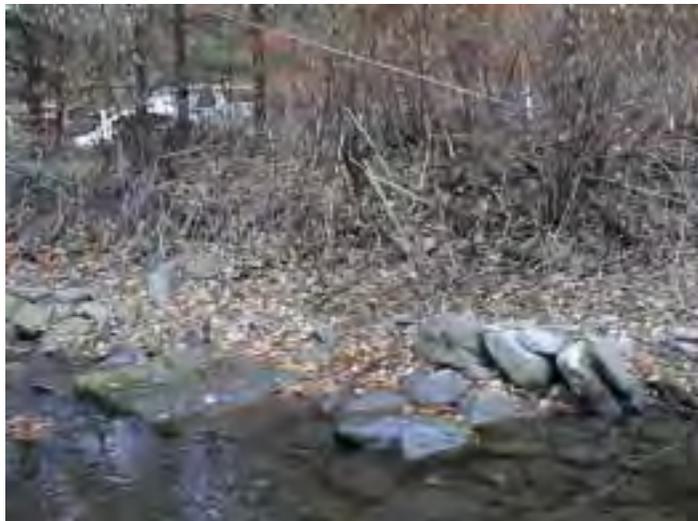
Japanese Knotweed, a non-native, invasive plant, was documented on 95 feet (3%) of the banks in this unit during stream assessment in 2001 (Photo 16). This species is an invasive exotic, and damaging to riparian integrity<sup>7</sup>. Japanese Knotweed is fast growing, can crowd out native vegetation and the roots provide little or no soil-anchoring action.

Photo 16. Japanese Knotweed, winter dormant state, right bank at monitoring cross-section 27 (flow from right to left).

Japanese Knotweed is aggressive and spreads easily; pieces break off, wash downstream and can take root where they land, especially in disturbed areas (such as eroding banks or continually disturbed maintenance areas). To avoid further spread of this plant to downstream areas that may be vulnerable to colonization, Japanese Knotweed at this reach should be removed, and the area replanted with a mix of competitive native species to prevent re-colonization. Additional maintenance of this area may be needed, as Japanese Knotweed is very difficult to remove successfully.
