## Broadstreet Hollow Management Unit 3

Management Unit 3 (MU3) is located in Greene County, NY, beginning at the outlet of County Bridge 3201230 near Regina's Way and continuing downstream approximately 1,150 feet to the inlet of Town Bridge 3201240 at Timber Lake Road. This management unit is the location of the Demonstration Stream Stability Restoration Project site (“demonstration project”), constructed in 2000 and 2001<sup>1&2</sup> (Photo 1).

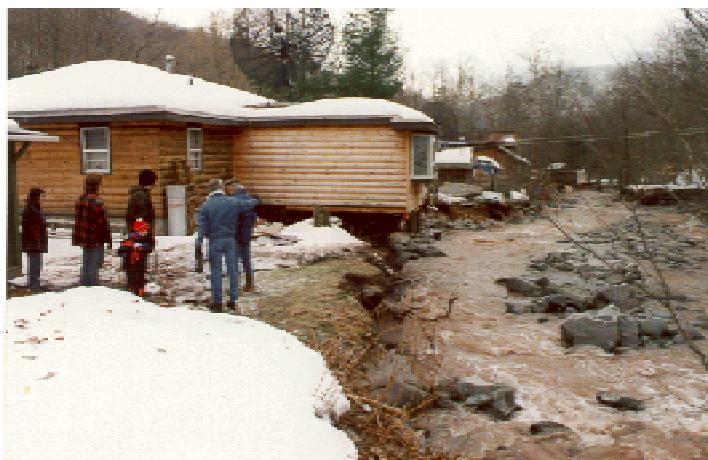
Photo 2. Looking downstream at left bank eroded under the Torregrossa home, 1996, following the January flood event.

Sometime before the mid-1960s, the Broadstreet Hollow stream was straightened and pushed into the hillside in this area, most likely to accommodate the road and houses. During the January 1996 flood, the Broadstreet Hollow stream eroded dramatically in many locations throughout the valley. In this section, the stream moved approximately 30 feet laterally (sideways), back to within a few feet of its pre-1960s location, recovering its original structural shape, or *morphology* (Photo 2).

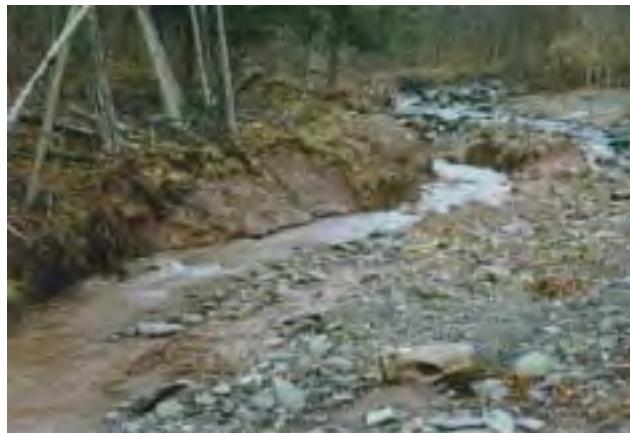
This development represented an imminent threat to life and property, hence making the site eligible for emergency repair work funding under the Emergency Watershed Protection Program, sponsored by the USDA-NRCS. While the program objectives were met, and the affected properties protected, glacial lake clays underlying the streambed were inadvertently exposed to a greater extent. (Photo 3).

Photo 3. Looking upstream, mid-MU3, showing glacial lake clay in stream bed and on hillslope to the left, 1997.

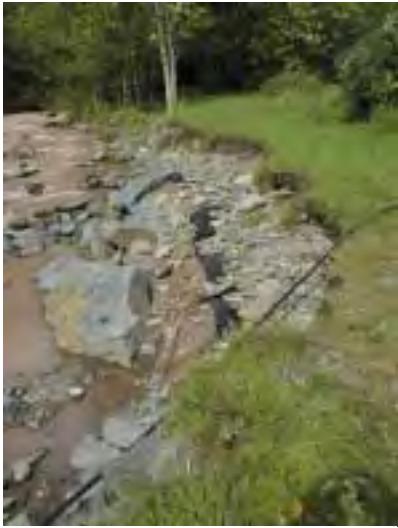
Photo 4. Looking upstream, failing riprap along left bank opposite clay hillslope, mid-MU3, 1998.

project to demonstrate techniques that work with natural stream processes including flood capacity, sediment transport and vegetative management. This site was chosen for the demonstration project in 1997, following further erosion of the stream bed, failure of the hillslope, and ongoing damage to the repair work on the bank (Photo 4).

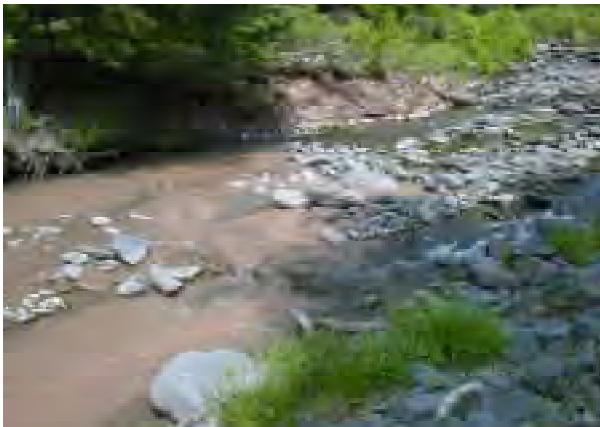
upwelling of muddy, or *turbid*, water (a “mud boil”) as it came to the surface in the streambed (Photos 5 and 6). The turbid condition prevailed during both low and high flow conditions, with the stream remaining turbid from the project site down to the confluence with the Esopus Creek, about 3 miles downstream<sup>5&13</sup>.

Photo 6. Artesian "mud boil", early summer, 2000, showing clay hillslope on right bank, mid-MU3. Stream flow is from right to left.

In the fall of 1999, flood conditions associated with Tropical Storm Floyd further degraded the stream channel. Rapid stream down-cutting, or *degradation*, along with saturation of the adjacent hillslope, accelerated the slope failure and opened up an underground spring.

Water moving under pressure (an *artesian* condition) through the clay layers underground produced a constant

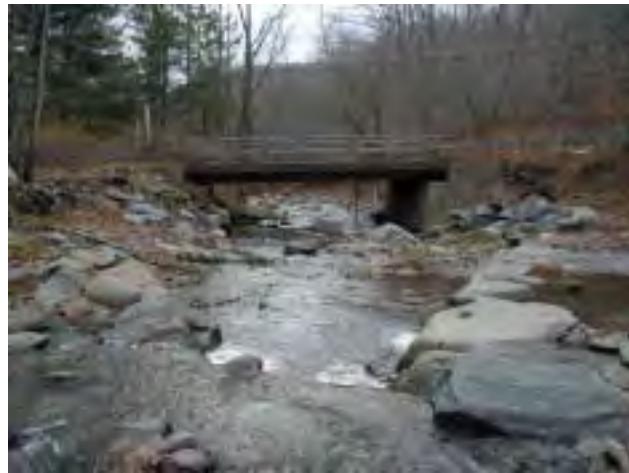
Photo 8. Looking downstream at County Bridge 3201240, at the bottom of MU3.

The downstream bridge is constructed more narrowly than the natural stream both upstream and downstream from the bridge location (Photo 8).

A bridge that is too narrow can result in maintenance problems, both of the bridge itself as well as the stream channel or banks both upstream and downstream of the bridge. The constriction at the bridge can cause water to back up during floods, which can lead to increased erosion both upstream of the bridge, as the water swirls, or *eddies*, behind it, and as the water rushes through and eddies

around the banks just downstream. This bridge shows evidence of such bank erosion both upstream and downstream of the bridge structure, as well as subsequent bank stabilization, or revetment work, to address ongoing instability. This bridge will likely have maintenance problems over time, unless it is reconstructed to accommodate the natural width of the stream<sup>8</sup>.

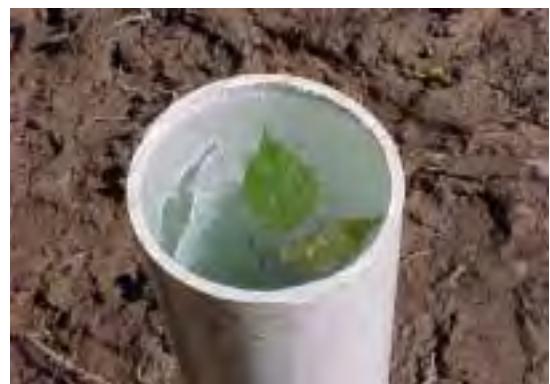
Photo 11. Groundwater relief well on the failing hillslope during construction, showing water from 30 feet down flowing up out of the ground under pressure. Note groundwater is clear before it comes in contact with the clay layers.

The final restoration design included the installation of three groundwater relief wells in the center of the project reach (Photo 11). This was designed to force the groundwater through a piped outfall to the stream, instead of through layers of clay and up into the stream bed, thus keeping the water clear<sup>13</sup>.

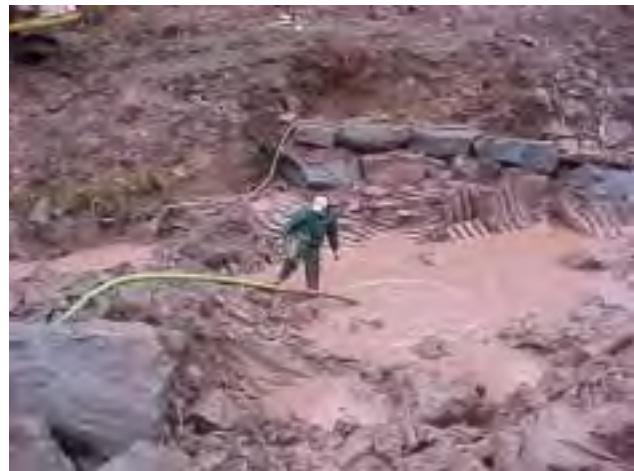
At the time of the stream assessment survey in 2001, MU3 had approximately 140 feet (6%) exposed clay in the banks and channel bottom. This clay was likely left over from the construction process, or was a result of adjustment in the reach as it equilibrates through several flood events, and will likely stabilize itself over time. The demonstration project design included over-excavation of clay material in the streambed, and back filling with clean gravel and cobble materials similar to what occurs naturally in the stream (Photo 12)<sup>5&13</sup>.

Photo 12. Excavation of a plunge pool below a cross vane during construction, 2000. Clay material in the stream bed was over-excavated and removed, and back filled with clean sediment to form the new stream bed.

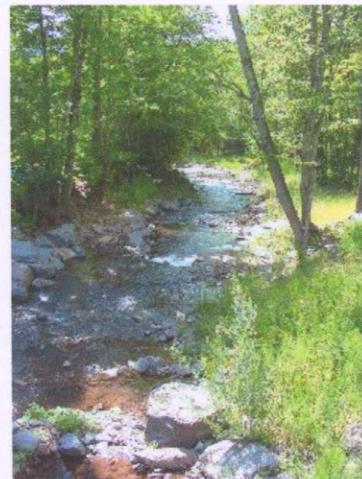
Following primary reconstruction of the stream channel, vegetation was reestablished on the floodplain and surrounding areas disturbed during construction activities (Photo 13). Techniques included live willow *fascines*, posts, live material transplants, bare root seedlings and potted trees/shrubs. Temporary soil stabilization was provided by spraying bare soil areas with a mix of seed and mulch material, or *hydro-seeding*, with a conservation grass seed mix. Planting was completed by the project contractor, GCSWCD staff and a wide range of volunteers including many local Broadstreet Hollow residents, and members of Trout Unlimited (Photo 14)<sup>13</sup>.

Photo 13. Looking downstream from the top of MU3, spring 2002, showing new riparian vegetation becoming established. Note mature trees left intact on both banks during construction of the project.

Establishing a functioning and self-sustaining riparian zone is very difficult, and can require a number of years and ongoing maintenance to achieve success. Under-vegetated areas in MU3 should continue to be vegetated or supplemented with a mixture of native riparian species to improve shade, cover and water temperature conditions for aquatic habitat<sup>9</sup>, as well as to improve bank stability and reduce the need for future restoration work that could cause or increase stream ecosystem
