Broadstreet Hollow Management Unit 4

General Description:

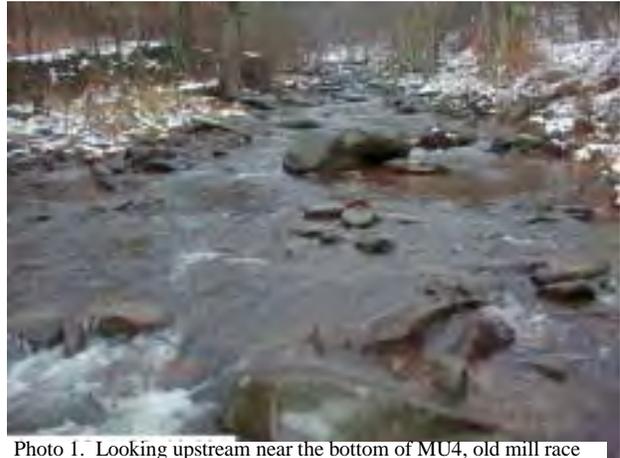
Photo 1. Looking upstream near the bottom of MU4, old mill race and dam wall at left, Broadstreet Hollow Road at right.

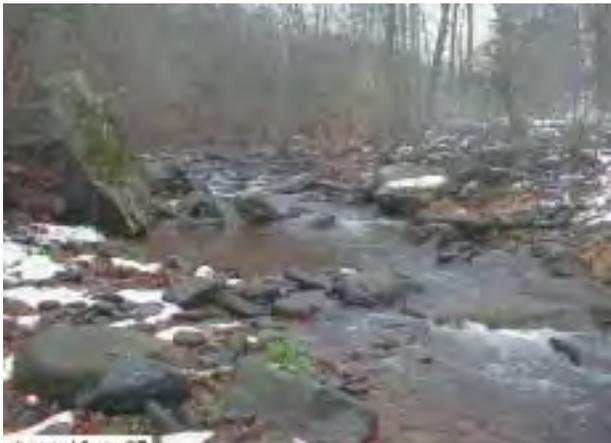
Photo 2. Looking upstream, near the middle of MU4, with steep valley wall to the left, and material stockpiles and plow side-cast berms to the right along Broadstreet Hollow Road.

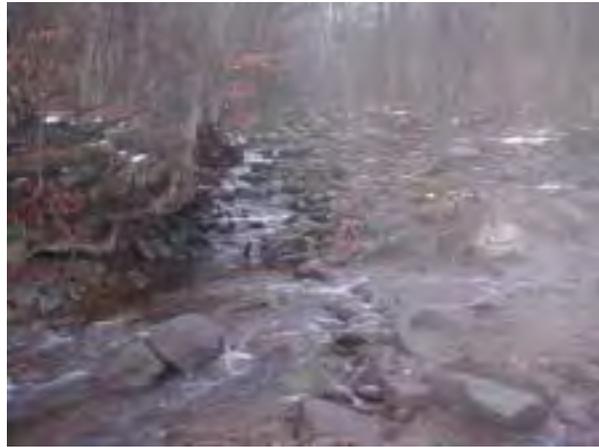
Jay Hand Hollow, the largest side stream, or *tributary*, in the valley, enters the main Broadstreet Hollow stream near the top of the unit ¹(Photo 3). *Confluence* areas (where two streams join) tend to be unstable by nature's design, as the smaller stream delivers pulses of floodwater and sediment to the main stream. Eroding banks in the main stream opposite the confluence are a common feature, and do not necessarily indicate systemic instability, but are worthy of monitoring to assess changes or increased erosion, especially if instability conditions are locally common.

Photo 3. Looking upstream into Jay Hand Hollow, at the confluence with the main Broadstreet Hollow stream. Flow in the main stream is from right to left.

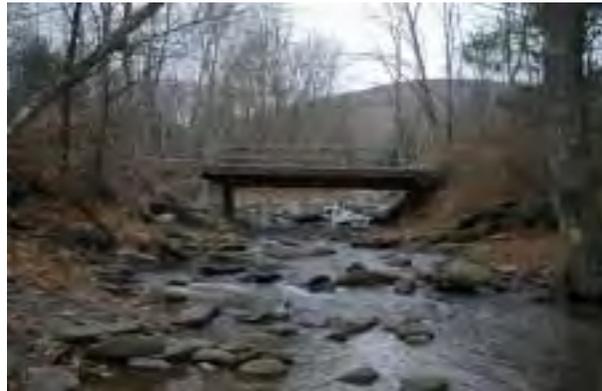
The span under County Bridge 3-20124-0 (Timber Lake Road, at the top of MU4) is approximately 24 feet, compared to the average natural stream channel width both upstream and downstream from the bridge location of approximately 33 feet (Photo 4).

Photo 4. Looking upstream into the top of MU4 at the Timberlake Road bridge, County BIN 3-20124-0.

Both of these bridges show some evidence of such bank erosion both upstream and downstream of the bridge structure, as well as subsequent attempted bank revetment work to address this ongoing instability. Both of these bridges will likely have maintenance problems over time, unless they are reconstructed to accommodate the natural width of the stream⁸. Addressing stream bank stability separate from amending the bridge will likely only offer a temporary fix.

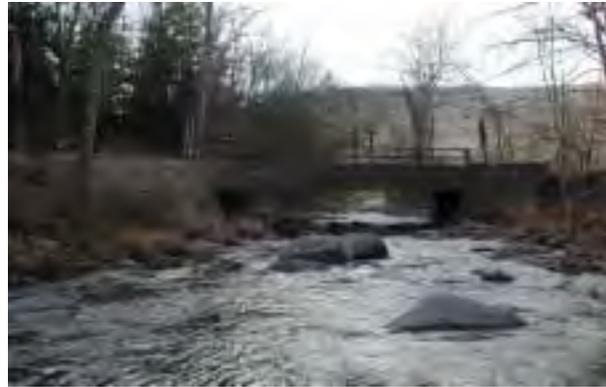
County Bridge 3-20122-0 (Broadstreet Hollow Road, at the bottom of MU4), though constructed at a more appropriate width of approximately 30 feet, is still narrower than the average local stream width of approximately 38 feet (Photo 5). Additionally, due to the valley and road configuration, this bridge was built into a sharp turn in the road to accommodate stream flow direction, but still crosses the stream at an angle. The result is that the stream is directed into the right abutment (looking downstream) during high flow, increasing potential for bridge structural instability and stream bed scour.

A bridge that is too narrow can result in maintenance problems, both of the bridge itself as well as the stream channel and banks both upstream and downstream of the bridge. Constriction at a bridge can cause water to back up during floods, which can lead to increased erosion both upstream of the bridge, as the water swirls, or *eddies*, behind it, and as the water rushes through and eddies around the banks just downstream^{3&5}. Also, constriction raises flood level, or stage, upstream of the bridge, increasing the risk of inundation of the road, which can cause road damage or access restrictions.

Photo 5. Looking downstream near the bottom of MU4, at inlet of County bridge 3-20122-0, Broadstreet Hollow Road at right of stream. .

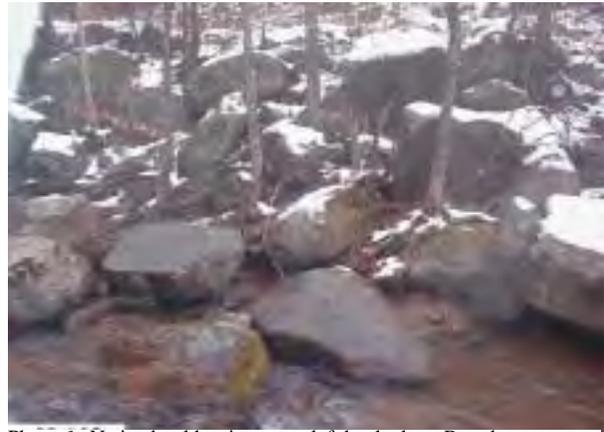
Approximately 310 feet, or 9% of the stream bank in MU4 has been rip-rapped with medium to large boulders, either *non-quarried natural boulders* from outside the stream, or local (*native*) material from the stream channel itself (this type of revetment is an older method, not practiced currently). This rip-rap is generally older, and vegetated with some trees between the boulders (Photo 6).

Photo 6. Native boulder rip-rap on left bank along Broadstreet Hollow Road, sparsely vegetated with trees. Flow in the stream is from left to right.

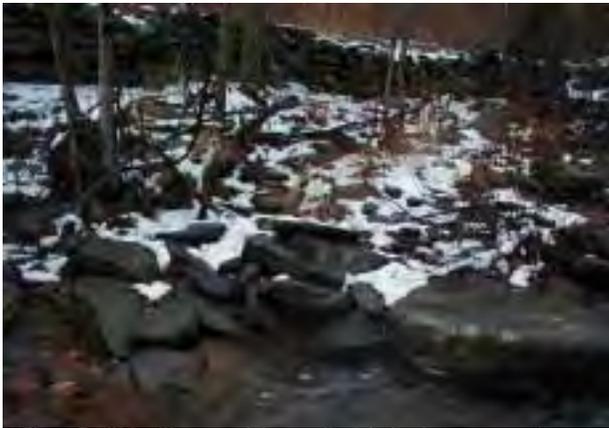
Photo 7. Old mill race and dam wall, right bank upstream of County bridge 3-20122-0. Flow is from right to left.

stacked rock wall or stone wall revetment. One wall, approximately 150 feet in length, is at the site of an old mill dam, and does not provide any necessary stream bank protection (Photo 7).

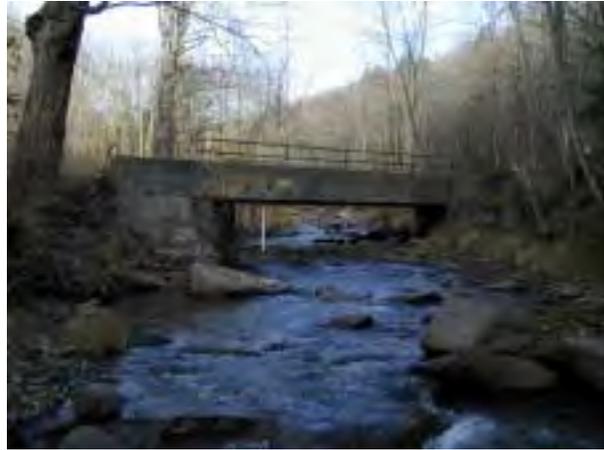
The other walls, totaling about 60 feet, stabilize the stream bank and road fill in a short section just downstream of County bridge 3-20122-0 (Photo 8), and in the middle the unit between a rip-rapped and a bermed section where the road and stream are in closest proximity.

Photo 8. Looking upstream toward County bridge 3-20122-0, showing short section of stacked rock wall at left, with large tree, along Broadstreet Hollow Road.

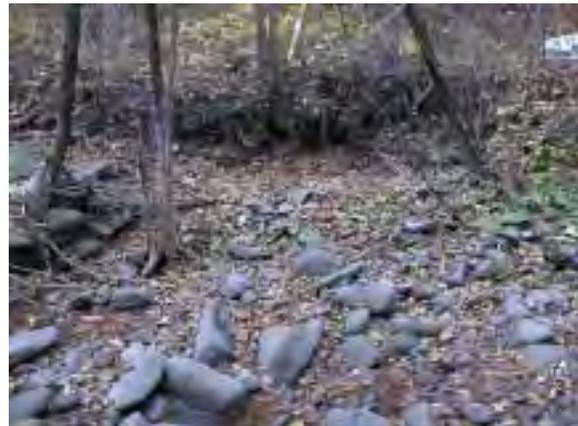
Photo 9. Eroding left bank along Broadstreet Hollow Road, opposite the Jay Hand Hollow confluence with the main stream (flow from left to right). Pink flag marks the location of monitoring cross-section 19.

Monitoring cross section 19 (the downstream-most section) received a moderate BEHI ranking. This monitoring cross section was installed to track erosion on the road side of the stream associated with the confluence with the Jay Hand Hollow. Monitoring cross-sections 20 and 21 were installed in different locations along the same long bank on the opposite side of the stream from the road. Both received high BEHI rankings, indicating they have a higher potential for future erosion, though this area of erosion does not currently threaten houses or infrastructure.

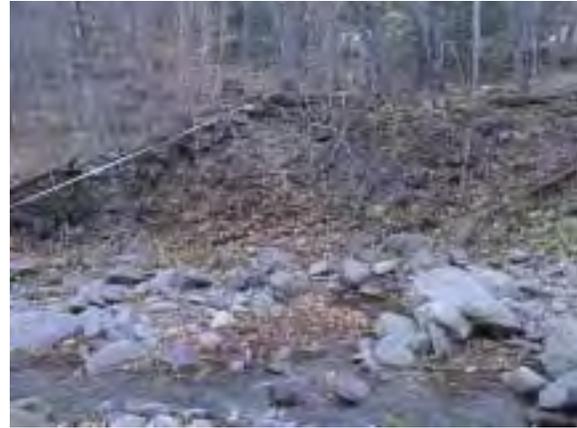
Photo 10. Eroding right bank at wooded terrace, monitoring cross-section 20, stream flow is from right to left.

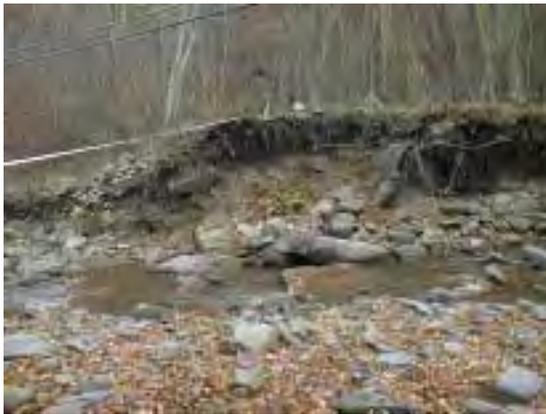
Photo 11. Eroding right bank at sparsely wooded terrace on NYS DEC land, monitoring cross-section 21, stream flow is from right to left.

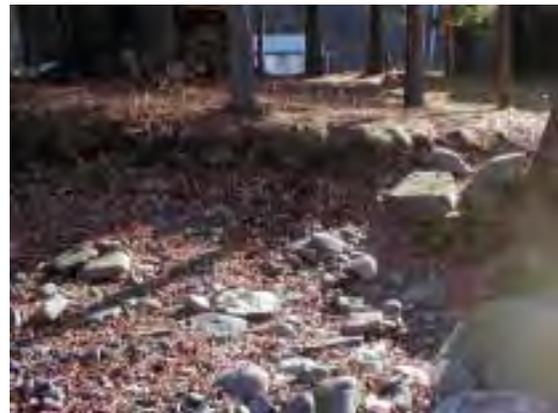
Minor bank erosion at the left bank just downstream from the Timberlake Road bridge was noted, but was not monumented for further monitoring (Photo 12). While this section does not currently threaten any structures or the road, this area is just upstream of a residential lawn area, and probably represents eddy erosion associated with the bridge.

Photo 12. Low eroding left bank, just downstream from Timberlake Road bridge near the top of MU4, stream flow is from left to right.

This section should be visually monitored, as it may represent a potential future risk to stream stability and clearly indicates an imbalance in this reach^{3&8}. Additionally, this area could benefit from additional riparian vegetation to improve bank stability and prevent ongoing property damage⁷.
