Broadstreet Hollow Management Unit 6

General Description:

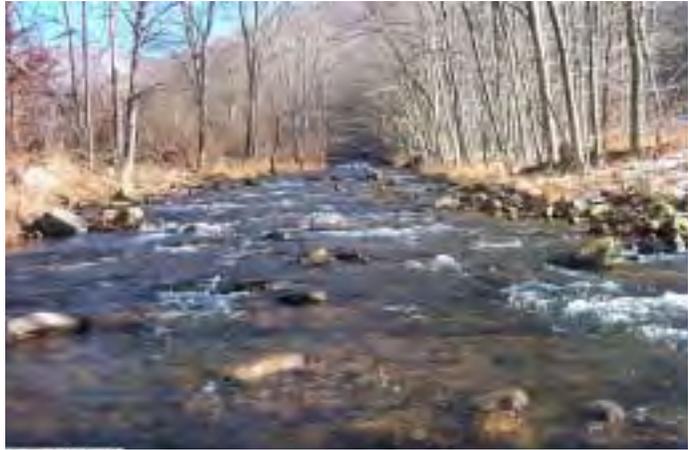
Management Unit 6 (MU6) is located in Ulster County, NY, running downstream approximately 510 feet starting from the County line^{1&2}. The stream flows well away from the road through most of the Unit, with no development on either bank (Photo 1). The stream is in generally good condition, or *stable*.

Photo 1. Looking upstream from the bottom of MU6.

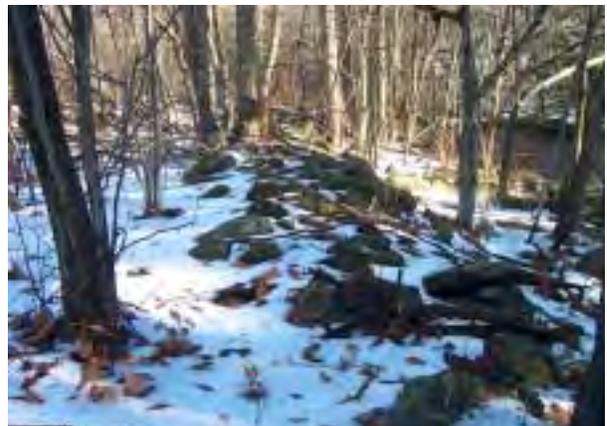
Approximately 75 feet, or 7%, of the stream bank in MU6 contains a pushed up mound of earth and rock, or *berm*, at the top of the Unit on the right bank (Photo 2). This berm is of unknown age, though is well vegetated with some large trees. The intended purpose for this berm is unknown. Unfortunately, berms such as these generally do not offer protection from flooding. In fact, berms can cause stream *entrenchment*, which is a type of erosion that cuts down into the stream bed, making the floodplain a greater

Photo 2. Berm along right bank at the top of MU6.

distance from natural channel, a steeper height than and higher flood *stage* (water surface height) locally by preventing floodwaters from flowing over the floodplain, cutting off an important function of these flat areas.

Floodplains function to reduce flood velocity, increase absorption of floodwaters, encourage deposition of silt and fine sediments (keeping them from being washed further downstream) and decrease flood stage, or height, in downstream areas. The majority of Broadstreet Hollow stream floodplains consist of small, low, discontinuous floodplain benches that perform the important floodplain functions in small mountain streams. Because MU6 has generally good morphology, and a network of discontinuous floodplain benches, removal or reconfiguration of the berm is not recommended at this time³.

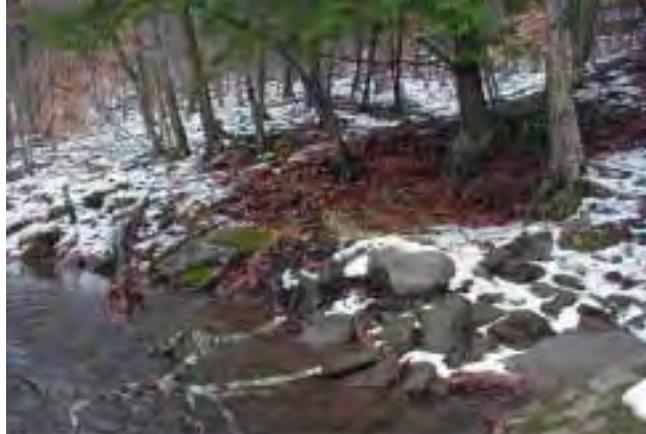
Approximately 165 feet, or 16%, of the stream bank (in one section along the left bank) contains exposed *glacial lake clay* as documented in 2001 (Photo 3)¹. This clay exposure may cause increased turbidity in this reach from fine sediment (silt and clay) coming from stream bank and bed material, especially during high flow events. This section should be visually monitored to assess any changes in stream bed condition in MU6 that may contribute to further instability or water quality problems, but no more detailed assessment or management is recommended.

Photo 3. Stream bed clay exposure location, left bank, flow from left to right (clay can't be seen in photo, exposure is in the stream bed).

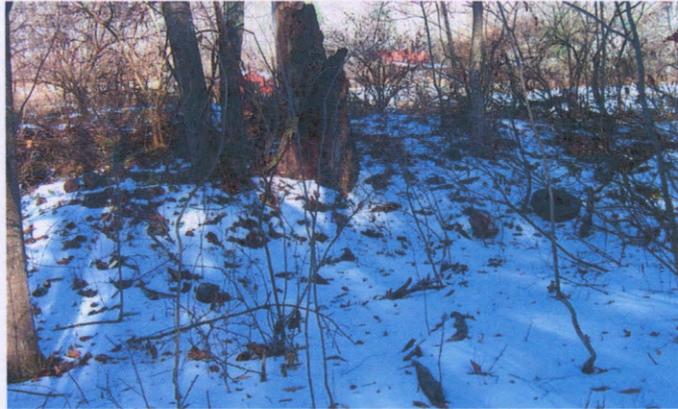
One landfill/dumping site was documented in MU6 in 2001, along approximately 145 feet, or 14%, of the right bank near the top of the unit (Photo 4). Materials include old glass and small metal objects, and this area is mostly behind the berm and not in direct contact with the stream. Planning efforts to organize cleanup of sites like this were initiated in 2002, and should continue, as labor and funding become available.

Photo 4. Old landfill/dumping site, right bank, consisting primarily of glass and small metal objects, stream behind the viewer.

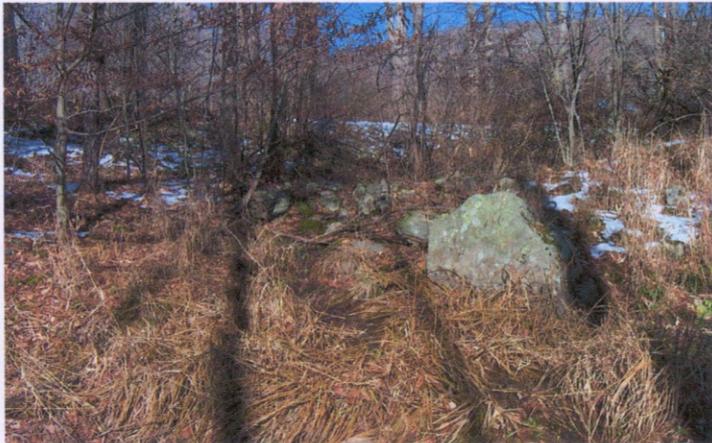
One small spring-fed side stream, or *tributary*, enters the main stream in MU6, near the bottom of the unit (Photo 5). *Confluence* areas (where two streams join) tend to be unstable by nature's design, as the smaller stream delivers pulses of flood waters and sediment to the main stream. The mouth of this very small tributary runs unconcentrated (not in a discrete channel) over approximately 50 feet of floodplain before entering the

Photo 5. Looking from the stream at tributary confluence on floodplain, right bank. Broads reet Hollow Road in the background.

main channel, so does not pose the same problems of sediment influx. In addition, this area may provide localized valuable *wetland* habitat, though this was not specifically investigated as part of the stream assessment survey in 2001.
