Broadstreet Hollow Management Unit 11

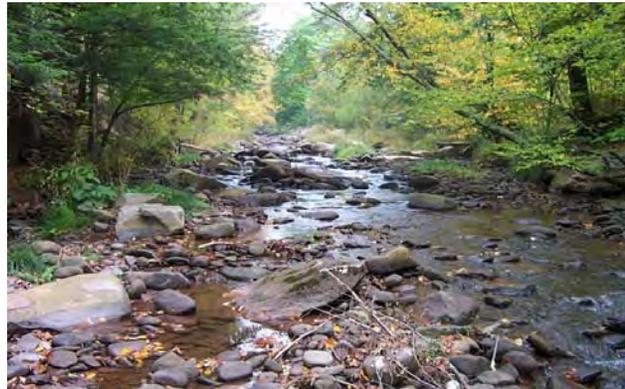
Photo 1. Looking upstream toward the top of MU11, Broadstreet Hollow Road at left in background, upstream tributary confluence at right in background.

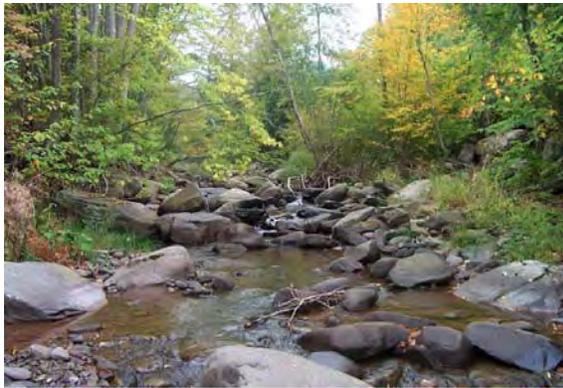
Photo 2. Looking upstream from the bottom of MU11, toward downstream tributary confluence at right.

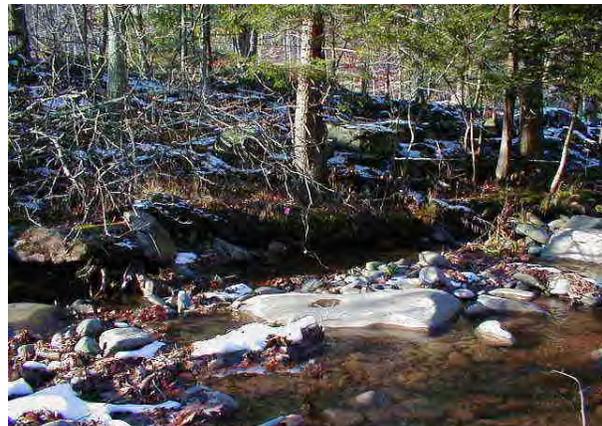
relatively narrow and fairly steep, primarily with *riffles* and *pools* interspersed with some small waterfalls (“steps”), and stream banks formed into low benches, or *discontinuous floodplains*, that function as small overflow areas during floods. MU11 lacks these discontinuous floodplains along much of the left bank along the valley wall, but maintains a limited amount of these features on the right bank⁵ (Photo 3).

Photo 3. Right bank showing low, discontinuous floodplain benches, here with mosses and some grasses. Stream flow is from right to left.

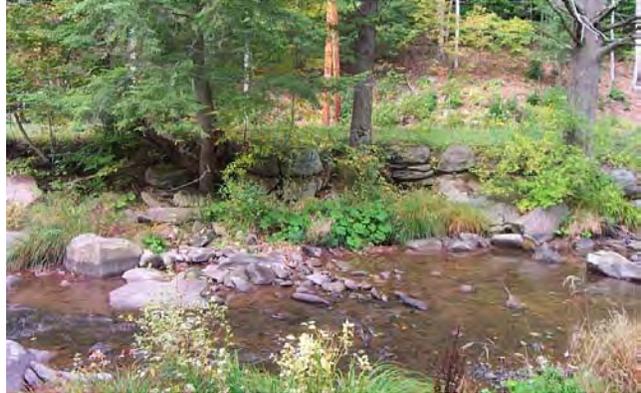
Stream assessment survey in 2001 showed approximately 80 feet, or about 10%, of the banks in MU11 have been rip-rapped, historically with partially stacked large boulders, predominantly either *non-quarried natural boulders* from outside the stream, or local, or *native*, material from the stream channel itself^{3&7} (Photo 4). This bank stability work, or *revetment*, is not recent, having large trees growing between the boulders.

Photo 4. Right bank rip-rap along Broadstreet Hollow Road. Stream flow is from right to left.

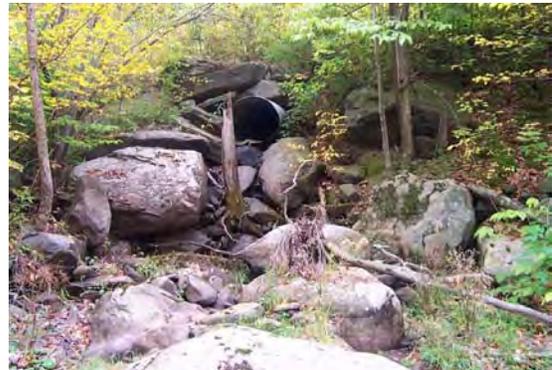
The only culvert documented in MU11 from the stream assessment survey provides a crossing under a private road for a small tributary to the main stream (Photo 5). *Confluence* areas (where two streams join) tend to be unstable by nature's design, as the smaller stream delivers pulses of flood waters and sediment to the main stream. Though the outlet of this culvert and the main Broadstreet Hollow stream itself appears in relatively good condition, or stable, water enters the main stream from far above the stream channel. Water falling into the stream from a height above the main channel has greater erosive potential as it falls and hits the stream bank or bed below. In addition, water runs over a distance of bare rock before entering the stream, potentially heating the water and increasing stream temperature³.

Photo 5. Left bank culvert near the bottom of MU11, providing a private road crossing for a small tributary. Main stream is behind the viewer, flow is from left to right.

Where possible, culvert outlets should be reconfigured to allow water to directly enter the stream, at a low angle with vegetation, to minimize erosion. The 2001 stream assessment survey documented the current condition of this culvert as partially crushed, and should be evaluated for replacement.

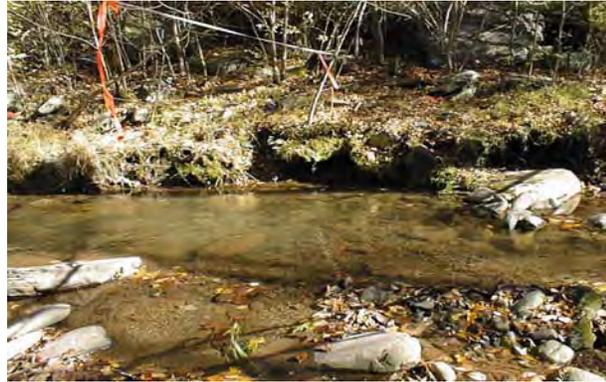
Stream assessment conducted in 2001 showed approximately 40 feet (5%) of eroding stream bank in MU11, in two small sections on opposite banks (Photo 6 and 7). These banks have been monumented at a representative location for future monitoring (location designated as “monitoring cross-section 8”) to determine erosion rate and priority for potential restoration³. This site has been assessed and ranked based on calculation of a *Bank Erodibility*

Photo 6. Eroding left bank with exposed glacial lake clay in the bank and bed, at monitoring cross-section 8. Stream flow is from left to right.

Hazard Index (BEHI) using data collected at the time of the stream assessment survey in 2001. Both eroding banks at monitoring cross-section 8 received a BEHI score showing moderate potential for future erosion, though the shape of the stream in this area causes stream energy to focus on the left bank, which may be even more vulnerable due to the glacial lake clay exposure in the bed and bank along the left side⁴.

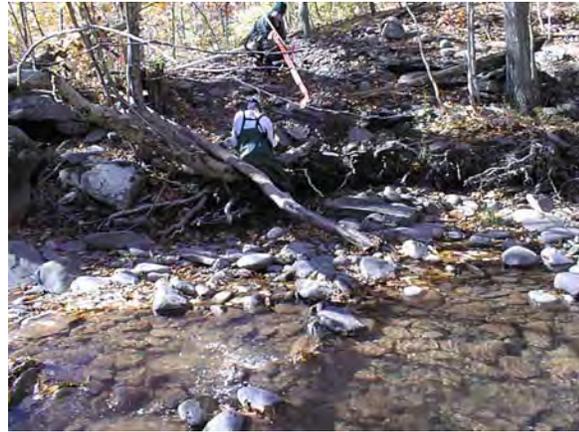
Photo 7. Eroding right bank at monitoring cross-section 8. Stream flow is from right to left.

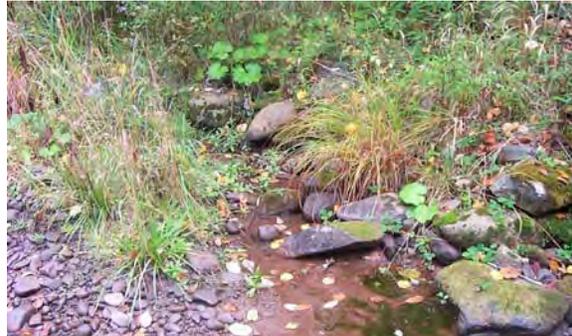
A small spring-fed tributary enters the main stream at the top of MU11 (Photo 8). The mouth of this tributary runs through a small, flat riparian *wetland* area, approximately 60 feet in length along the stream bank, before entering the main channel, so does not pose the same problems of sediment influx typical of a confluence area (Photo 9). In addition, this area may provide localized valuable wetland habitat and potential water quality improvement functions, though this was not specifically investigated as part of the stream assessment survey in 2001.

Photo 8. Small wetland tributary on left bank, near the top of MU11. Main stream is behind the viewer, flow is from left to right.

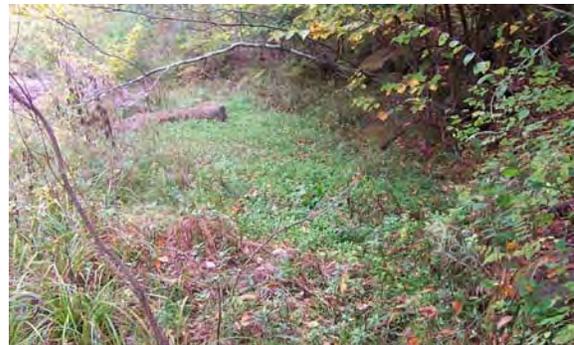
Photo 9. Looking upstream at small riparian wetland with tributary running to the right, and main stream to the left.
