## Broadstreet Hollow Management Unit 13

# Broadstreet Hollow Management Unit 13

## General Description:

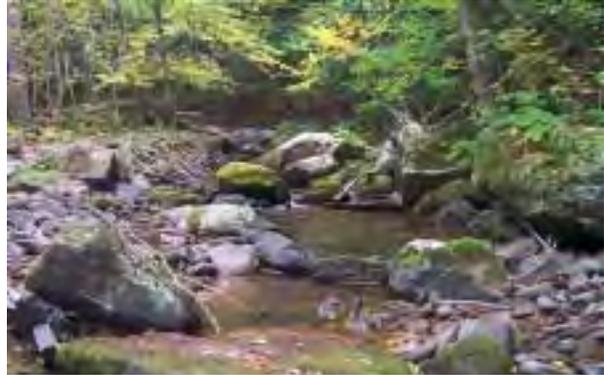
Management Unit 13 (MU13), is a unique section of split-channeled stream (both in nature and in Broadstreet Hollow), located in Ulster County, NY. MU13 begins approximately 170 feet below County Bridge 3-34671-0, at the property at 108 Broadstreet Hollow Road, (Photo 1). MU13 extends approximately 965 feet downstream, to where the stream returns to a single-thread channel, opposite the end of a long section of guiderail on Broadstreet Hollow Road (Photo 2). The stream flows well away from the road through most of the unit, with no development on either bank<sup>1&2</sup>.

Photo 1. Looking upstream near the top of MU13, in the main channel.

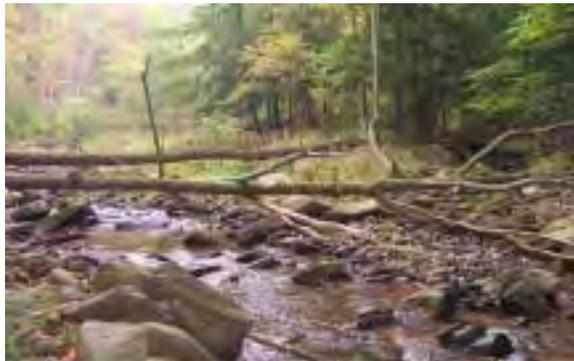
Photo 2. Looking upstream into the bottom of MU13, where two channels rejoin. The main channel is to the left.

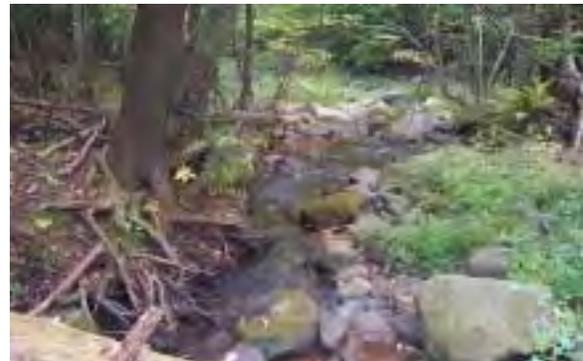
The stream in MU13 contains numerous interconnected channels, termed a *braided* stream. Each individual channel is a stable side stream with unique flow characteristics (Photo 3). This type of stream is very complex, providing valuable riparian and aquatic habitat for fish, insects, birds and other animals, and produces conditions for excellent water quality and stream channel stability, with large trees holding banks in place, and floodplain areas with a variety of plant species.

Photo 3. Looking downstream into one of the side channels in MU13. Note large riparian trees to the left, vegetated floodplain bench area to the right, and large dead wood in the foreground providing habitat for fish and other animals.

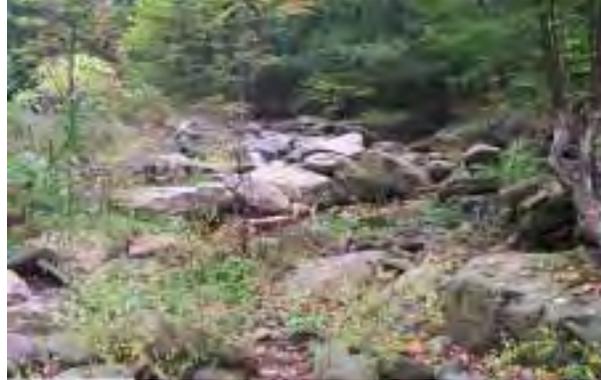
A large boulder berm was constructed near the top of MU13, to protect the 108 Broadstreet Hollow road property from flood-related erosion damages at the base of the hillside adjacent to a side channel. No further known stream bank or channel work has been done in MU13 (Photo 4).

Photo 4. Looking upstream into the top of the main side channel at the top of MU13, the 108 Broadstreet Hollow Road hillside is to the left outside the frame, boulder berm in the center background.

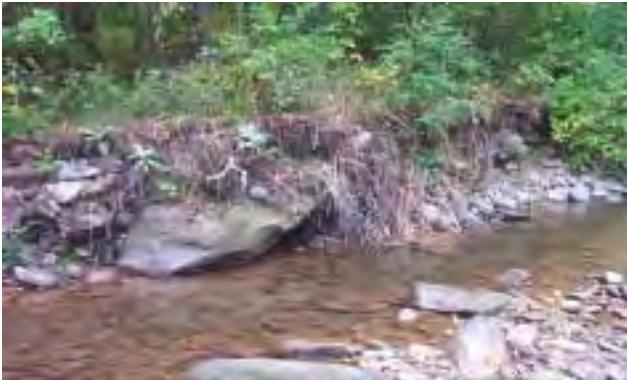
Stream assessment in 2001 showed one eroding bank in MU13, though it was not determined to be significant enough currently to warrant extensive stabilization or monitoring (Photo 5). No monumented monitoring cross-sections have been installed to document the extent or rate of potential erosion<sup>4</sup>. However, this section should be visually inspected periodically, as eventually this section could erode into road fill, or *embankment*, areas to the west. This bank may be more vulnerable to ongoing damage due to the presence of easily erodible glacial lake clays in the stream bed at the toe (base) of the stream bank, where stream energy in the main channel is concentrated.

Photo 5. Eroding right bank, with glacial lake clay exposure in the stream bed and some of the bank. Stream flow is from right to left.

The stream assessment conducted in 2001 showed the eroding bank discussed above (see Photo 5) contains approximately 95 feet of stream bed and bank exposure of *glacial lake clay*. This clay exposure, comprising about 5% of the stream bank length in MU13, may cause increased *turbidity* in this reach from fine *sediment* (silt and clay) coming from stream bank and bed material, especially during high flow events, though this bank doesn't appear to be eroding very quickly, and contains large sediment and healthy riparian vegetation to hold bank materials in place<sup>4</sup>.

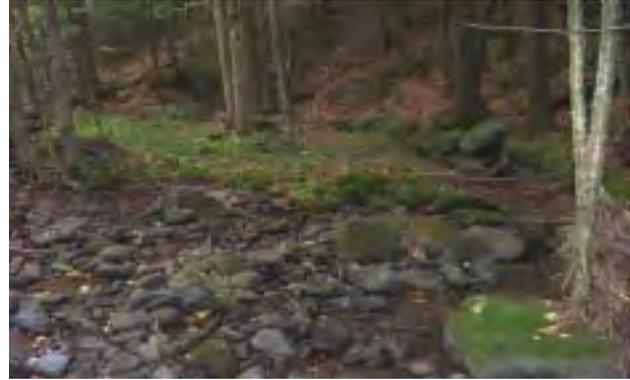
The stream assessment conducted in 2001 did not investigate specific streamside (*riparian*) plant species or density, other than to note areas of insufficient or stressed vegetation that could affect stream stability, flooding or erosion threats, water quality or aquatic habitat for trout species. Based on these general, non-quantitative observations, riparian vegetation throughout MU13 appears healthy and dense, providing all the benefits of a functioning riparian zone (Photo 6).

Photo 6. Looking upstream against the east valley wall, opposite the road. Note forested floodplain area and stable side channel morphology, densely shaded.
