## Broadstreet Hollow Management Unit 14

# Broadstreet Hollow Management Unit 14

## General Description:

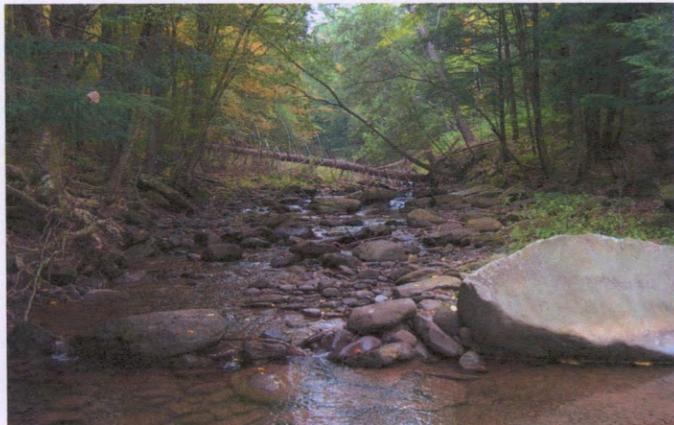
Photo 1. Looking upstream, near the downstream end of MU14.

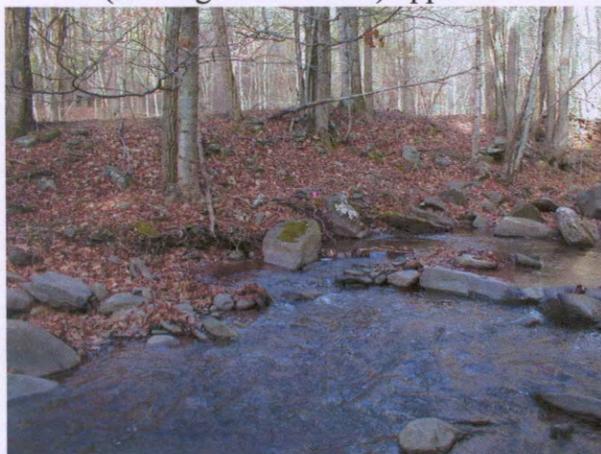
Photo 2. Right bank, showing development of low floodplain bench area inside the larger stream channel, with forested old floodplain terrace above. Stream flow is from right to left.

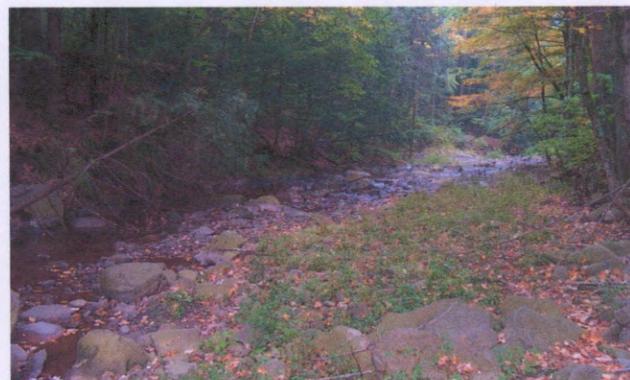
*discontinuous floodplains*, that function as small overflow areas during floods. These features are particularly important in the absence of long expanses of floodplain area (as is now the terrace area in MU14). MU14 has developed some of these discontinuous floodplains along both banks, as well as some vegetated gravel bar areas within its entrenched channel, that perform critical floodplain functions (Photo 3)<sup>5</sup>.

Photo 3. Looking downstream from the top of MU14, showing vegetated gravel bar to the right, with healthy riparian forest.

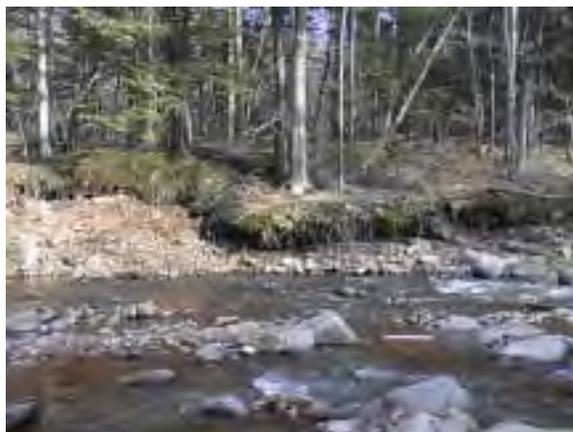
Stream assessment in 2001 documented approximately 210 feet, or 20% of the stream bank length in MU14, in a single eroding bank area with a significant exposure of highly erodible *glacial lake clay* (Photo 4). This clay forms a layer, over which the riparian forest is sliding into the stream in large flat sections (almost like a sled), with large cracks, or failure scarps, visible behind them parallel to the stream (Photo 5).

Photo 4. Eroding bank with unvegetated, glacial lake clay exposure sloping up from the stream bed, densely forested hillside on a "shelf" above, held together by a dense mat of tree roots. Stream flow is from left to right.

The stream continues to erode between the clay layer and the top layer of soil held together by forest tree roots, causing the slope to continue to migrate slowly streamward. Trees on the stream bank show a classic "pistol butt" curved shape, indicating the slope has been moving downward toward the stream very slowly, and the trees have been continuously readjusting to grow upward for many years (Photo 6).

The density of the riparian forest, and relative health and vigor of the trees, provides substantial stability to this bank, holding material in place long after stream and hillslope processes should have washed it away. The undercut bank visible in this section is five feet deep at its farthest, with this shelf of land still supporting, and being supported by, the large trees on the surface.

This bank received a BEHI rank of "high" potential for further erosion, though the greatest threat from this bank is to water quality from the clay (see discussion below). No structures or other development are currently threatened by erosion at this site.

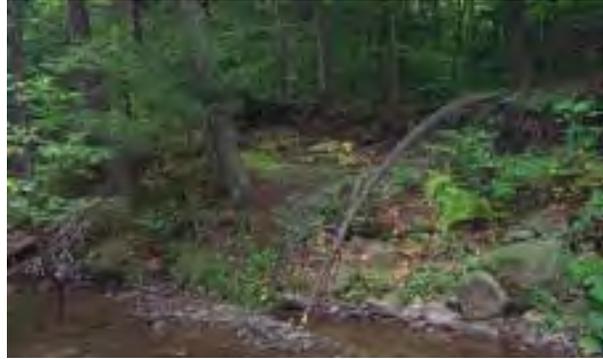
Photo 5. Left bank, upstream from area in Photo 4. Note trees leaning toward the stream, a long crack in the hillside behind them, parallel to the stream, demonstrating the downslope streamward motion of large sections of the hillside, held together by tree roots. Stream flow is from left to right.

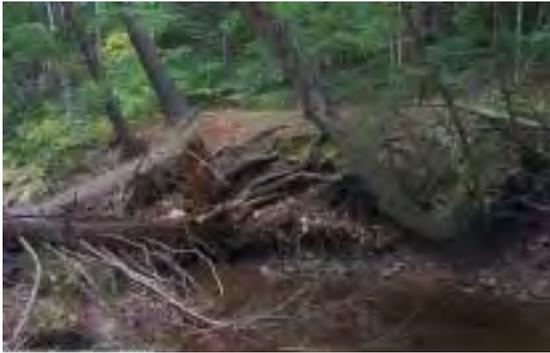
Photo 6. Left bank, downstream from area in Photo 4, showing trees on a large section of hillside migrating streamward, with "pistol butt" shape of tree trunks demonstrating slow, continuous downslope movement. Stream flow is from left to right.

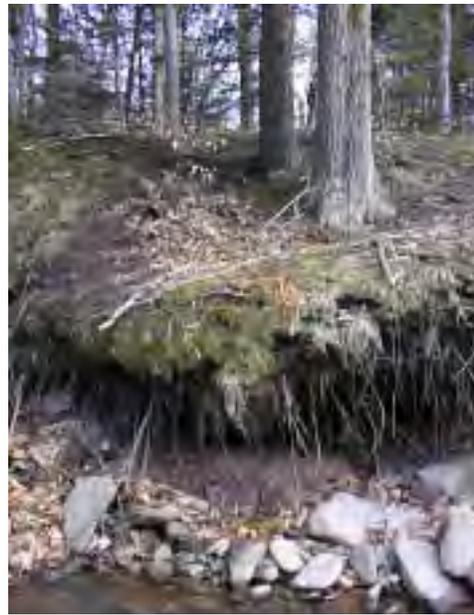
A representative location was chosen and permanently marked with metal rebar, or *monumented*, for future monitoring (designated as "monitoring cross-section 7") to determine erosion rates and priority for potential restoration (see Photo 7, orange flagging on bank marks cross-section location)<sup>3</sup>. This site has been assessed and ranked based on calculation of a *Bank*

Stream assessment conducted in 2001 showed the eroding bank at monitoring cross-section 7 contains a significant bank and stream bed exposure of glacial lake clay, which comprises the length of this 210-foot bank, or 20% of the total bank length in MU14 (see Photos 4 – 7 above). This clay exposure may cause increased *turbidity*

Photo 7. Close-up of eroding left bank, showing deep undercut forming a "shelf" held together by dense tree roots. The shelf is up to five feet deep, straight back into the bank. Note reddish clay exposure above the stream cobbles. Stream flow is from left to right.

in this reach and downstream from fine *sediment* (silt and clay) coming from stream bank and bed material, especially during high flow events<sup>4</sup>. Bare clay material does not support vegetation readily<sup>7</sup>, and consistent disturbance from high flows impinging on the bank prevent soil formation on exposed clay at the surface.

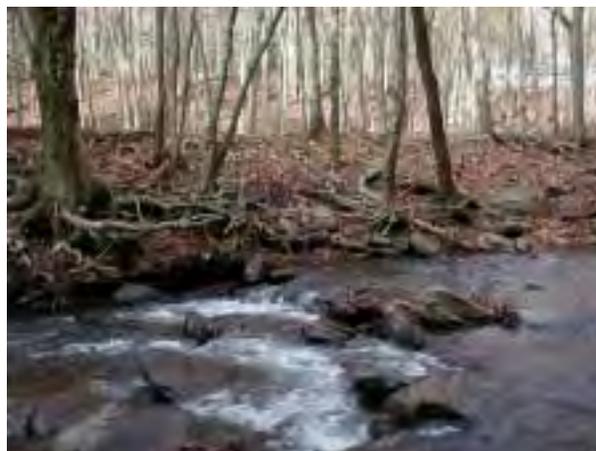
Investigation of other possible sources of contamination was not part of the stream assessment conducted in 2001. However, no evidence was found for *nutrient* or *pathogen* contamination in the stream (i.e., odors or discolored water). Any runoff of water from the road and culverts that may contain salts or other pollutants was not specifically investigated. However, the long distance from the road, and the density and health of the riparian vegetation, definitely provides some protection from such runoff<sup>7</sup> (Photo 8).

Photo 8. Densely wooded right bank terrace, showing a higher terrace with a house in the background. Broadstreet Hollow Road is on the higher terrace, about 200 feet from the stream. Stream flow is from right to left.

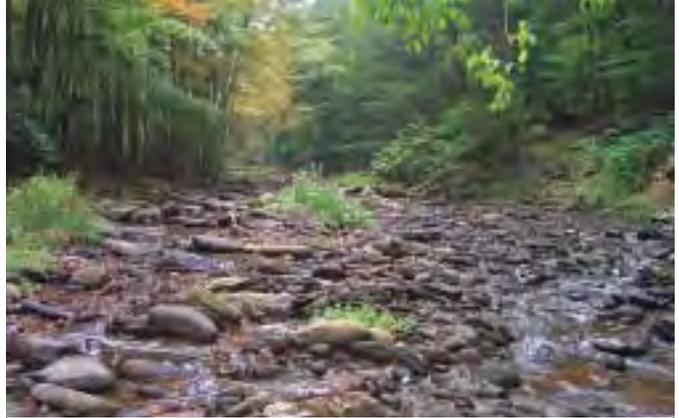
throughout MU14 appears to be in good condition along both banks, sufficient to provide the full benefits of a healthy riparian zone <sup>7</sup> (Photo 9).

Photo 9. Looking upstream near the middle of MU14, showing dense, healthy riparian forest on both banks.
