Broadstreet Hollow Management Unit 16 -19

Broadstreet Hollow Management Unit 16

General Description:

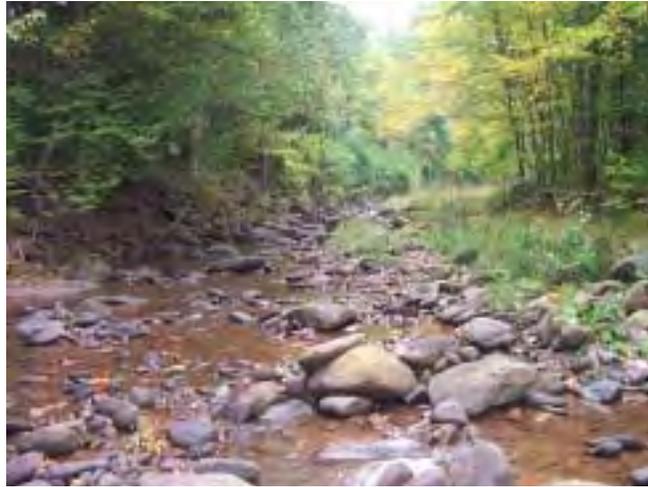
Management Unit 16 (MU16), is located in Ulster County, NY, beginning just below the small pond outlet MU15 and extending approximately 330 feet downstream to the pond inlet at the abutting northeasterly property boundary (Photo 1)^{1&2}.

Photo 1. Looking upstream into the top of MU16, showing healthy riparian vegetation on both banks, and vegetated floodplain to the right.

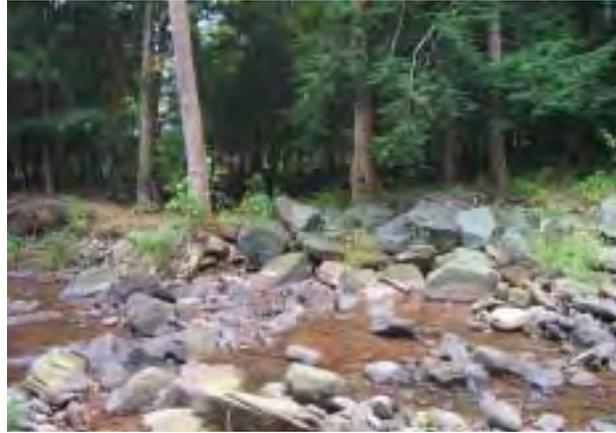
Currently only about 25 feet, or 4%, of the stream bank in MU16 has been hardened with large quarried boulder rip-rap, to protect a low pond inlet area that has experienced erosion during high flows, particularly as a result of the January 1996 flood (Photo 2). Large sycamore trees in the vicinity of this rip-rap are currently at some risk for becoming undermined and falling into the stream, in part due to eddy scour created as water moves and swirls around the boulders and impinges on the tree roots. Additional boulders placed carefully under the tree roots, in addition to added shrub and tree vegetation in between rip-rap rocks, could improve the chances for the survival of these important riparian trees⁷.

Photo 2. Right bank quarried boulder rip-rap, stabilizing pond inlet area. Note sycamore tree, being undercut at the roots. Stream flow is from right to left.

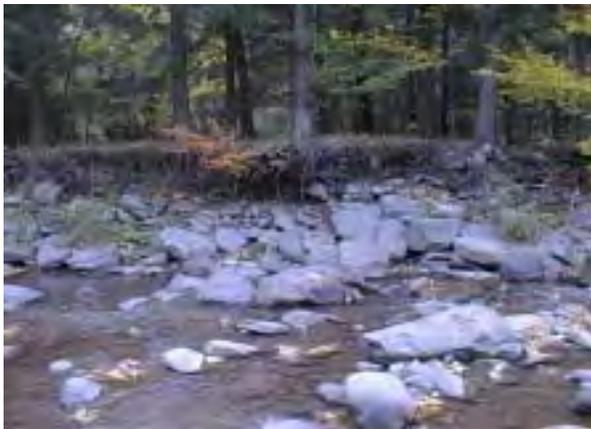
Photo 3. Eroding right bank terrace, at monitoring cross-section 4 showing healthy riparian forest. Stream flow is from right to left.

This bank comprises an eroding section of terrace, approximately five feet from top of bank to the toe, or base of the bank, in the stream channel (Photo 3). Fairly dense riparian forest trees hold the soil surface layer together, though roots do not penetrate deeply enough to hold the entire bank in place⁷. This bank received a BEHI rank of “high” potential for further erosion, though the concentration of stream energy away from this bank due to the shape of the stream channel may decrease this potential. No structures or other

development are currently directly threatened by erosion at this site⁴.

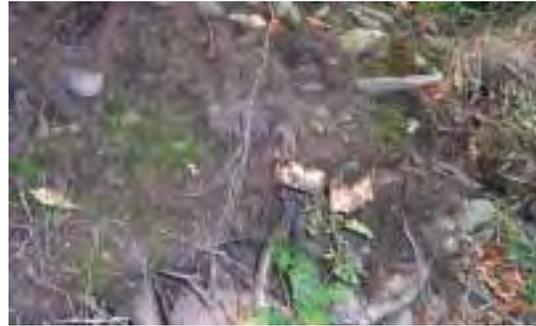
Approximately 7 feet (1%) of dumped materials, primarily glass and small metal objects, were mapped along the right bank in MU16 in 2001 (Photo 4). Planning efforts to organize cleanup of sites like this were initiated in 2002, and should continue, as labor and funding are available, though any water quality risk from this site is minor.

Photo 4. Small old dumping site, with glass and small metal objects, right bank. Stream is behind viewer, flow from right to left.
