## Broadstreet Hollow Management Unit 18

### General Description:

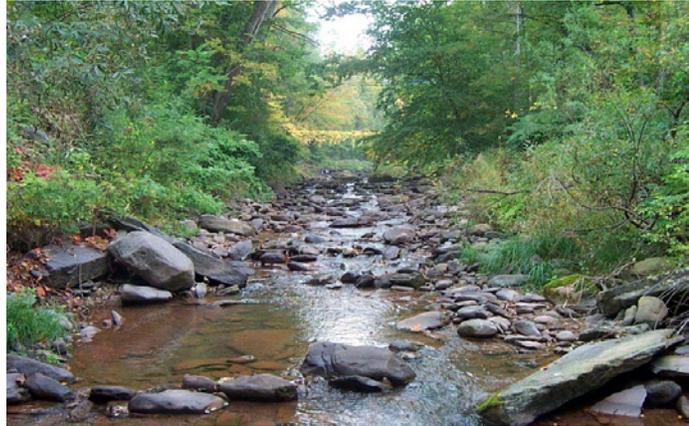
Photo 1. Looking upstream from the Route 28 Bridge, near the bottom of MU18, with partially vegetated rip-rap and hardened areas on both banks.

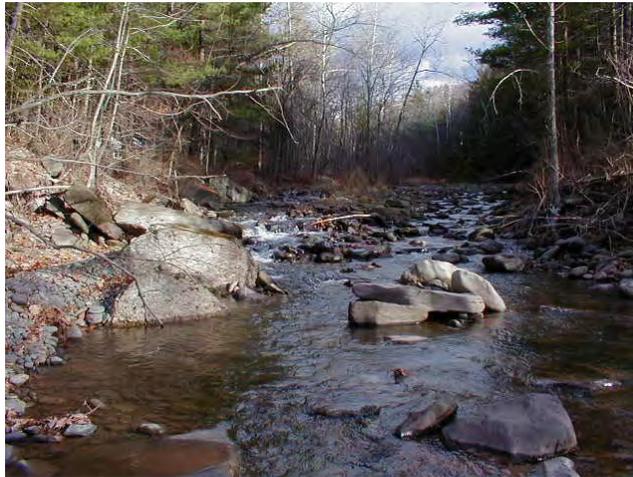
The structural shape, or *morphology*, of the stream (i.e., slope, width and depth) is uniform in this unit, comprising a single section, or *reach*, with distinct structural character, or *stream type*<sup>5</sup>. The valley in MU18 is particularly narrow compared to other units, as the stream has incised, or cut into its bed, deep enough so that the wide flat area on either side, which may have historically functioned as an overflow area, or *floodplain*, is now far above the stream, forming an abandoned floodplain, or *terrace* (Photo 2).

Photo 2. Looking upstream into the top of MU18, note concrete slabs to the left, terrace at top of bank to the left.

Approximately 190 feet, or 20% of the stream bank in MU18 has been rip-rapped, in three main sections, using mixed materials including dumped and laid up boulders, and concrete or blacktop slabs <sup>1&2</sup> (see left side of Photo 2). The newest section of dumped boulder rip-rap is the upstream-most rip-rapped section (Photo 5), on the right bank just downstream of a section of eroding bank (see discussion below). This rip-rap was placed following the January 1996 flood event, which resulted in stream bank erosion and property damage in this area. Large quarried boulders were piled and rearranged from the bank, with no work in the stream channel.

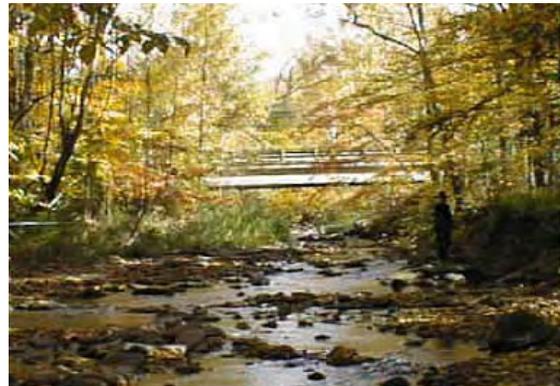
State Route 28 crosses MU18 at the bottom of the unit (Photo 3). This bridge is maintained by the State Highway Department, and appears wide enough to accommodate the natural stream width. Under the bridge, between the abutments, a

Photo 3. Looking upstream at bridge crossing NY State Route 28. MU18 ends just downstream from the bridge.

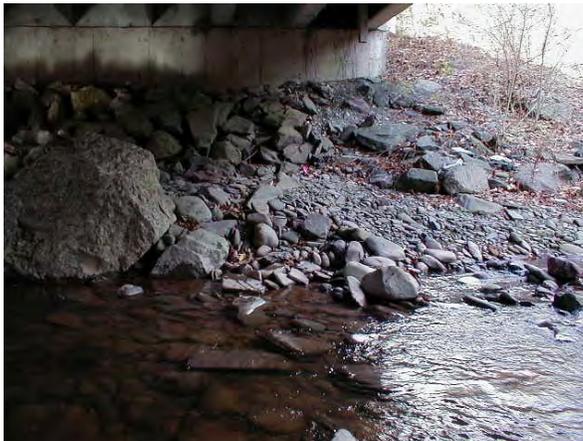
Photo 4. Right abutment of Rte. 28 bridge, showing gravel bar forming within the abutments, narrowing and deepening the active channel to improve sediment transport capacity, and reducing potential for further maintenance. Stream flow is from right to left.

gravel bar area is developing that may evolve into a small floodplain bench over time, enhancing stream morphology and preserving stream function, including sediment transport capacity (Photo 4).

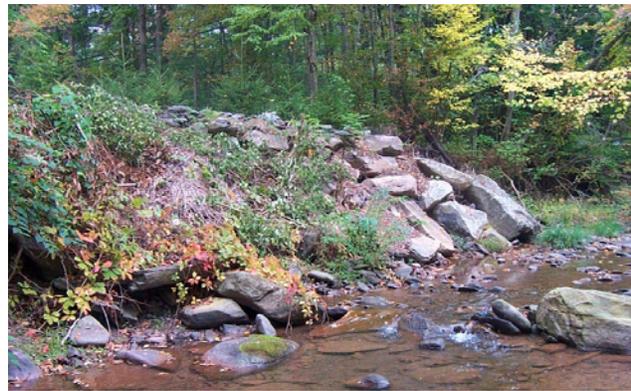
Photo 5. "New" dumped boulder rip-rap on right bank, just downstream from eroding bank section. Stream flow is from right to left.

The disadvantage to dumping rock over the stream bank is that without having either a wall or other larger structure, and without individual boulders *keyed-in* (stabilized by other boulders being placed under the stream bed and into the bank), the stability of the bank relies simply on the size and weight of each boulder to maintain stability. Unfortunately, the Broadstreet Hollow stream is powerful enough to erode soil and larger sediment in the stream bed and banks out from under and

behind each boulder, eventually digging a hole into which the boulders can fall, causing

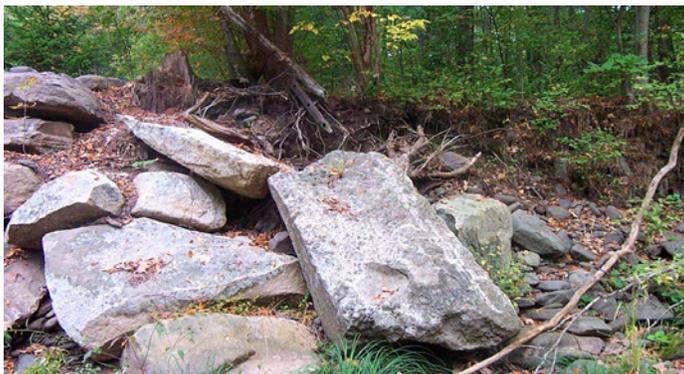
Photo 6. Upstream end of "new" boulder rip-rap section shown in Photo 5, with bank erosion just behind the end boulders, continuing upstream. Note trees eroding just behind, on the terrace. Stream is behind the viewer, flow is from right to left.

the entire bank to fall in as the rocks at the base of the pile shift and drop. Additionally, without proper stabilization of the transition between the rip-rap and non-rip-rapped banks, the abrupt change in materials often results in the water swirling, or eddying, behind the boulders and eroding the “softer” bank material on either end. This phenomenon can be seen at the upstream end of this rip-rapped section, where the bank area with tree roots that may have assisted keeping the bank in place are being eroded at the edge of the boulder pile (Photo 6).

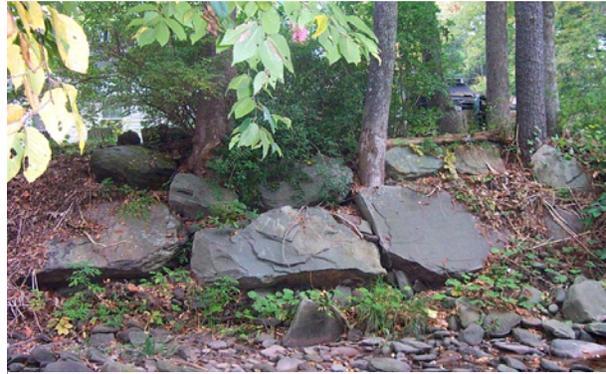
Just downstream from the dumped boulders is a fairly recently constructed section of rip-rap composed primarily of flat boulders “laid up” in a smooth wall along the bank (Photo 7). While the structure of these boulders may add some stability, note that the bottom boulders are also not keyed in, so are vulnerable to the same erosion and under-cutting as the boulders in the dumped section upstream. Also, trees in this section that contribute to bank stability, shade and cover, have their trunks buried with material, which causes stress to many tree species and may make them unhealthy or even die, reducing benefits to bank stability in addition to the aesthetic, water quality and habitat benefits they provide<sup>7</sup>.

Photo 7. "Laid up" boulders along the right bank in the middle of MU18. Note trees with buried trunks. Stream flow is from right to left.

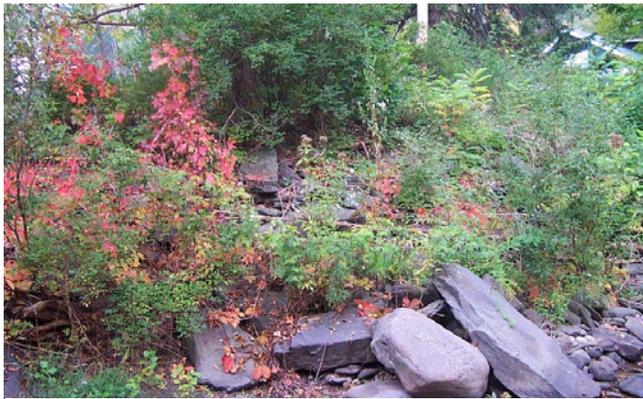
Photo 8. Mixture of dumped rock fill and laid up stone, with some vegetation colonizing the bank, just upstream from Rte. 28 bridge. Stream flow is from right to left.

Further downstream, adjacent to the bridge, both banks contain an older mixture (actual age unknown) of dumped rock fill, laid up and stacked boulders (Photo 8). These sections have been re-colonized by a mixture of riparian shrubs and trees, and show greater stability and provide more water quality and habitat benefits as a result. The banks in this section are not as steep, which also increases revetment function and life<sup>5&7</sup>.

Dumped rock fill revetment, even with vegetation and a low slope, can continue to wash or fall into the stream during and following flood events, remaining an ongoing maintenance problem for County and State Highway Departments (Photo 8). Broadstreet Hollow stream can transport very large rocks along the stream bed (rocks and gravel moving along the bed of the stream is called *bedload sediment*). The size of sediment in dumped rock fill is often smaller than the bedload, and gravel or bank run

material is always smaller than the bedload. As a result, rocks on the bank continue to wash downstream over time from the toe (base of the slope), needing periodic replacement<sup>5</sup>. Continuing disturbance of the bank area can prevent streamside, or *riparian*, trees and other vegetation from becoming established, reducing the likelihood the bank area can stabilize on its own. Further, some riparian tree species become stressed and weakened when their trunks are buried, so existing trees that may be providing some bank protection are eventually killed by ongoing maintenance, reducing long-term bank stability, as well as compromising other important habitat and aesthetic benefits. Alternatives to dumped rock fill should be strongly considered, to reduce maintenance costs and preserve riparian areas<sup>3</sup>. Existing mixed revetments should be re-vegetated or augmented with a mixture of native riparian species to increase longevity as well, to reduce revetment maintenance or replacement costs<sup>7</sup>.

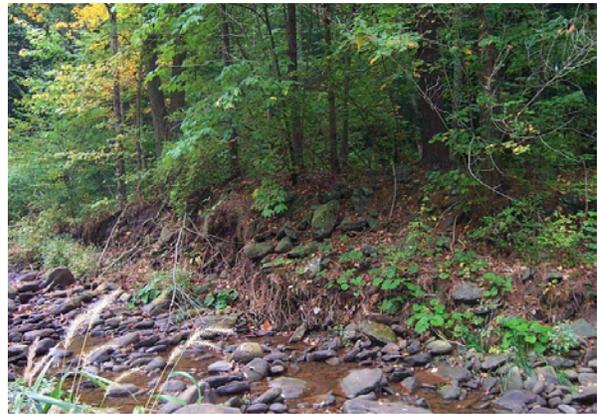
The left bank, starting at the top of MU18, contains a mixture of bermed areas, rip-rap and dumped rock fill. The berms total approximately 170 feet in length, in two overlapping sections. These berms appear to be material pushed up onto the banks in response to 1996 flood damages, and may have been the site of such practice in earlier floods (Photos 9 and 10). This practice of “cleaning” the gravel out of a stream in this way is sometimes thought to increase flood capacity by creating a larger stream channel.

Photo 9. Pushed up material forming a berm along the left bank near the top of MU18.

Unfortunately, berms such as these generally do not offer much if any protection from flooding (inundation), especially if the berm is uneven or ends abruptly, and typically represents a place to store material in what is thought of as an “out of the stream” location. The channel is typically made too wide (not deep enough) for the stream to transport its sediment, causing additional deposits (gravel bars) and ongoing flooding and/or maintenance problems.

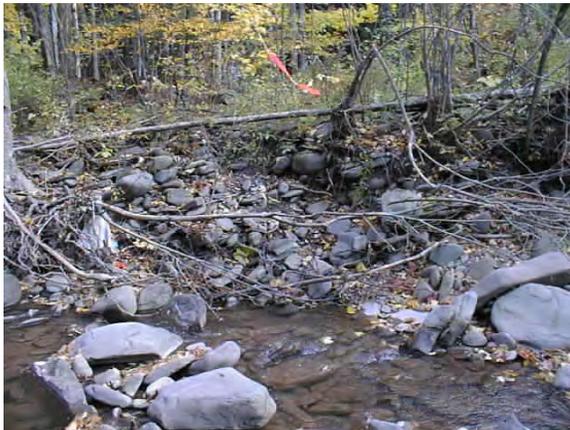
Photo 10. Pushed up material forming a berm along the left bank, just downstream from the berm shown in Photo 8, and opposite the eroding bank area documented in MU18. Stream flow is from left to right.

These berms also prevent floodwaters from spreading out onto low lying floodplain or terrace areas, increasing flood height, or *stage*, and causing greater erosive potential. The berms at the top of MU18 are opposite an eroding bank area, which may be exacerbated by this constriction.

Floodplains function to reduce flood velocity, increase absorption of floodwaters, encourage deposition of silt and fine sediments (keeping them from being washed further downstream) and decrease flood stage in downstream areas<sup>5</sup>. The majority of Broadstreet Hollow stream floodplains consist of small, low, discontinuous floodplain benches that perform the important floodplain functions in small mountain streams. MU18 is in a section of the Broadstreet Hollow Valley that would benefit from any additional floodplain storage area, lacking any floodplain or overflow bench areas. Removal or restructuring of these bermed areas should be considered to add floodplain function to this area, perhaps setting berms back where flood inundation protection might be desired (such as in the vicinity of homes on the right bank in the middle of MU18<sup>1</sup>)<sup>3</sup>. The other bermed area upstream could safely be removed entirely, as there are no structures and no other development in the floodplain.

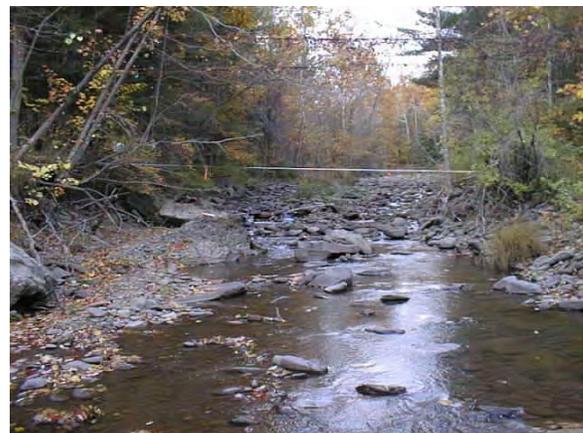
Stream assessment conducted in 2001 revealed approximately 75 feet (8%) of eroding stream bank in MU18, in one section at a forested terrace on the right bank (Photo 11). Though the bank on the right was the primary site of interest for monitoring (Photo 12, the berm on the left bank was noted to be eroding as well (see Photo 10). This site does not appear to contain any glacial lake clay.

A representative location was chosen and permanently *monumented*, or marked with metal rebar, for future monitoring (designated as “monitoring cross-section 2”) to determine erosion rates and priority

Photo 11. Looking upstream into location of monitoring cross-section 2, location shown by white tape stretched across the stream.

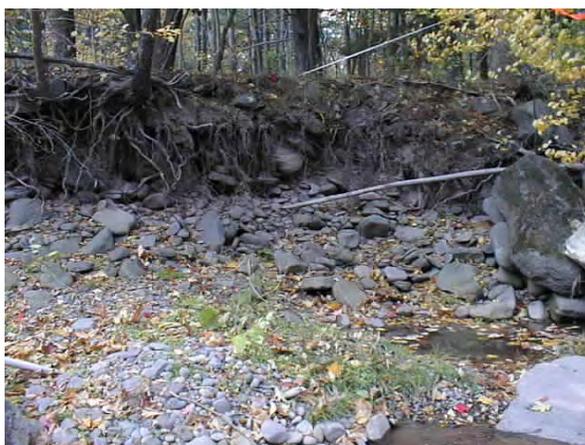
Photo 12. Eroding right bank, monitoring cross-section 2, at forested terrace, just upstream from hardened banks with boulders and concrete slabs. Stream flow is from right to left.

for potential restoration (see Photo 10, white tape across the channel marks the cross-section location)<sup>3</sup>. This site has been assessed and ranked based on calculation of a *Bank Erodibility Hazard Index* (BEHI) using data collected at the time of the stream assessment survey in 2001<sup>4</sup>.

This bank received a BEHI rank of “high” potential for further erosion, though no structures or other development are currently threatened by erosion at this site. Removal of the berm on the opposite bank would decrease stream entrenchment, reconnect the stream with

a section of floodplain, and would probably lower the erosion potential on the right bank.

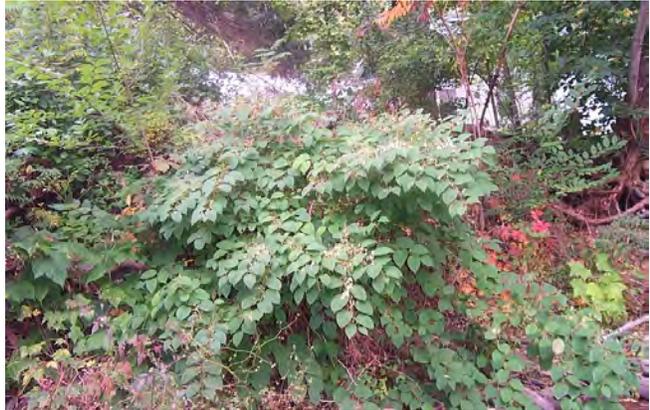
Japanese Knotweed, a non-native, invasive plant, was documented on 50 feet (5%) of the banks in this unit during stream assessment in 2001 (Photo 13). This species is an invasive exotic, and damaging to riparian integrity<sup>7</sup>. Japanese Knotweed is fast growing, can crowd out native vegetation and the roots provide little or no soil-anchoring action.

Photo 13. Japanese Knotweed, a non-native, invasive plant that colonizes disturbed areas and out-competes native species adapted to provide riparian habitat, water quality and bank stability benefits. Though it looks lush, it is shallowly rooted and weak. Stream is behind the viewer; flow is from right to left.

Japanese Knotweed is aggressive and spreads easily; pieces break off, wash downstream and can take root where they land, especially in disturbed areas (such as eroding banks or continually disturbed maintenance areas). To avoid further spread of this plant to downstream areas that may be vulnerable to colonization, Japanese Knotweed at this reach should be removed, and the area replanted with a mix of competitive native species to prevent re-colonization. Additional maintenance of this area may be needed, as Japanese Knotweed is very difficult to remove successfully.
