# BRANDYWINE RESTORATION PROJECT - BATAVIA KILL -

IMPLEMENTATION & MONITORING REPORT

BRANDYWINE PROJECT - BATAVIA KILL  
TOWN OF ASHLAND, GREENE COUNTY, NY

UPDATED  
MARCH 2008

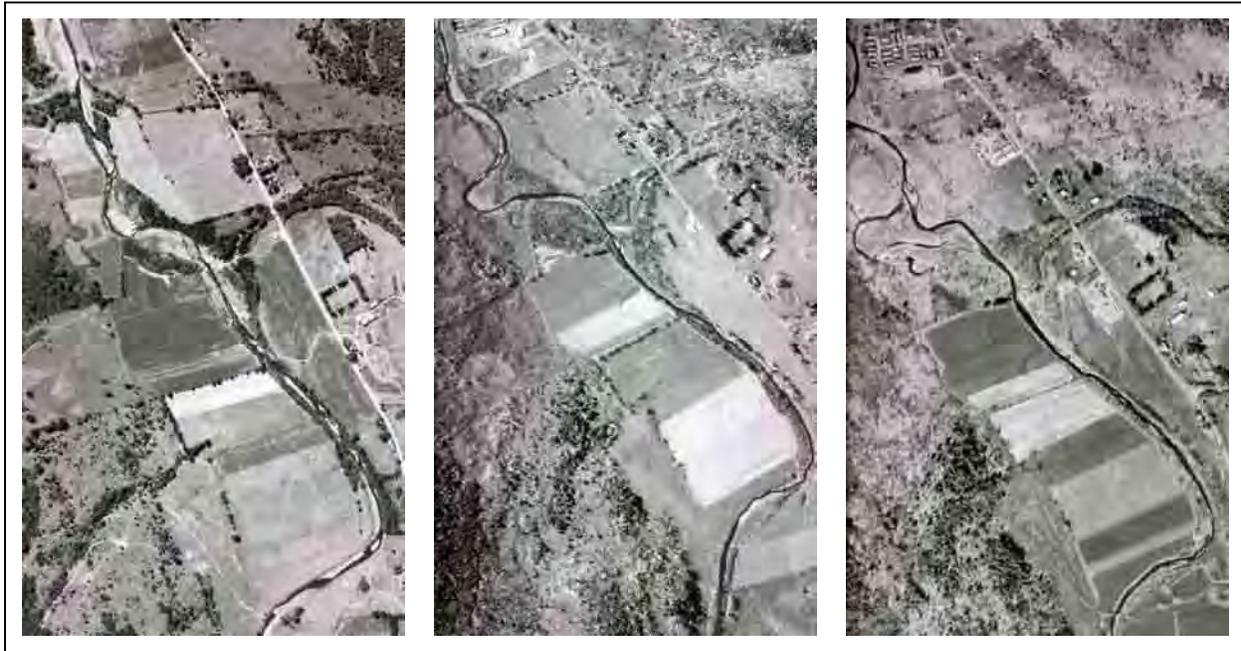
Figure1 Historic Aerial Progression of the Brandywine Reach

A historical aerial photograph progression was performed which characterized the lower reach as exhibiting unstable planform behavior and excessive channel migration (Figure 1). This was particularly apparent in the area downstream of the confluence with North Settlement Creek in which channel migration and several channel avulsions had resulted in oxbow and oxbow cutoffs formations (Figure 4). Measurements determined 980 feet of channel migration between the years of 1959 and 1997.

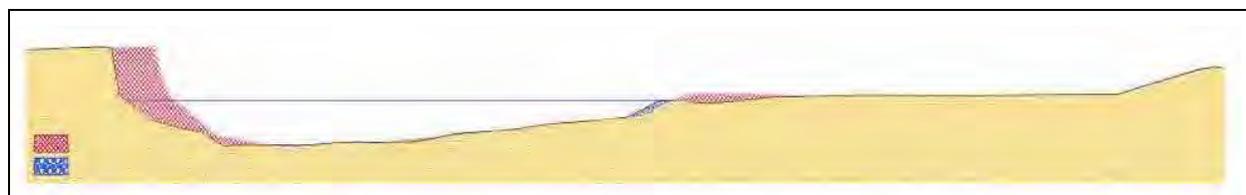
Figure 2 Overlay of cross section #1 on the Brandy Wine site, 1997 - 1999.

The Brandywine site was classified as a Rosgen C4 stream type with channel sediment dominated by very coarse gravel. In general, the assessment determined a over-widened channel condition and high width/depth ratios. The principal channel erosional processes were lateral migration and avulsions during extreme events and inefficiency to transport the sediment regime.

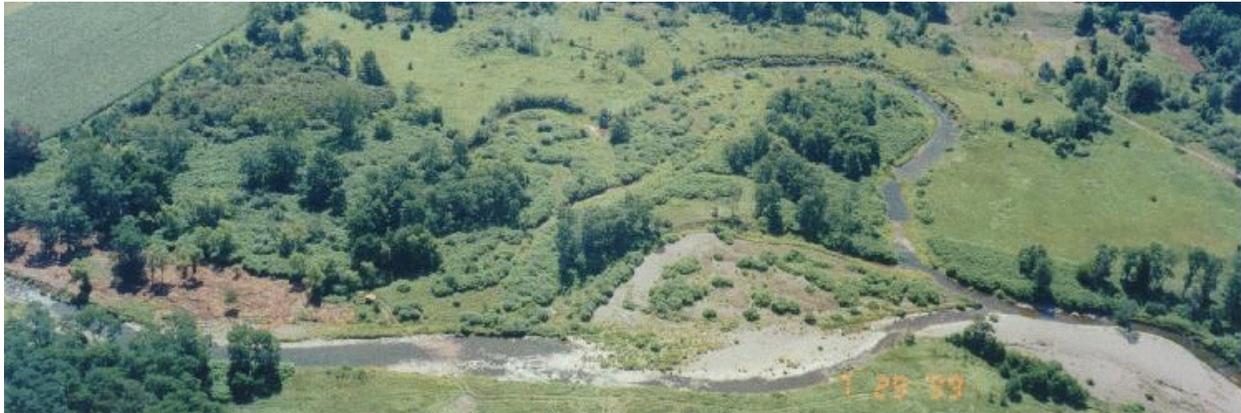
Figure 4 Historic channel meanders and avulsions.

After reviewing the historic trends of channel migration, it was determined that the channel was expanding its available belt width and increasing overall sinuosity by laterally eroding the streambanks within the reach. The goal for the channel realignment was to develop a stable plan form, in order to accelerate the channels evolution toward a more stable form. The final design included the partial realignment of 2,750 feet of stream channel. The channel alignment was created using regime and reference conditions paired with the analysis of historical aerial photography. Modifications to the proposed planform were made to provide the best applicable alignment through the bridge structure. The planform dimensions were carried upstream from the bridge to a point above the project where the new geometry could be matched into the existing conditions. The slight increase in channel meandering would provide for a reduction in local channel slope and allow for better local floodplain interaction near the bridge structure. The cut and fill quantities and feasibility of construction were also considered during the design for realignment.

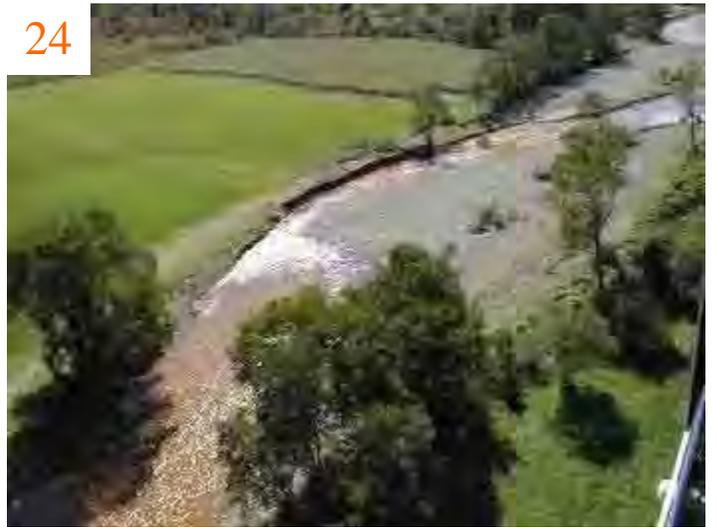
Brandywine Stream Restoration Project  
Post Flood Damage September 24, 1999

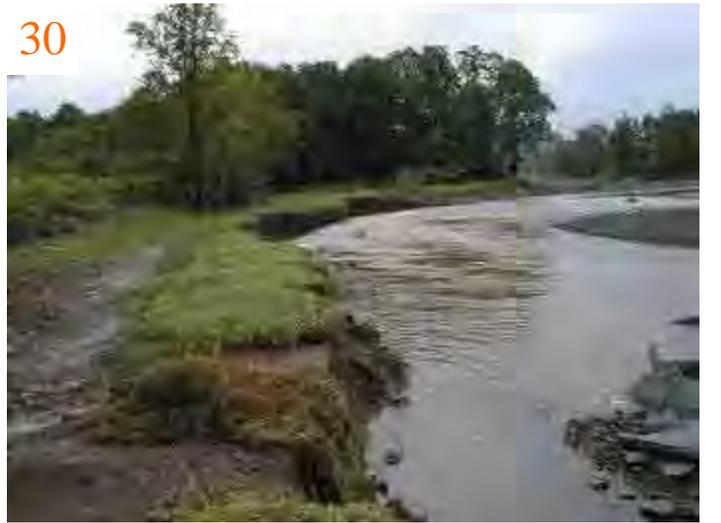
Brandywine Stream Restoration Project  
Post Flood Damage December 1999
