E. Chestnut Creek Management Unit 5

Chestnut Creek Stream Management Plan

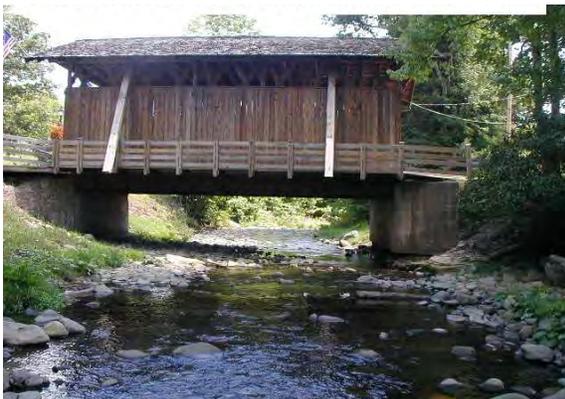
Photo 1. Looking downstream upstream at the historical Covered Bridge at the Town of Neversink, Agricultural Society Fairgrounds along Route 55, at bottom MU 5.

The historic Covered Bridge was built in 1976 as a bicentennial community project (see Photo 1). Inspected by NYSDOT as a County bridge (BIN: 5524660), it provides access to the Town Park and Fairgrounds and an emergency access to Davis Lane. Although the cross-sectional area of the bridge opening is adequate to pass the bankfull discharge, the relatively narrow span may contribute to backwater conditions and scour through the bridge opening, as the width from bank to bank is smaller than the up and downstream bankfull cross sectional width. During the 2001 Stream Assessment Survey, scour was noted along the right abutment (looking downstream). The bridge wingwall was repaired in 1991 (Photo 9). Bridge inspections in 2000 and 2001 indicated that additional repair work was required. Repairs planned for 2003 were conducted.

7. Evaluate the Covered Bridge to determine the best method for reducing scour and improving sediment transport and conveyance of bankfull and flood flows.

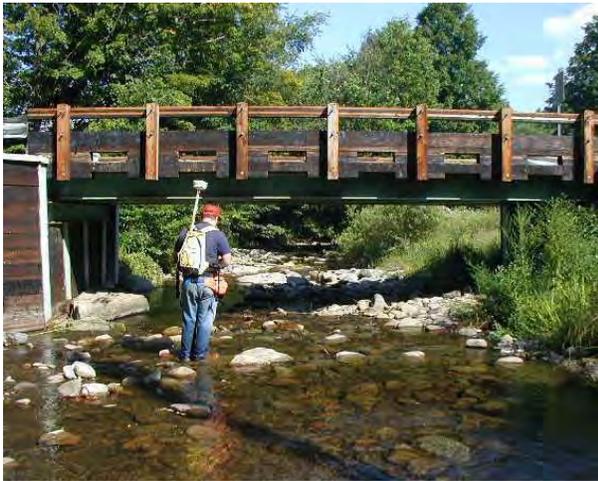
Photo 5. Looking downstream at Clark Road Bridge.

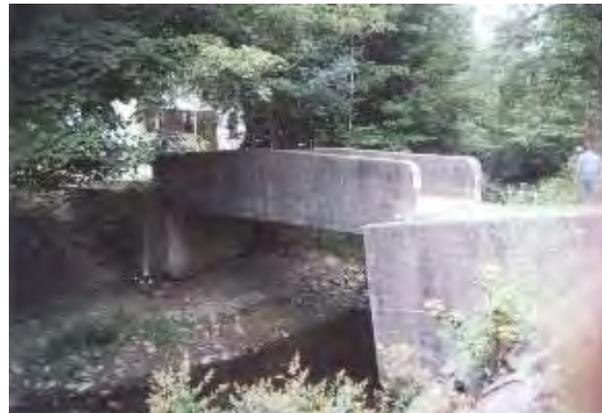
Although privately owned, the bridge at the Mohr Property provides emergency access for several landowners. The bridge was originally used as access for the local school before the present day Tri-Valley School was established in 1950. The bridge is currently in poor condition. The bridge span was measured to be less than the *bankfull width* immediately both up and downstream of the structure. The left abutment (looking downstream) is also located in the *thalweg* or deepest part of the active stream channel which can be seen in Photo 7. This puts significant stress on the structure as well as the stream channel in the vicinity of the bridge as evidenced by the large scour hole that has undermined the left abutment (Photo 6). Approvals were obtained from NYSDEC in 1998 to repair the failing abutment. The concrete wall that runs along the left bank adjacent to Route 55 is attached directly to the failing abutment (Photo 7). If the bridge is not repaired or replaced the factors contributing to its failure may ultimately affect the structural integrity of the concrete wall.

Photo 6. Failing left abutment (on photo right) attached to concrete wall at Mohr's Bridge, stream flow from right to left.

5. Repair or replace the bridge at the Mohr's Property. If the bridge is replaced it should be designed to convey the 25-year storm and have a cross-section and width that effectively conveys the bankfull discharge without causing scour or deposition.

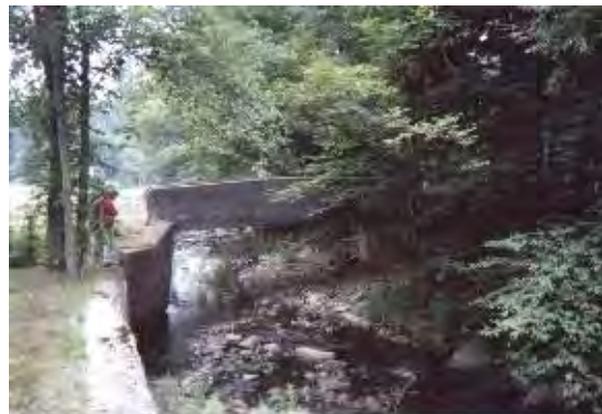
Photo 7. Looking downstream at concrete wall on left bank tied into edge of Route 55 and Mohr's Bridge.

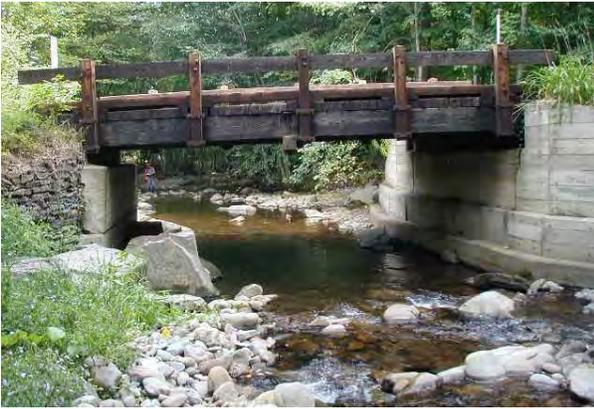
Hilltop Road Bridge also a County bridge (CBN: 340, BIN: 3357180) was built in 1967 (Photo 8). The bridge width from bank to bank, is smaller than the immediate up and downstream cross sections. This narrow span may contribute to backwater conditions and scour through the bridge opening. Flood damage to the foundation and wingwalls occurred during a severe thunderstorm in July 1995. A general permit was issued for repairs that included removal of gravel and debris deposits, replacing riprap, new toe footings and base protection. Bridge inspections in

Photo 8. View looking downstream at Hilltop Road Bridge, gabion revetment can be seen on left of photo.

2000 and 2001 indicate minor scour erosion was evident. However, the decking, abutments, and wingwalls for this structure are in satisfactory condition.

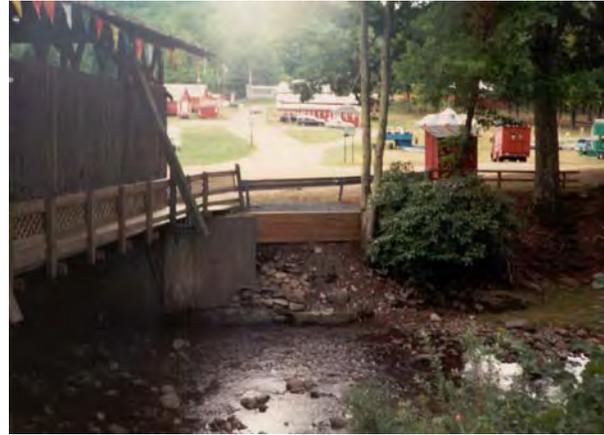
Photo 9. Looking upstream right bank Covered Bridge and Fairgrounds. Archive photo obtained from NYS DEC of repair work conducted on wingwall scour in 1991.

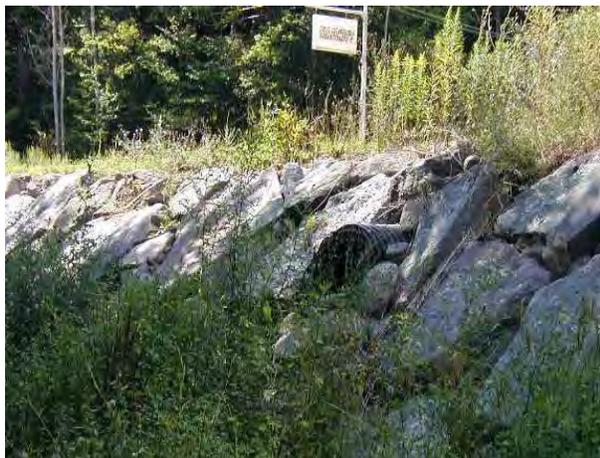
parking lots directly to the creek (Photo 10). Two storm drain outfalls were identified in this management unit during the 2001 Assessment Survey.

Photo 10. rip-rap along left bank and Rt. 55 with 2' diameter culvert from the road – below Mohr's bridge.

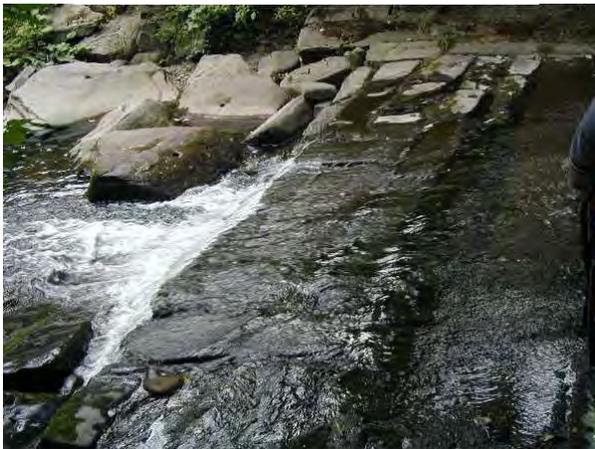
Photo 11. Rock and cement bed/elevation control – looking toward right bank below Clark Road Bridge.

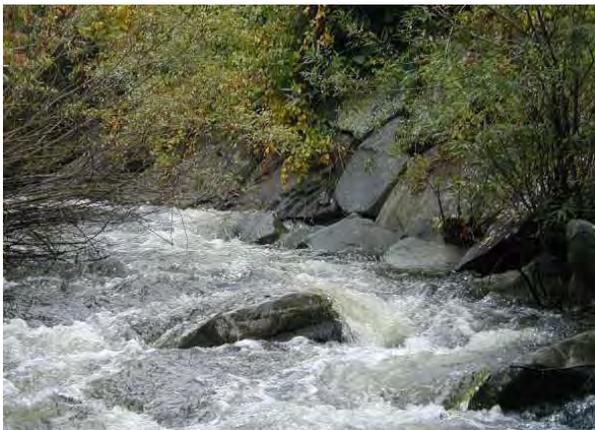
Photo 12. Left channel riprap looking upstream several hundred feet above covered bridge opposite fairgrounds.

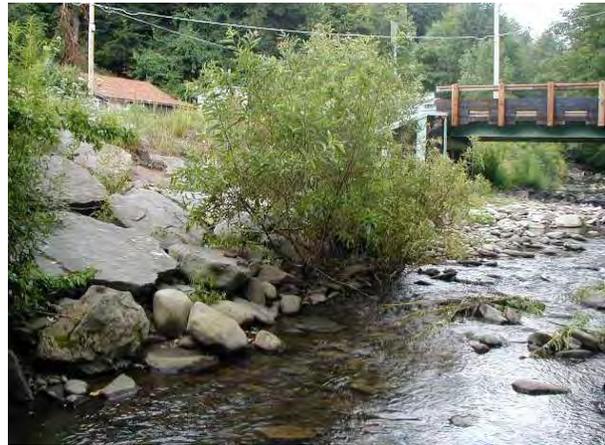
Photo 13. Rip-rap on right bank below Clark Rd. Bridge – view looking upstream at end of bridge opposite from Route 55.

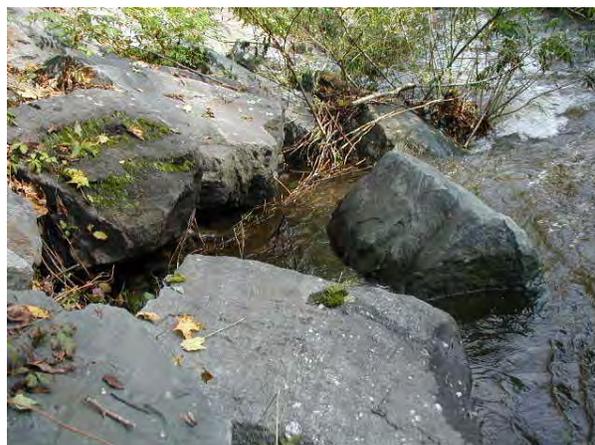
protective measures appear to have been relatively successful in some areas, while less successful in other areas. For example, the banks along the rear of the Black Property in the middle reaches of this unit had been riprapped during previous maintenance attempts. Currently riprap has been dislodged, fallen into the channel and is inappropriately redirecting higher flows and scouring stream banks (Photo 14).

Photo 14. Dislodged riprap in the channel.

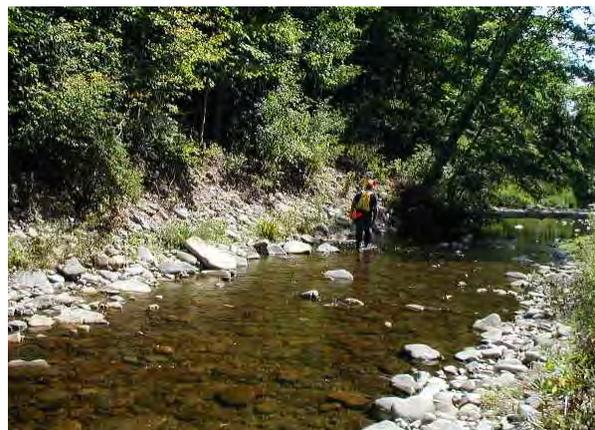
Photo 15. Looking downstream towards eroded left bank and fallen Sycamore trees near Fairground area-monitoring cross section 6.

streambanks are actively eroding (Photo 15). Bank to bankfull height ratios along this unit ranged from 1.1 – 3.6, confirming that a significant length of the channel is *incised*. Rosgen (2002) notes that bank to bankfull height ratio is a good measure of vertical stability, as well as an indicator of sediment supply potential. Stability assessment resulted in banks along the actively eroding areas to be rated very high in terms of bank erosion potential, meaning that the potential for continued bank erosion, loss of trees and channel migration is very high compared to other sites. In fact, as meander bends and bars continue to develop lateral erosion and meander migration will accelerate. Because the channel is cutting into terraces and fill slopes in some areas they may continue to be a significant source of sediment for downstream *reaches*.

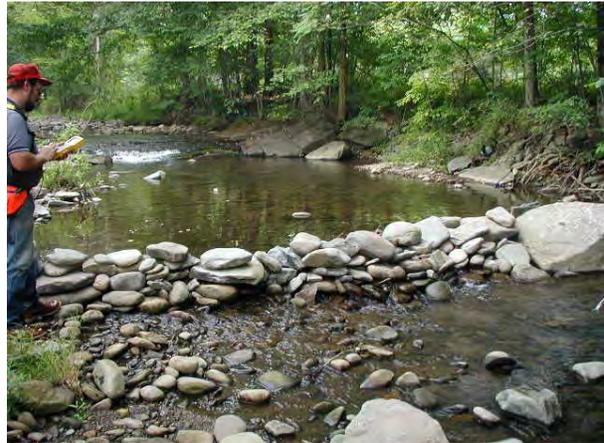
Photo 16. Rock check dam, between Clark Road Bridge and Hilltop Road Bridge.

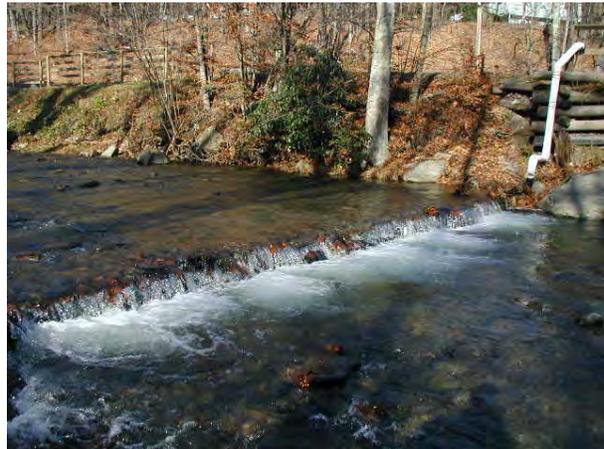
Photo 17. Just below Covered Bridge MU5, Wood Weir serving dry hydrant in downstream MU (see MU6 for more detail).

13. Reconstruct problematic dry hydrant sites utilizing cross vanes to provide low maintenance facilities.

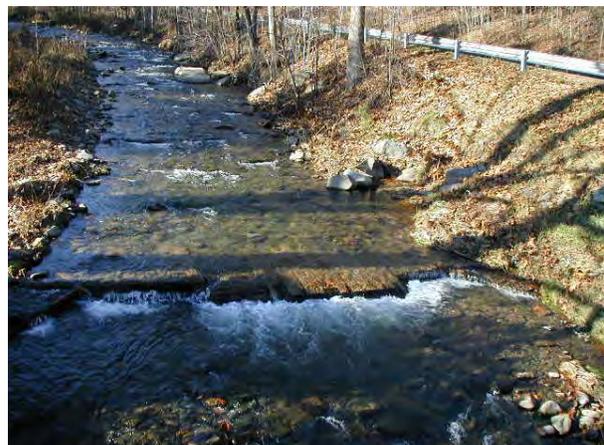
Photo 18. Log sill located just above Covered Bridge.

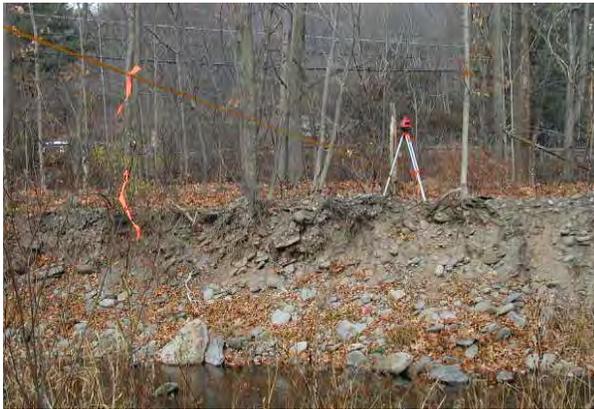
Photo 19. Monitoring cross section 4 at eroded left bank view from right opposite tennis courts at Fair-ground.

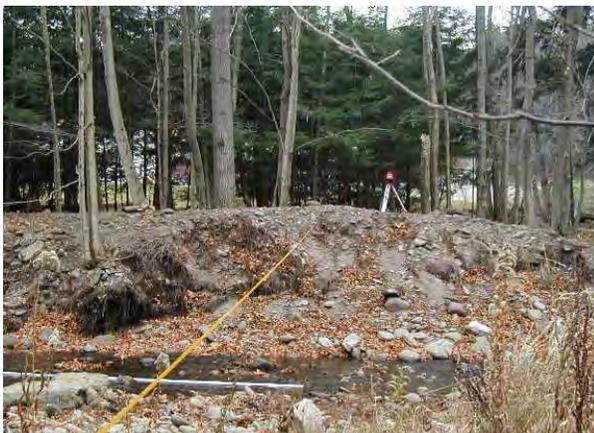
Photo 20. Monitoring cross section 5, view looking at right bank, tennis courts in background beyond tree, approximately 200' downstream of monitoring cross section 4.

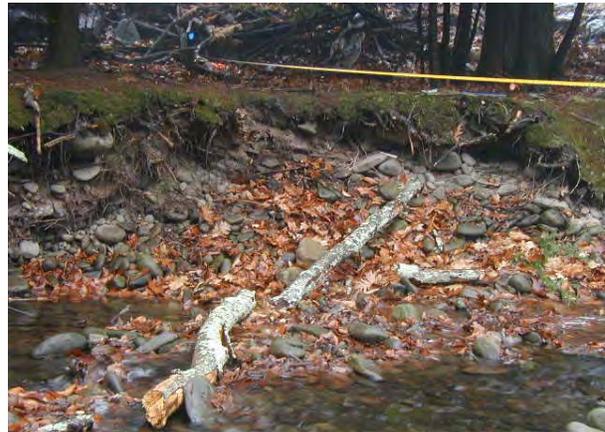
Photo 21. Monitoring cross section 6, approximately 200' eroded right bank, downstream of monitoring cross section 5.

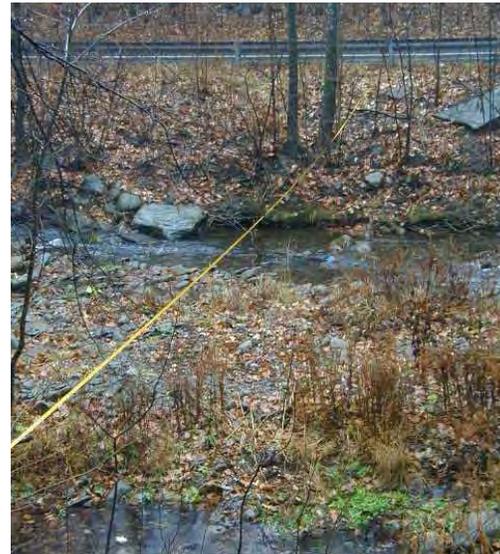
Photo 22. Aggradation monitoring cross section 1, just upstream Covered Bridge.
