G. Chestnut Creek Management Unit 7

1. Summary Description

Chestnut Creek Stream Management Plan

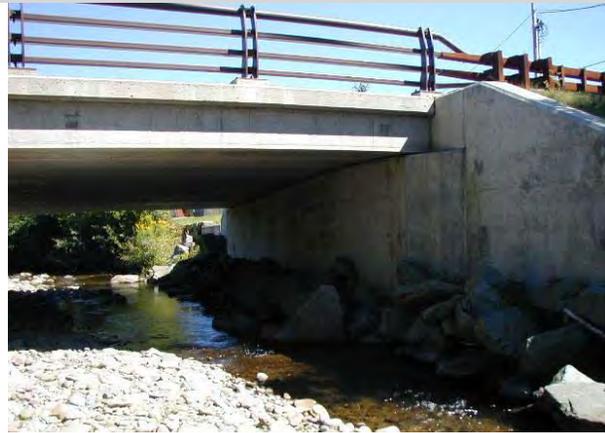
Photo 1. View looking downstream at Route 42 Bridge, cobble bar under bridge with main channel flowing into right abutment armed with riprap.

8. Evaluate the State Route 42 Bridge for the ability to convey both bankfull and flood flow, as well as proper sediment transport. Design modification should reduce scour and provide for fishery passage.

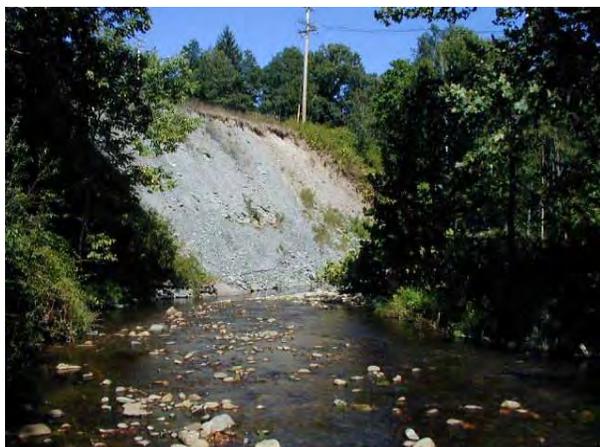
A number of natural constraints and human-made modifications were inventoried within the unit during the 2001 Stream Assessment Survey. These include traditional applications consisting of placed rock revetment, such as *riprap*, floodplain *berms*, and grade control structures such as check dams and weirs, as well as sewer and bridge crossings. Channel alignment has been historically constrained by high terraces, in areas along both banks. In the center of the unit, the stream channel currently impinges along the toe of a high bank along State Route 55, on NYCDEP property, resulting in severe erosion and *mass wasting* (Photo 4 & Appendix Projects Ranking).

Photo 4. Steep eroded left bank on DEP property, along Route 55-view looking downstream toward road & left bank from XS-170.

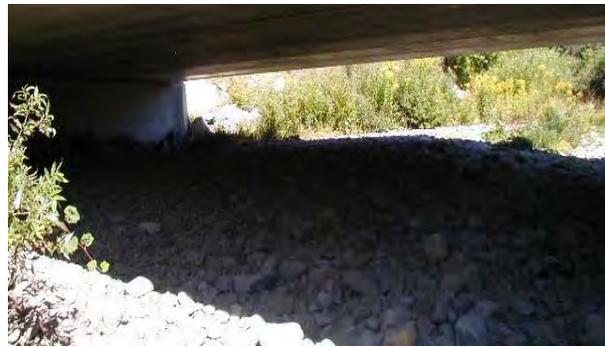
a large gravel bar had formed under the opening of the structure (Photo 8). Gravel deposition can result from inadequate bridge width or location over the bankfull channel width. Reduction of the *hydraulic* opening under a bridge causes ongoing maintenance problems as well as potentially results in higher stress along the bridge abutments. Field surveys verified that the deepest part of the stream channel currently runs directly into and along the right bridge abutment (see Photo 1). Evaluation of the bridge alignment and width over the bankfull channel width would be beneficial to both the longevity of the bridge and the integrity of the stream.

Photo 8. Cobble bar under Route 42 bridge along left abutment.

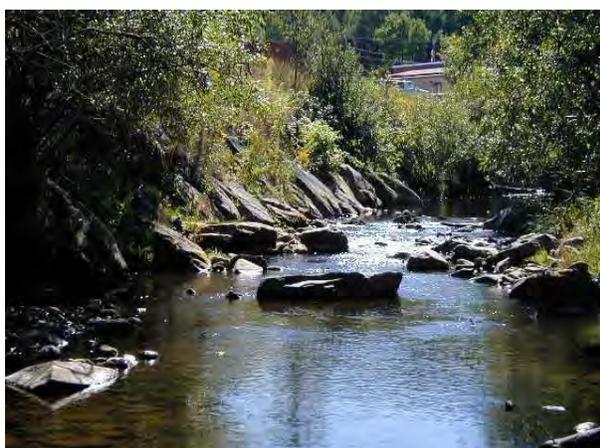
Photo 9. End of rip-rap on right bank, downstream of Route 42 Bridge – on DEP property – view looking upstream from the center of the stream.

reducing channel slope by increasing belt width through erosion and lateral migration. This process is prevented by riprap, but is potentially amplified or transferred to the downstream areas.

6. Evaluate the potential of replacing or modifying stabilized areas (riprap), as needed with alternative stabilization techniques including bioengineered vegetation and vane/log style structures. These techniques can prove to be more aesthetically pleasing, promote physical habitat, and facilitate other multiple secondary benefits.

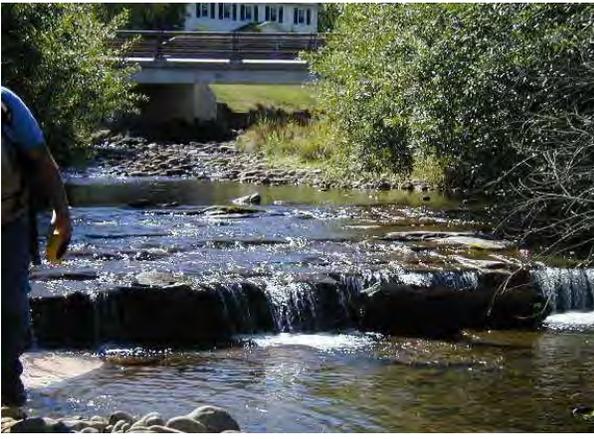
Photo 10. Stone and cement bed-grade control-view looking upstream towards Route 42 Bridge.

Route 42 Bridge may be affected by the check dam. Often a stream will migrate around a check dam requiring ongoing maintenance. Use of extensive riprap discussed above may have been implemented to prevent loss of this check dam.

4. Assess the potential effects of the check dams on channel stability, sediment transport, habitat improvement, and fish passage. Remove poorly sited and/or poorly functioning check dams, with attention to promoting multi-objective restoration.

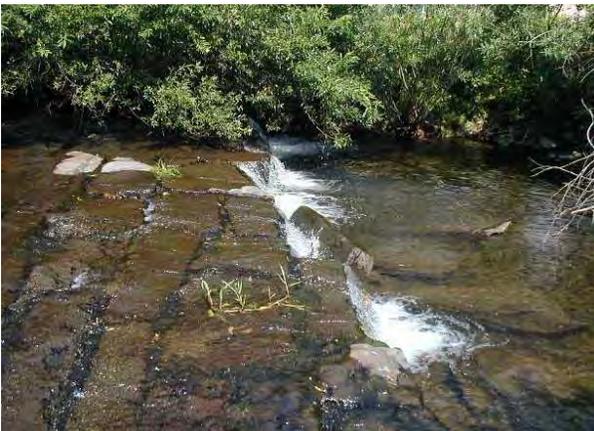
The second structure is a v-notched weir located at the USGS gaging station, 1,400 feet downstream from State Route 42 Bridge (Photo 11). The effects of this structure independently were not evident from the assessment, however the combination of these structures and the

Photo 11. Stone step weir on DEP property at USGS gage.

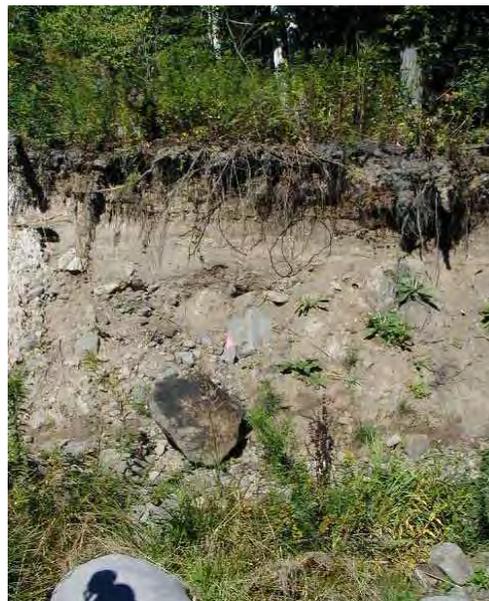
The high bank of concern is located 800 feet downstream of State Route 42 Bridge on NYCDEP property. The bank is 38 feet in height at its center and over 100 feet long. The bank at its center is uniform in slope with a bank angle of approximately 42 degrees. Bank configuration in 2001 was considered over-steepened, in comparison to upstream and downstream areas of the same terrace formation and is presently located less than 20 feet from Rt. 55. It has been estimated using aerial photography that more than 73,000 ft³ of sediment has been eroded from this single bank in the six years between 1995 and 2001. No protective vegetation existed on the bank top, face, or toe of the bank (Photos 12 & 13).

Suspected cause of failure was initialized by sediment *entrainment* from water flowing parallel to the bank, causing erosion by removal of soil particles at the bank toe. Field evidence revealed the soil

Photo 12. Monitoring cross section, DEP 2, eroded left bank.

Field inspections revealed slumped grass from the top of the bank along the bank toe indicating active erosion and slumping. The 2001 Stream Assessment Survey included establishment of monitoring cross sections, two of which were placed in the area of the high bank, to verify this process. The bank was evaluated using a *Bank Erosion Hazard Index (BEHI)* scoring system, which evaluated

parameters such as bank height, vegetation rooting depth and density, bank surface protection, angle and materials. The bank was rated with an extreme potential for erosion, which is the highest applied score in the entire Chestnut Creek mainstem.

Historically, the bank material has been unable to withstand the near bank stress imposed by flow in the channel. Further compounding the risk of continued bank failure is a lack of suitable bank protection along the bank toe, exacerbated by current stream alignment. Apparent from historic imagery is the trend of increasing sinuosity and channel length in the area of the high bank through lateral migration at the bank, and a channel avulsion downstream. The 2001 aerial photo further displayed down valley migration of the meander leading into the area of the bank, directing flows into the face of the bank. The effect of this migration is suspected to have reduced local slope, and increased deposition in the area of the bank, ultimately accelerating erosion into and at the bank.

downstream. An immediate temporary stabilization effort should be considered along the bank toe to prevent further failure and potential catastrophic damage to the adjacent highway.

1. Relocate and stabilize the stream channel in the area of the high eroding bank. (See following section)
2. Perform further assessment of the Red Brook tributary to determine the extent of erosion and potential sources of excess sediment to the mainstem of the Chestnut Creek in Management Unit 7.

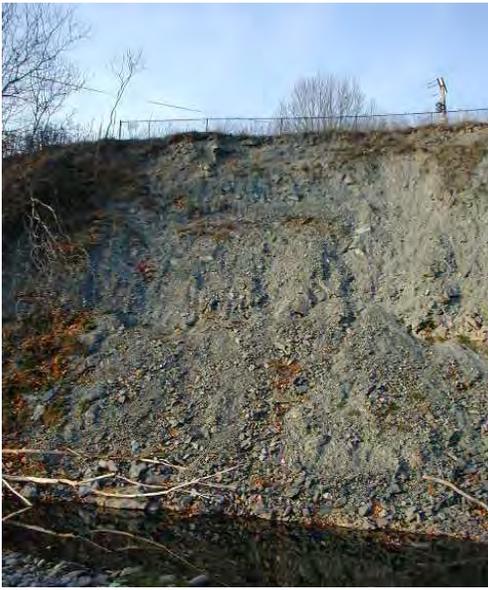
Photo 13. Monitoring cross section, DEP 1, left toe of eroding bank close up of Photo 9, stream flow left to right.
