East Kill Management Unit 3

Town of Jewett – Vista Ridge Road Bridge (Station 67789) to Station 62465

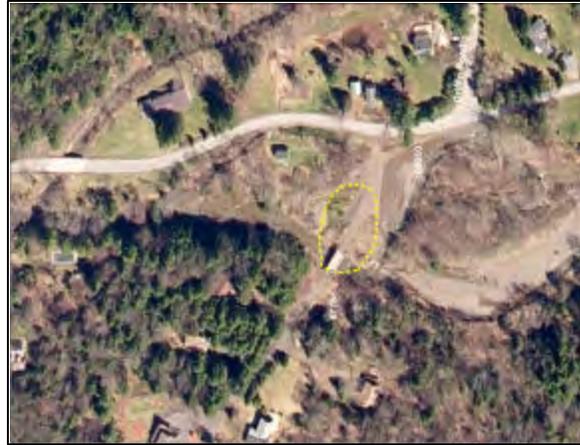
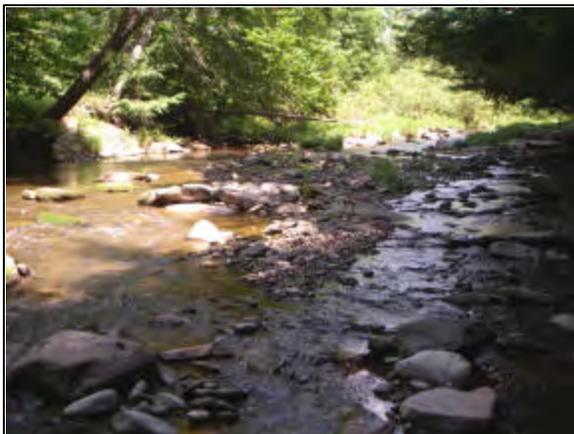
*Transverse bar, Stations 67473 – 67400
looking upstream*

Downstream of the tributary there was a *transverse bar* (Station 67473 – 67400), a diagonal accumulation of sediment across the channel, that stretched for approximately 73 feet. Along the left bank, there was a water intake pipe associated with the nearby residence.

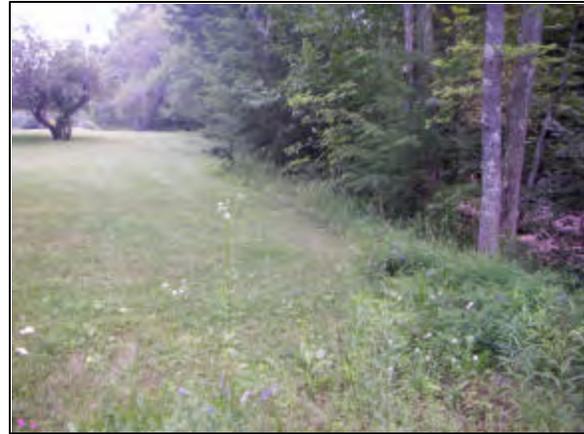
Continuing downstream, along the right bank there was a recommended planting site. At the time of the assessment, there was a thin line of trees with mown lawn to the top edge of the stream bank. Recommendations for this site (Station 67300) include augmentation of the existing buffer with the planting of additional native trees and shrubs along the top of the streambank and the adjacent upland area. Buffer width should be increased by the greatest amount agreeable to the landowners, but increasing the buffer width by at least 100 feet will increase buffer functionality, such as filtering nutrients and pollutants, if present, and protecting the stream from nearby land uses.

*Planting site at Station 67300
looking upstream*

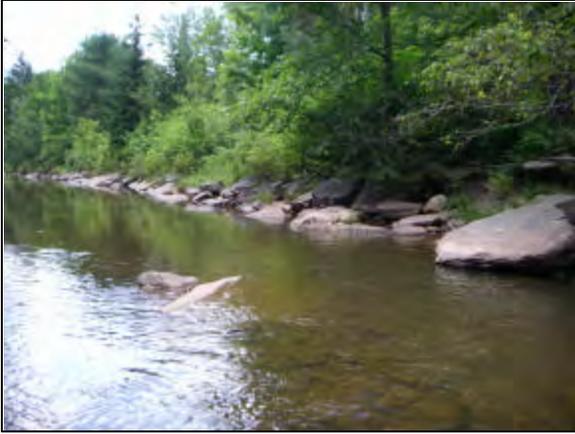
Rip-rap along right bank, Stations 67193 - 66890

continued downstream, stabilizing a total of approximately 303 feet of stream bank. Following the 1996 flood, the NYS Department of Environmental Conservation (DEC) issued an emergency stream disturbance permit (Station 67055) for flood repairs along 300 feet of stream channel. The permit included woody debris removal, repair of rock rip-rap, and for excavation of sand and gravel to restore stream flows to pre-flood

conditions. Although this rip-rap was in good condition at the time of the assessment, interplanting the rip-rap and reinforcing the toe of this streambank with native shrub and sedge species is recommended. This planting will help to strengthen the revetment, while enhancing aquatic habitat. The riparian buffer beyond the rip-rap installation was thin, with some mature trees and mown roadside vegetation. The risk to bank stability and to infrastructure can be minimized by augmenting the buffer with plantings of native tree and shrub species.

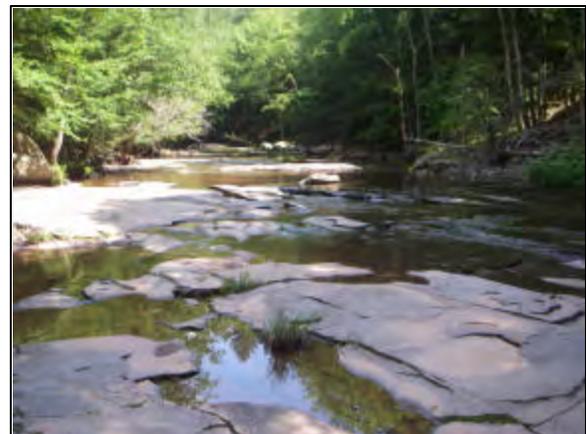
As the stream meandered to the right, there was bedrock (66300) along the left stream bank and bed, gradually covering the full bed of the stream channel, for approximately 381 feet. The bedrock provided lateral control along the upstream portion of the bedrock by limiting stream bank erosion; it provided grade control for the channel by preventing *degradation* or

Bedrock at Station 66300

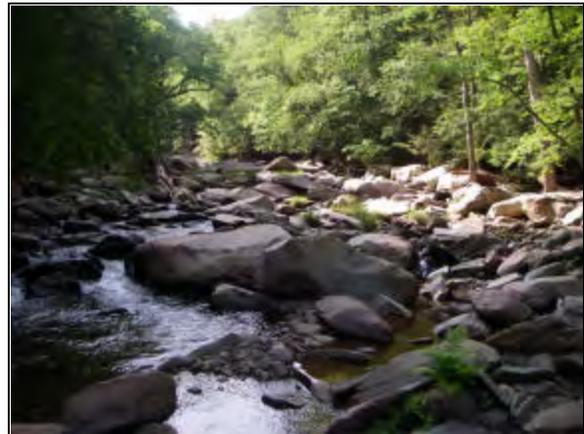
Downstream of the bedrock, there was a *step pool complex* (65856) that stretched for approximately 210 feet with large boulders and multiple locations of excessive sediment deposition throughout. A step pool sequence is a series of short drops interspaced with pools. This type of morphology is a common feature of high gradient streams, the steps provide grade control and the pools dissipate energy.

Step pool complex, Stations 65856 – 65646 looking upstream

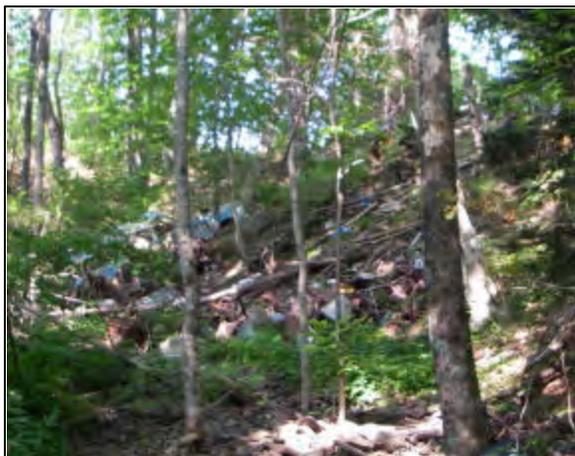
Dump site at Station 65506

The channel of the second of these tributaries passed through a large dump site (Station 65506) on the left bank. Approximately 105 feet upland from the East Kill, there were piles of scrap metal, an old car, household waste and miscellaneous objects thrown over the hillside slope. This dump site posed a water quality threat to the East Kill, particularly when there is flow in the tributary channel that passes through it. It is

recommended that the dump site be cleared to eliminate the potential safety and pollution hazards associated with the dumped material.

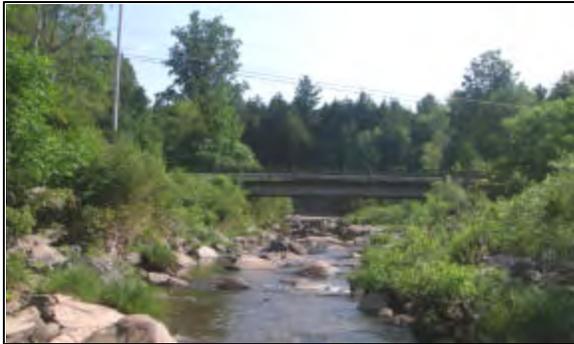
Colgate Road Bridge at Station 65078

Further downstream, there was excessive sediment deposition along the right stream bank and within the stream channel including, a point bar and center bar. As the stream approached the Colgate Road Bridge (# 3302990, Station 65078), the left stream bank was reinforced with rip-rap that was in good structural and functional condition, and

there were shrub and herbaceous species growing along the revetted bank. The riparian buffer beyond the rip-rap installation was sparse, with some mature trees and mown lawn. The risk to bank stability and to infrastructure can be minimized by augmenting the buffer with plantings of native tree and shrub species. There was sediment deposition upstream and downstream of the bridge. Deposits such as these are commonly caused by inadequate sizing of the bridge opening. An undersized bridge opening causes water to back up upstream of the bridge, reducing stream velocity, which results in sediment deposition. While bankfull flows may flow freely through this bridge, higher flows may backwater, resulting in the upstream aggradation. If this bridge is replaced in the future, it is recommended that a hydraulic analysis be conducted in order to determine the appropriate bridge width that will provide the capacity to convey flood flows through the opening.

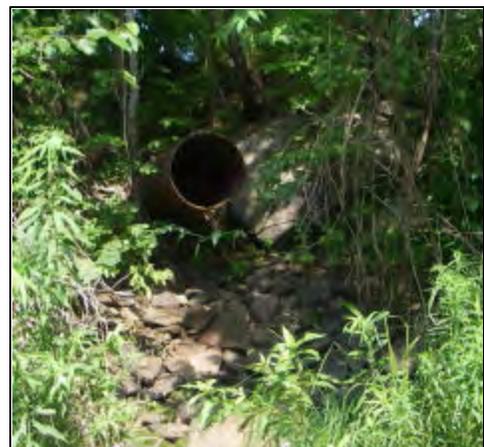
Just downstream of the bridge, there was a 15 inch piped outfall (Station 65063) sticking four feet out from the left stream bank. This outfall appeared to provide drainage for the nearby residential land use and Colgate Road. Though outfall protection was absent, there did not appear to be any recent erosion associated with the piped outfall; there was no flow at the time of the assessment.

Piped outfall at Station 65063

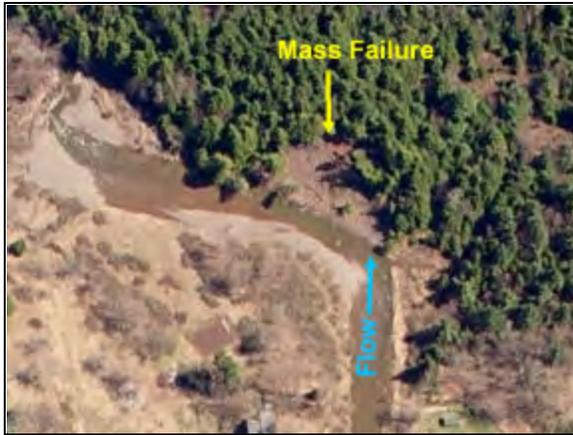
Mass failure, BEMS #06EK1667
Stations 64820-64640

right stream bank was affected by a *mass failure* (Station 64820 to Station 64640, Figure 4.3.1 Inset B), a large slope failure associated with downcutting stream channels and undermined support of steep slopes. Stream bank erosion often occurs on the outside of meander bends where the stream velocity is greatest during high flows. Along this section of stream, the

thalweg flowed up against the toe of the bank undermining the steep slope, resulting in an erosion area of approximately 12,567 ft², exposing mixed till (Stations 64820-64640) along the bed and bank and compromising mature trees along the bank. During high flows and times of active erosion, a significant amount of clay may enter the stream from this bank. Fine sediment inputs into a stream can be a serious water quality concern because they increase *turbidity*, degrade fish habitat, and can act as a transport mechanism for other pollutants and pathogens. To study erosion along this reach, this stream bank has been monumented as a Bank Erosion Monitoring Site (BEMS # 06EK1667, Station 64731).

A cross-section and long profile survey were conducted to collect baseline data. In the future, this cross-section can be resurveyed to calculate the bank's erosion rate. It is recommended that monitoring of this site continue.

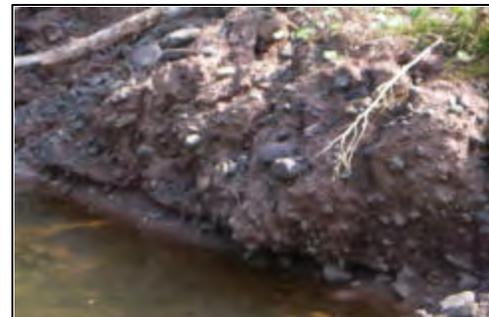
Clay exposure near Station 64820

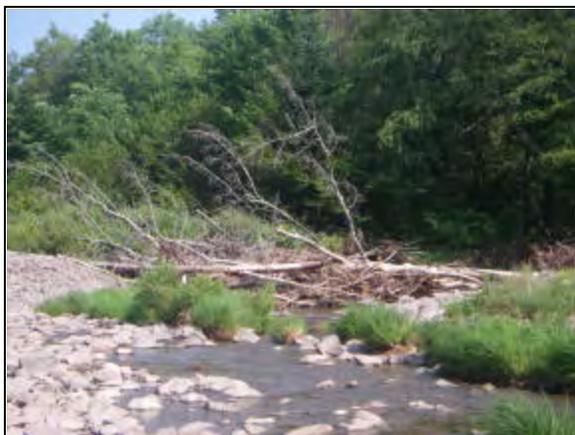
Woody debris & sediment deposition at Station 64372

Throughout the stream reach downstream of the mass failure, there was an accumulation of woody debris and excessive aggradation. Opposite the mass failure, and continuing downstream there

was continuous sediment deposition (Stations 64910 – 64400) resulting in a point bar (that changed to a side bar and back to a point bar) that stretched for approximately 510 feet along the left bank. Sediment was also deposited along the right bank downstream of the mass failure, forming a side bar (Stations 64541 – 64373) with some herbaceous vegetation and abundant woody debris accumulation. Just before the stream turned sharply to the right, there was a large woody debris pile (Station 64372) and a significant drop off from the sediment bars, with a drop of approximately five feet from the top of the aggradational areas to the stream channel.

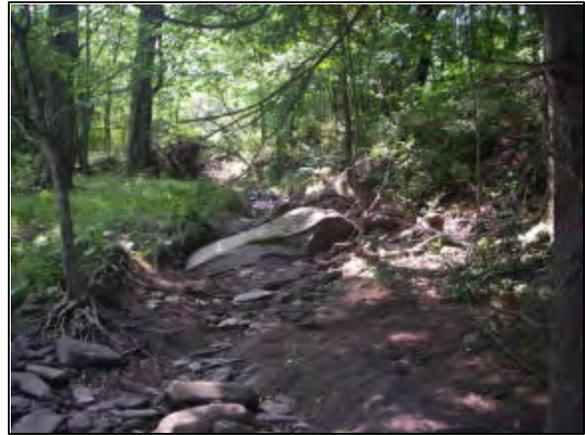
Flood chute at Station 63779

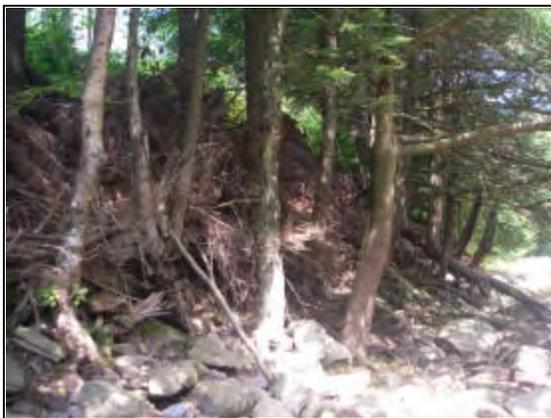
Downstream of the flood chute, there was some erosion along the left stream bank (Stations 63672 – 63516). Although the erosion appeared to be relatively minor, there was a house located at the top of the bank; therefore, if the bank continues to erode, it may pose a threat to the nearby residence. It is recommended that the riparian buffer along this bank be maintained and enhanced with plantings of native shrub and tree species; reinforcing the toe

Erosion at Stations 63672 - 63516

of the bank by planting sedge species is also recommended.

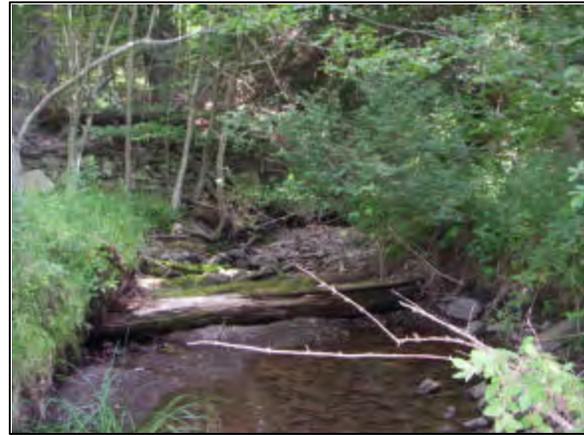
Continuing downstream, a small unnamed intermittent tributary (Station 63400) entered along the right bank. At the time of the assessment, it appeared as though a portion of this tributary may have functioned as a flood chute, although no channel divergence was observed upstream. The channel of this tributary seemed to lose its ability to transport sediment; flow was subsurface along the upstream portion of the tributary, and there was excessive sediment deposition at its confluence with the East Kill, likely contributing to the aggradation along this reach of the East Kill.

Tributary at Station 63400

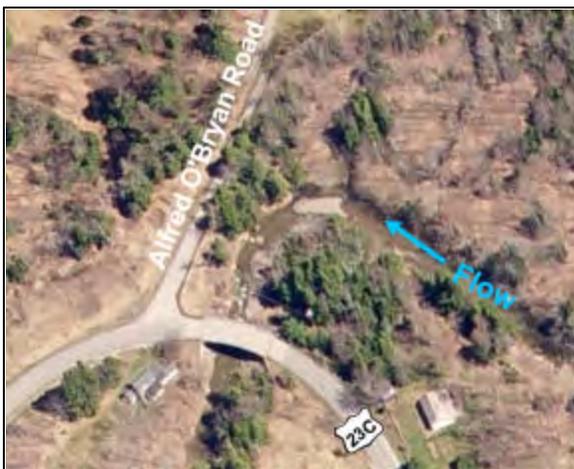
Route 23C Bridge at Station 63149

63149, Figure 4.3.1 Inset A) seemed to provide an adequate span for low flows, it appeared

that higher flows would backwater, reducing stream velocity, which resulted in upstream aggradation. If this bridge is replaced in the future, it is recommended that a hydraulic analysis be conducted in order to determine the appropriate bridge width that will provide the capacity to convey flood flows through the opening.

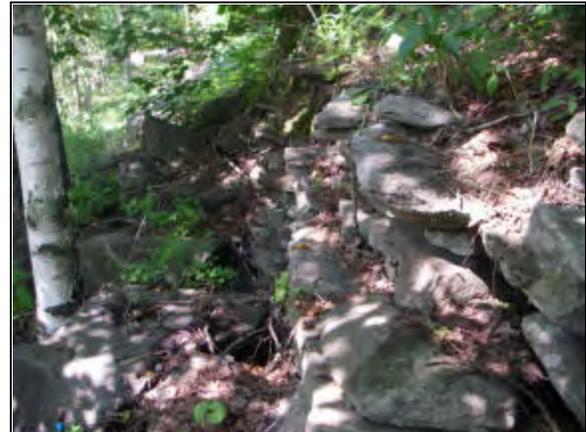
Just downstream of the bridge, roadway drainage was directed through a piped outfall and entered the stream from the left; there was good outfall protection and revetment surrounding the pipe, and the drainageway appeared to receive intermittent flow. The right stream bank was reinforced with a stacked rock wall (Station 63100 - 63035) that was in fair structural and functional condition. Following the 1996

Rock wall at Stations 63100 - 63035

flood, NYS DEC issued an emergency stream disturbance permit (Station 63076) for flood repairs along 65 feet of stream bank, which involved repairing the stacked rock wall. There was a narrow strip of trees at the top of the bank along the rock wall, with mown lawn from a house to the edge of this thin buffer. Widening the buffer width, by planting native shrubs and trees, is recommended. There was a small piped outfall along the right stream bank at the end of the rock wall (Station 63035); flow was intermittent and there was no flow at the time of the assessment.

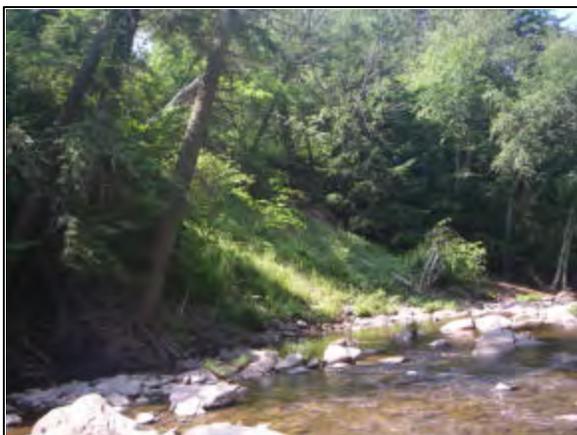
Erosion at Stations 63000 - 62786

Continuing downstream, the left bank had experienced hydraulic erosion and mass failure (Station 63000 to Station 62786) along approximately 214 feet of stream channel. This resulted in an erosion area of approximately 4,273 ft² that had compromised mature trees along the bank. There was a seep on the face of the bank, which may exacerbate the erosion at this site. Although

this bank was a significant erosion site, it appeared to be slowly recovering, with herbaceous vegetation, including grasses and ferns, becoming established on the face of the bank. However, without deep-rooted shrub and tree species, it is likely that this bank will continue to erode during future high flows. At the top of the bank, there was mown lawn to the edge. This erosion site may be a good candidate for remediation using vegetative toe and bank protection. Recommendations for this site (Station 72223) include planting native trees and shrubs along the streambank and the upland area. Buffer width should be increased by the greatest amount agreeable to the landowners. Prior to proceeding with any work, this site would require a more detailed site assessment.

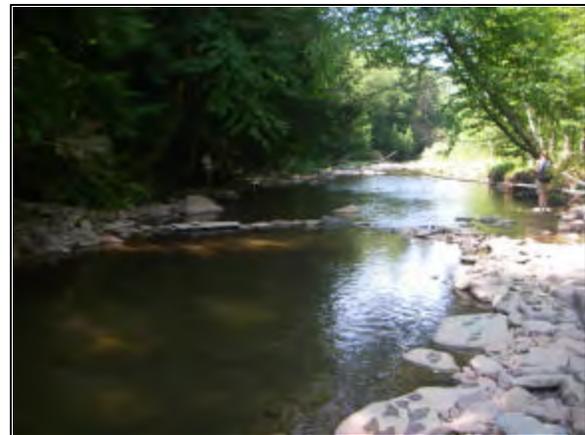
Near the downstream end of the erosion, there was a handmade dam obstructing the channel (Station 62834). The dam was constructed of stream cobbles and caused a pool to form upstream of the obstruction.

Handmade dam at Station 62834

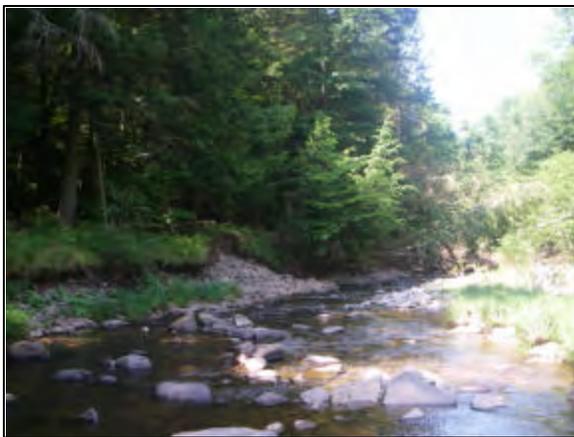
Erosion at Stations 62550 - 61817

Near the end of management unit # 3 there was some minor erosion and scour

(Stations 62550 – 61817) along the left stream bank for approximately 87 feet that continued into management unit # 4 for an additional 558 feet. Along a portion of the eroding bank, some mature trees had been compromised and were hanging over the stream channel.
