East Kill Management Unit 6

Town of Jewett – Station 40130 to Station 37758

**East Kill Management Unit 6
Stream Feature Inventory**

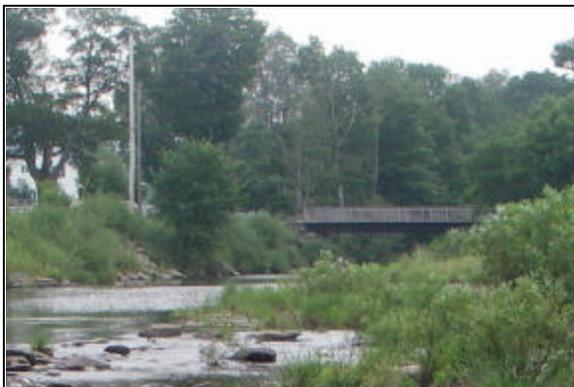
This management unit began as the stream flowed under a private bridge (Station 40130); there was rip-rap along both stream banks upstream and downstream of the bridge. Sediment deposition upstream and downstream of the bridge was observed at the time of the

Bridge at Station 40130
photo orientation – looking upstream

assessment; downstream there was a side bar on the left and full channel aggradation. During periods of high water, streams tend to deposit sediment when velocity slows due to flow constriction under a bridge. While bankfull flows may flow freely through this bridge, higher flows may backwater, resulting in channel aggradation. If this bridge is replaced in the future, it is recommended that

a hydraulic analysis be conducted in order to determine the appropriate bridge width that will provide the capacity to convey flood flows through the opening. Near the bridge abutment, there was a water intake pipe (Station 40124), entering along the left stream bank that provided water for Farber Farm.

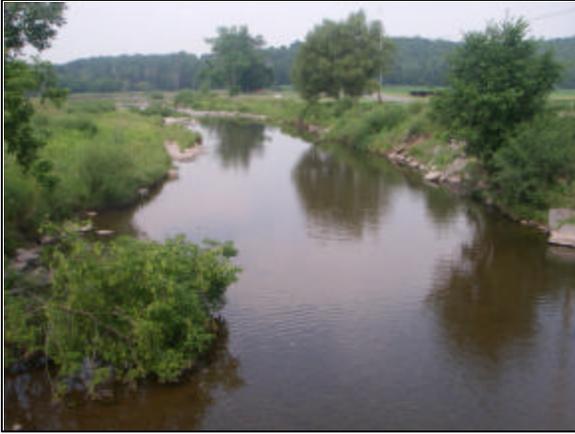
*Rip-rap at Stations 40130 – 39983
Woody debris at Station 40095
Riparian planting sites at Station 39922*

Just downstream of the bridge, the left bank was reinforced with 60 feet of rip-rap (Stations 40130 – 40070) that was in fair

structural and functional condition. There was a fallen tree along the left bank that provided a minor obstruction to flow. Along the right, the stream bank was reinforced with 147 feet of rip-rap (Stations 40130 – 39983) that was in good structural and functional condition.

Interplanting the rip-rap and reinforcing the toe of both stream banks with native shrub and sedge species is recommended. This planting will help to strengthen the revetment, while enhancing aquatic habitat. Continuing downstream a riparian planting site was identified along both stream banks (Station 39922). On the right, there was herbaceous vegetation with a few shrubs interspersed on the face and top of the stream bank, forming a narrow buffer between state Route 23C and the East Kill. This riparian buffer should be enhanced with native trees and shrubs to provide water quality protection from the runoff coming from the impervious road surface. Along the left, a

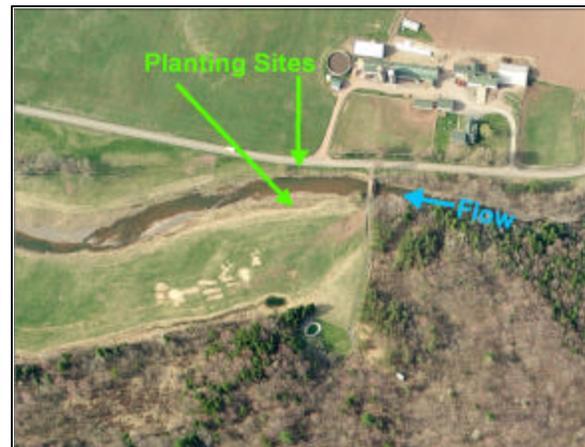
Riparian planting sites at Station 39922

vigorous buffer with mature trees is important because it may filter nutrients and pollutants, if any, from the adjacent agricultural fields. Recommendations for this site include augmentation of the existing buffer with the planting of additional native trees and shrubs along the streambank and the upland area. Buffer width should be increased by the greatest amount agreeable to the landowners. Increasing the buffer width to at least 100 feet

will increase the buffer functionality, by providing improved stream bank stability and protecting water quality.

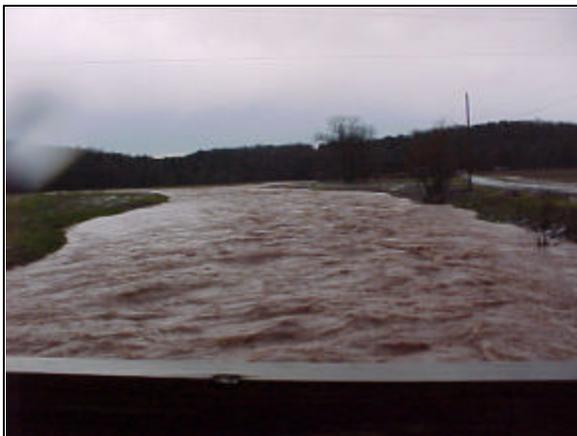
High Flow Event - December 2000

the constructed channel. However, most of the rock structures were functioning as designed and received little damage.

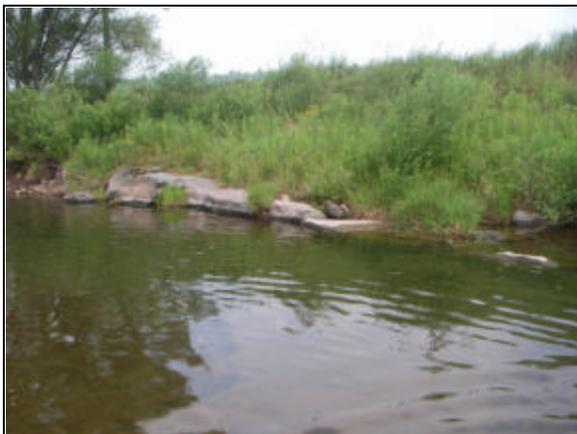
Rock vane at Station 39922

the bank from 20 to 30 degrees, just downstream of the point where the stream flow encounters the stream bank at acute angles. At the time of the assessment, this rock vane was in good structural and functional condition. The upstream portion of this rock vane was buried in the bed due to full channel aggradation (Stations 40150 – 39684) conditions that started upstream of the bridge and continued downstream for

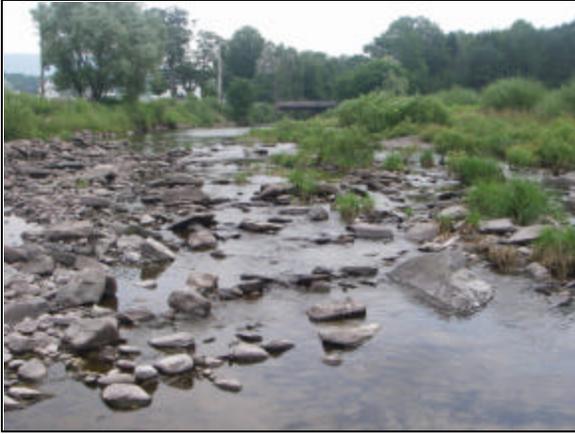
approximately 466 feet. Excessive sediment deposition persisted through this reach of stream and included side and transverse bars.

*Full channel aggradation at Stations 40150 -39684
photo orientation – looking upstream*

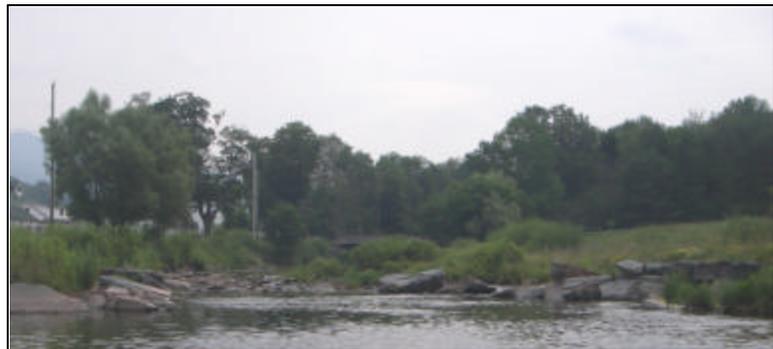
Therefore, this structure can be used to raise the bed and is often used at the head of a riffle to set the elevation of the upstream pool. At the time of the assessment, the cross vane appeared to be holding grade and the thalweg was flowing through a hole in the left vane arm.

Cross vane at Station 39679

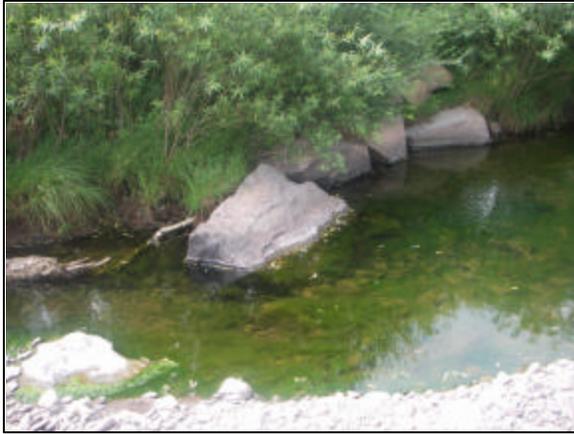
*Rock vane at Station 39305
photo orientation – looking at*

rock vanes along the left stream bank (Stations 39393, 39305 and 39230). A significant portion of each of these rock vanes was buried under a side bar (Stations 39620 – 39205) that stretched for 415 feet in the bed of the stream channel along the left. Due to the excessive sediment deposition and apparent damage to the structures from previous high flow events, the rock structures were in poor structural condition and appeared to be functioning poorly or not at all.

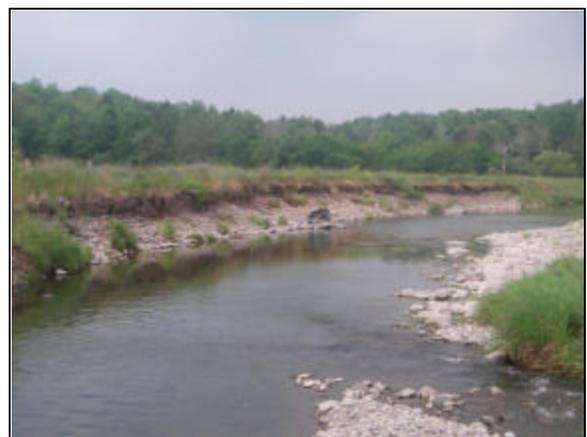
Continuing downstream along the left, there was erosion (Stations 39192 – 38901) along 291 feet of the stream channel, exposing approximately 2,039 ft² of the bank. There was a deep scour hole along the toe of the bank and several rocks from the upstream rock vanes were observed along the bank. At the top of the bank, there was herbaceous vegetation to the edge. Without deep-rooted shrub and tree species, it is likely that this bank will continue to erode during future high flows. This erosion site may be a good candidate for remediation using vegetative toe and bank protection. Recommendations for this site include planting

Erosion at Stations 39192 - 38901

native trees and shrubs along the streambank and the upland area. Buffer width should be increased by the greatest amount agreeable to the landowners. A vigorous buffer with mature trees is important at this site because it may also filter nutrients and pollutants, from the adjacent agricultural fields, thereby potentially reducing the nutrient enrichment and algal growth within the stream. Prior to proceeding with any work, this site would require a more detailed site assessment. During future repairs of the restoration project, it may be necessary to address the erosion at this site to improve bank stability with repairs to the rock structures and through bioengineering techniques.

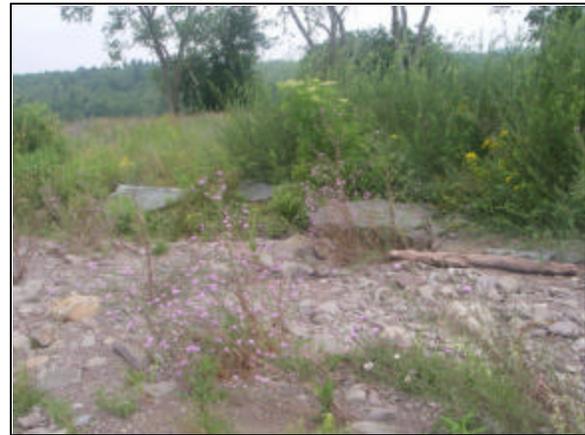
Opposite the eroding bank, there was a rock vane (Station 39051) along the right stream bank. At the time of the field assessment, most of this rock vane was buried under the aggradation through this stretch of the stream, and it did not appear to be functional.

Rock vane at Station 39051

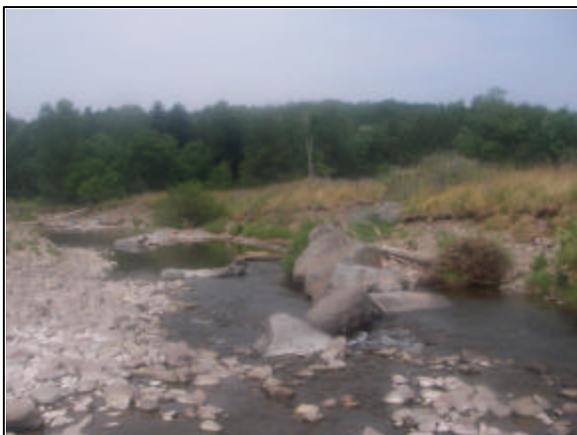
Erosion at Stations 38716 – 38401

Rock vane at Station 38718

Beginning along this rock vane, there was erosion (Stations 38716 – 38401) affecting 316 feet of the right bank. Stream bank erosion often occurs on the outside of meander bends where the stream velocity is greatest during high flows. Rock vanes are constructed to redirect flow away from the bank, however, due to the damage these

structures experienced during previous high flows and the excessive sediment deposition through this reach of stream, the effectiveness of the rock vanes has been reduced. Repair to the damaged rock vanes will help to stop the erosion at this site and prevent future erosion

with bioengineering techniques, and that the eroding banks receive stabilizing treatments.

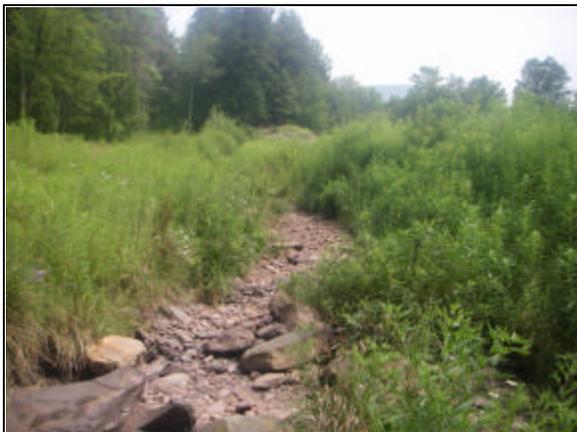
Intermittent tributary at Station 37936

Continuing downstream, a small unnamed intermittent tributary (Station 37936) entered through subsurface flow along the right bank. Just downstream, there was a cross vane (Station 37922), which was the final rock structure of the constructed channel. At the time of the assessment, the right vane arm was buried and the cross vane did not appear to be properly functioning. As mentioned previously, a more detailed

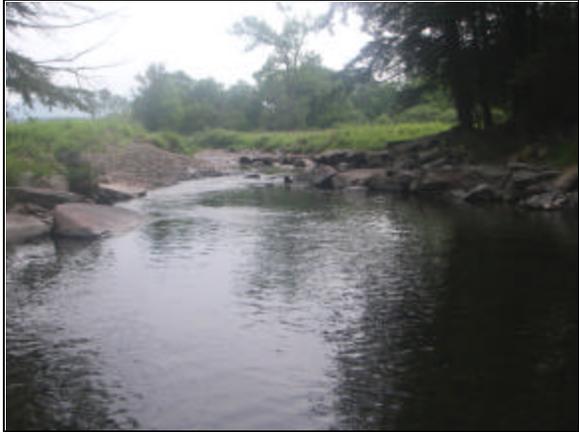
Cross vane at Station 37922

assessment of the restoration project damages will help to determine the extent of repair that is needed for each of the rock structures. The GCSWCD, in cooperation with the NYCDEP, plans to make repairs to this restoration project, which should improve bank stability and channel morphology throughout this management unit.

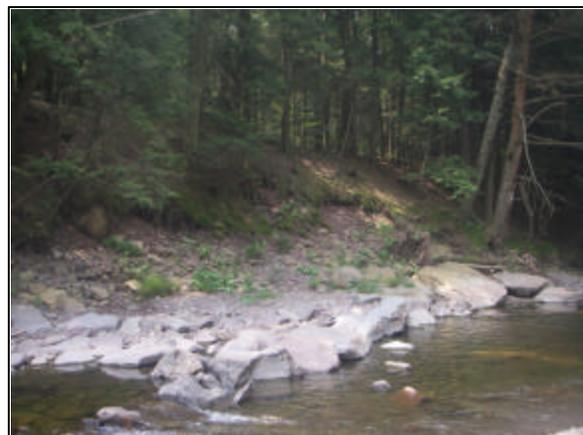
At the end of this management unit there was a *mass failure* (Stations 37900 – 37857), along 43 feet of the left stream bank that had exposed approximately 645 ft² of mixed till. At the time of the assessment, this bank appeared to be slowly recovering, with herbaceous vegetation, becoming established on the face of the bank. Along a portion of this erosion site, the toe of the bank appeared to be stabilized by the cross vane. However, without deep-rooted shrub and tree species along the face of this bank, it may continue to erode during future high flows. Just upstream from this bank, the land use changed from agriculture to forest. The forested riparian zone, along with additional plantings of shrubs and trees on the face of the bank may

Erosion at Stations 37900 - 37857

help to improve the stability of this bank.
