# East Kill Management Unit 11

Town of Jewett – Mill Hollow Road Bridge (Station 6699) to confluence with Schoharie Creek (Station 0)

This management unit began at Mill Hollow Road Bridge at County Route 17 (#3201130), and continued approximately 6,698 ft. to the East Kill’s confluence with Schoharie Creek.

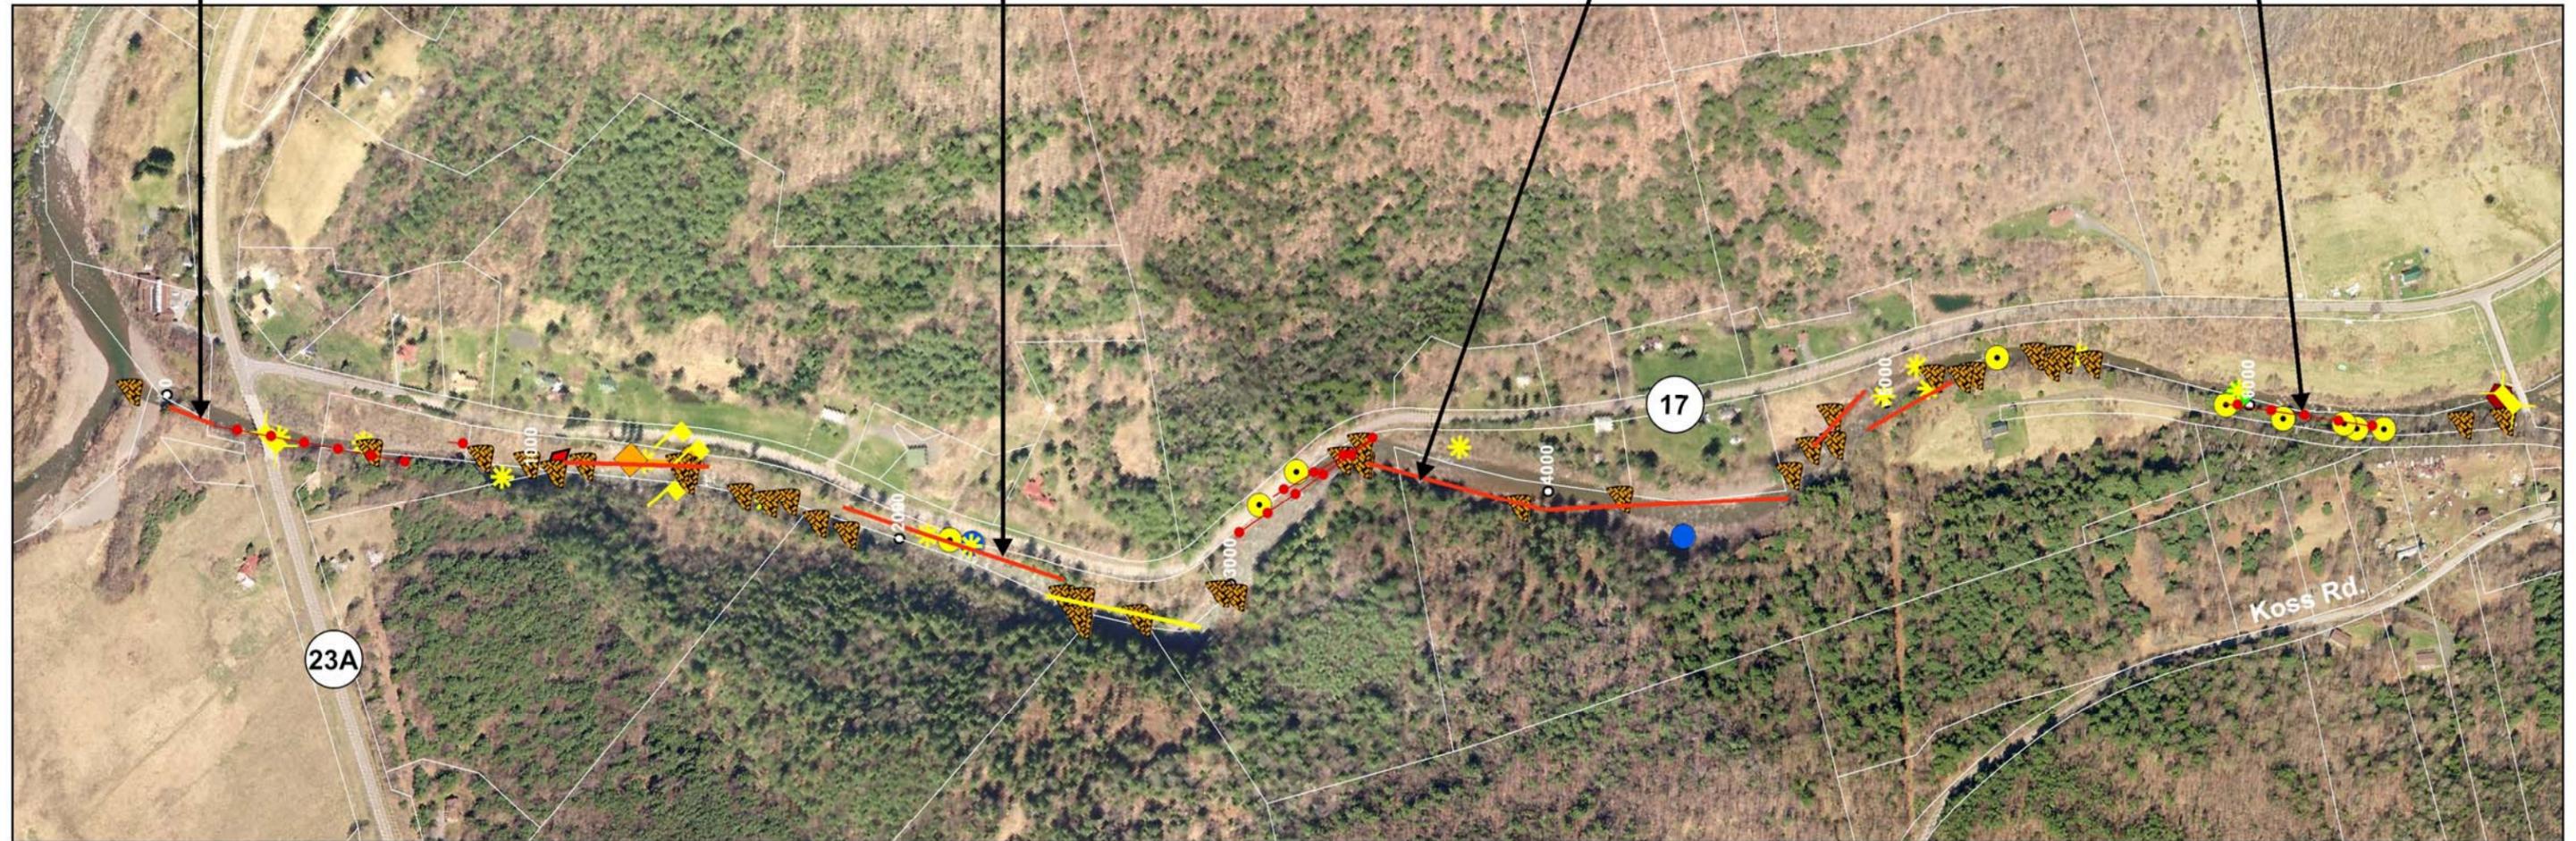
Figure 4.11.1 Management Unit 11 - 2006 aerial photography with stream feature inventory

The 2006 stream feature inventory revealed that 20.4% (2,728 ft) of the stream banks exhibited signs of active erosion along the 13,397 ft of total channel length in the unit (Figure 4.11.1). *Revetment* has been installed on 12.7% (1,707 ft) of the stream banks. No berms were identified in this management unit at the time of the stream feature inventory.

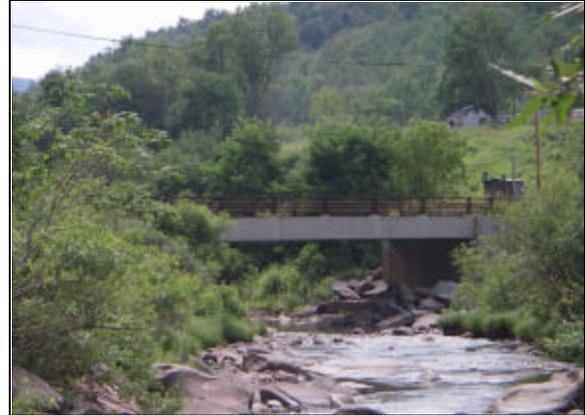
This management unit began as the stream flowed under Mill Hollow Road Bridge at County Route 17 (Station 6699, Bridge # 3201130). At the time of the assessment, excessive aggradational conditions were observed upstream of the bridge and continued downstream of the bridge. While the bridge opening seemed to provide an adequate span for low flows, higher flows appeared to backwater, reducing stream velocity, which resulted in upstream aggradation. If this bridge is replaced in the future, it is recommended that a hydraulic analysis be conducted in order to determine the appropriate bridge width that will provide the capacity to convey flood flows through the opening.

*Mill Hollow Road Bridge at Station 6699*

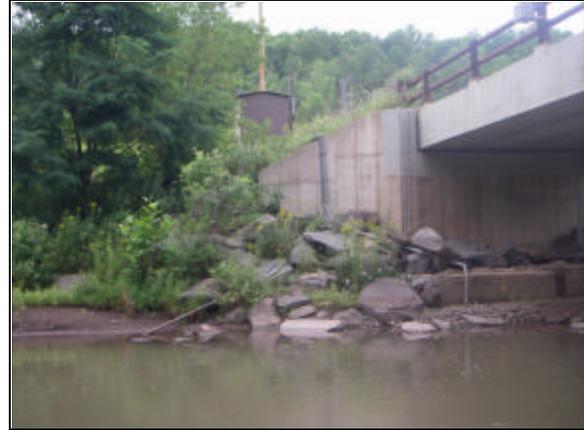
Just downstream of the bridge, there was a water-stage recorder and crest-stage gage (Station 6693) on the right stream bank. This gage is operated by the United States Geological Survey (USGS) in cooperation with the NYC Department of Environmental Protection. The gage (#01349700) has a drainage area of 35.6mi<sup>2</sup> and has been collecting

*Gage at Station 6693*

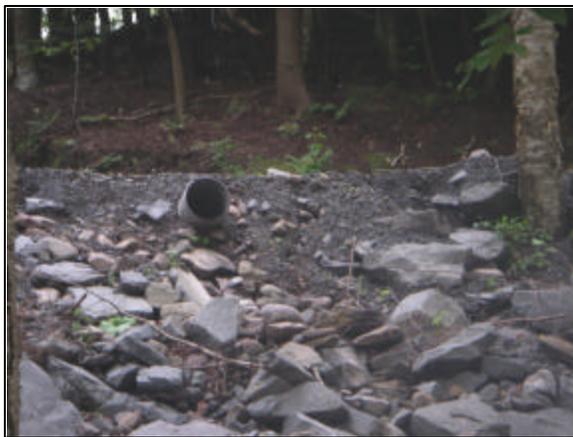
*Piped outfall at Station 6260*

Along the road embankment on the left, there were five piped outfalls (between Stations 6353 – 5943), that provided drainage for Whaley Road, four of which entered through the revetment. Two of the piped outfalls (Stations 6353 and 6260) had minimal

or no outfall protection, while the others had good outfall protection, including the piped outfall (Station 6088) that entered through the rock wall portion of the revetment. Flow through these outfalls was intermittent; at the time of the assessment no flow was observed. During heavy rains, when flow may be present, it is important to have stable and effective outfall protection to minimize further deterioration to the existing revetment and degradation of the road embankment.

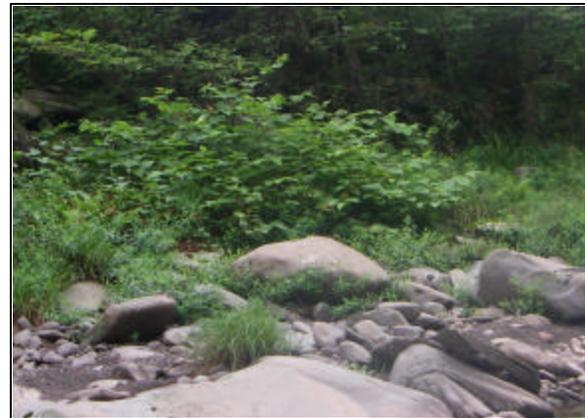
One small patch of Japanese knotweed (Station 6100) had become established in the rip-rap along the left stream bank, and two patches (Station 6387 and 5974) were observed opposite the revetment on the right stream bank. Japanese knotweed is an invasive non-native species which does not provide adequate erosion protection due to its very shallow rooting system, and also grows very rapidly crowding out more beneficial streamside vegetation. Removal of these Japanese knotweed patches is recommended to prevent the spread of this invasive species (See Section 2.7 Riparian Vegetation).

*Japanese knotweed at Station 6387*

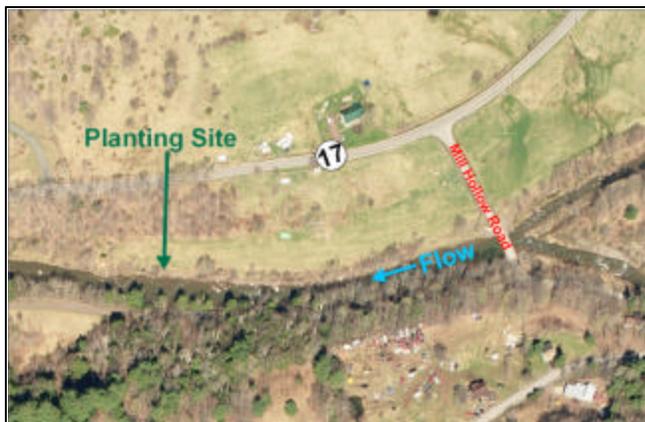
Along the right stream bank, the land appeared to be used as an agricultural field for hay. Between the field of herbaceous vegetation and the stream, there was a narrow buffer with a combination of herbaceous, shrubby and forested vegetation. A vigorous buffer with

*Riparian planting site at Station 5964*

mature trees is important at this site because it may filter nutrients and pollutants, if any, from the adjacent fields while providing improved stream bank stability. During the field assessment, this area was identified as a proposed riparian planting site (Station 5964). Recommendations for this site include augmentation of the existing

buffer with the planting of additional native trees and shrubs along the streambank and the upland area. Buffer width should be increased by the greatest amount agreeable to the landowners. Increasing the buffer width to at least 100 feet will increase the buffer functionality and protect the stream from nearby land uses.

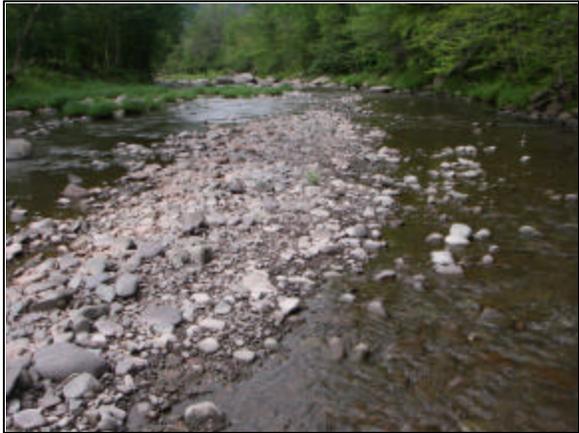
*Center bar at Stations 5575 - 5500*

As the stream meandered to the left, there was excessive sediment deposition (Stations 5575- 4700) along the entire meander bend, starting with a center bar (Stations 5575 – 5500). Along the meander bend the depositional features that were observed included, a side bar along the right channel bed, a series of center bars, a transverse, or diagonal bar, across the channel, full channel aggradation and a *point bar* along the left channel bed. Point bars are

depositional features that are caused by a decrease in sediment transport capacity and usually located on the inside of meander bends. There was also an abundant accumulation of woody debris (Stations 5533, 5121, 5118 and 5004) in multiple locations along this meander bend. Some of the debris had fallen from the adjacent stream banks; all provided only minor obstructions during low flows, but may pose a more significant obstruction during higher flows. Some of the accumulated debris appeared to contribute to localized scour and sediment deposition. Aggradational conditions also persisted downstream into the next meander bend. A piped outfall (Station 5323) entered along the right, providing drainage for County Route 17.

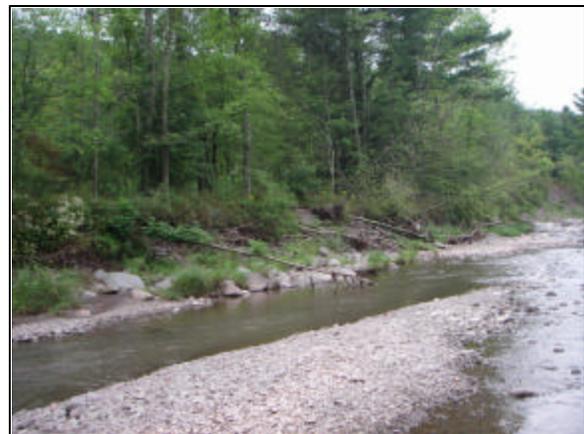
Along this meander bend, the left stream bank had eroded (Stations 5188 – 4925) for approximately 263 feet. The erosion site was along a low bank with some

*Erosion at Stations 5188 - 4925*

shrubs and young trees that were leaning and falling into the stream channel, providing only a minor obstruction at low flows. The face of the bank was somewhat bare, exposing roots and cobble, with herbaceous vegetation interspersed along the bank. This erosion site may be a good candidate for remediation using vegetative toe and bank protection, but may self recover with time.

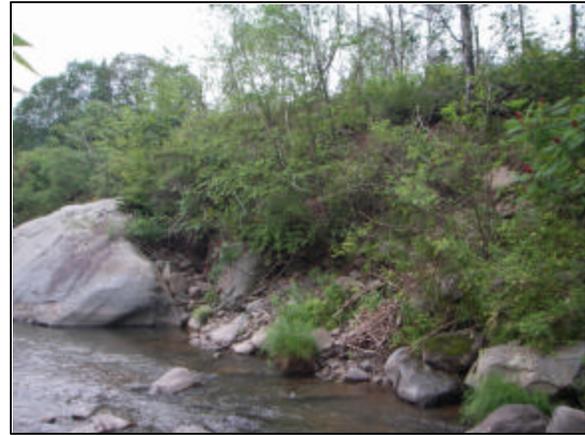
*Erosion at Stations 4991 - 4788*

Opposite this eroding bank, there was an erosion site (Stations 4991 – 4788) along the right stream bank for approximately 203 feet. It was a relatively high bank with a narrow riparian buffer along the upstream portion of the erosion. Further downstream along this erosion site, the height of the bank decreased, there was herbaceous vegetation to the top edge of the stream bank and a vegetated cobble bar appeared to provide some stability protection for the toe of the bank. Although this bank was a significant erosion site, it appeared to be slowly recovering, with herbaceous vegetation becoming established on the face of the bank. However, without deep-rooted shrub and tree species this bank may continue to erode during future high flows. This erosion site may be a good candidate for remediation using vegetative toe and bank protection. Recommendations for this site include planting native trees and shrubs along the streambank and the upland area. Buffer width should be increased by the greatest amount

agreeable to the landowners. Prior to proceeding with any work, this site may require a more detailed site assessment.

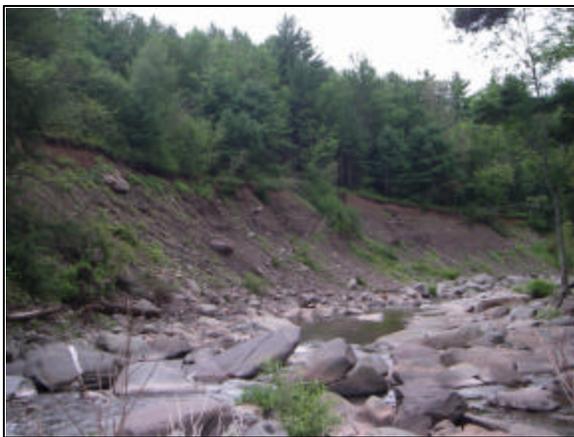
*Erosion at Stations 4655 - 4013*

As the stream meandered downstream, the hillslope was undermined by toe erosion, resulting in the mass wasting of a 32,086 ft<sup>2</sup> area along 642 ft of the left streambank (Stations 4655 – 4013). The face of the stream bank has been left unvegetated and

extremely susceptible to future erosion. A small tributary and seepage along this bank may exacerbate erosion. Stream bank erosion often occurs on the outside of meander bends where the stream velocity is greatest during high flows. This erosion continued for another 489 ft downstream, but was less severe (Station 4013 – 3524, Figure 4.11.1 Inset C). Slumping and fallen trees on the bank face still provide some protection from erosion.

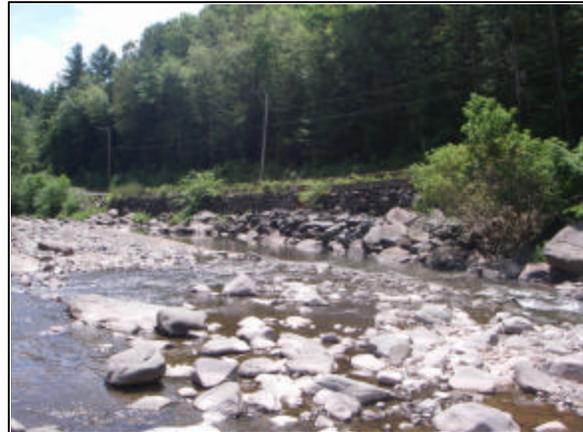
As the stream flowed directly into County Route 17, revetment including a 308 ft stacked rock wall (Station 3540 - 3232) and 436 ft of rip-rap (Station 3540 – 3104) covered the bank and toe of the right streambank. Interplanting the rip-rap with native tree and shrub species and reinforcing the toe of this stream bank with native sedge species is recommended. This planting will help to strengthen the revetment, while enhancing aquatic habitat by providing shade. Two piped outfalls (Stations 3340 and 3200) were located along this revetment. Flow through these outfalls was intermittent; at the time of the assessment no flow was observed.

*Revetment at Station 3540-3104*

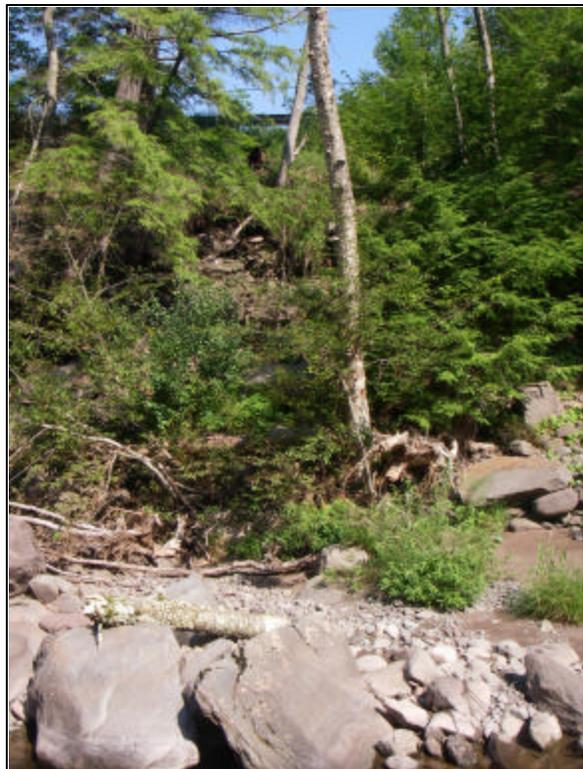
Downstream, 618 ft of the County Route 17 road embankment was threatened by a large mass failure of the streambank that resulted in the loss of mature vegetation from the face of the streambank (Station 2450-1832, Figure 4.11.1 Inset B). Stormwater from the outlet at the top of this bank appeared to be exacerbating erosion at this site (Inset Station 32130). Outlet protection, such as a rock lined channel, should be

*Piped outfall at Station 2130*

installed to dissipate flow and prevent erosion. To minimize erosion, stormwater outfalls should be designed to outlet near the base of the streambank, set back from the active stream channel, and enter the stream at a low angle.

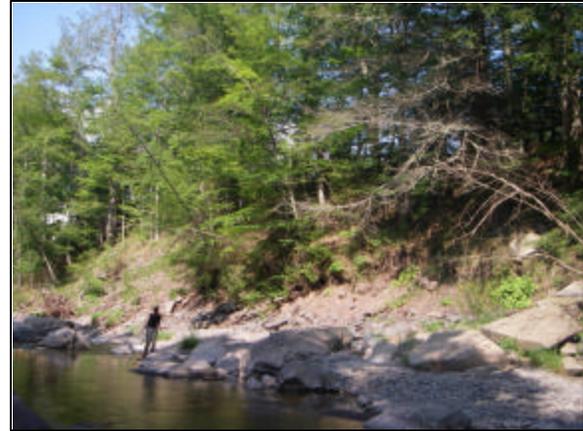
Continuing downstream, the right stream bank was affected by a *mass failure* (Station 1470 to Station 1084), a large slope failure associated with downcutting stream channels and undermined support of steep slopes. Along this section of stream, the thalweg flowed up against the toe and lower bank undermining the steep slope, resulting in an erosion area of approximately 7,716 ft<sup>2</sup> and compromising mature trees along the bank.

*Bank erosion, BEMS #06EK2422  
Stations 1470 - 1084*

During high flows and times of active erosion, a significant amount of clay may enter the stream from the 150 ft long clay/silt exposure along this bank. Fine sediment inputs into a stream can be a serious water quality concern because they increase *turbidity*, degrade fish habitat, and can act as a transport mechanism for other pollutants and pathogens.

To study erosion along this reach, this stream bank has been monumented as a Bank Erosion Monitoring Site (BEMS # 06EK2422, Station 1400). A cross-section and long profile survey were conducted to collect baseline data. In the future, this cross-section can be resurveyed to calculate the bank's erosion rate. It is recommended that monitoring of this site continue.

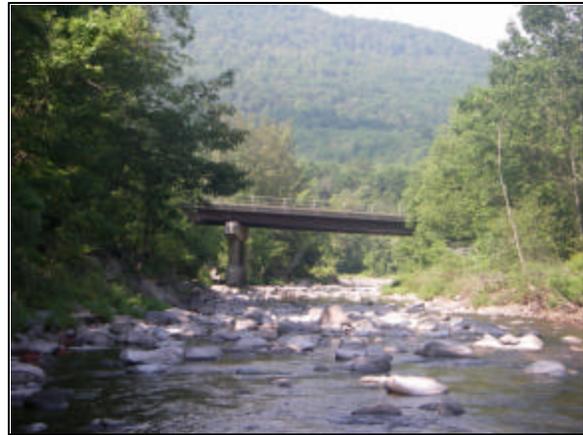
Near the end of this management unit the stream passed under the NYS Route 23A bridge (Station 300, Bridge # 1017930). Gravel deposits were noted upstream and downstream of the bridge. Deposits such as these are commonly caused by inadequate sizing of the bridge opening. An undersized bridge opening causes water to back up upstream of the bridge, reducing stream velocity, which results in sediment deposition.

*County Route 23A bridge at Station 300*

While bankfull flows may flow freely through this bridge, higher flows backwater, resulting in the upstream aggradation. Flood damage to bridges is typically caused by inadequate hydraulic capacity of the bridge, misaligned piers and/or abutments, or accumulation of debris. As bridges are replaced over time, these issues should be evaluated and adjusted if necessary to lessen the probability of flood damage by providing a more effective conveyance channel that promotes water and sediment flow through the bridge opening.

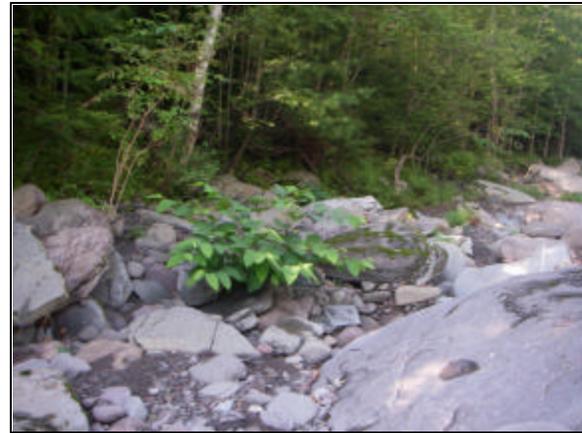
increased surface runoff leading to a loss of valuable topsoil. Japanese knotweed locations were documented as part of the stream feature inventory conducted during the summer of 2006 (Riparian Vegetation Mapping, Appendix A). The first appearance of Japanese knotweed on the East Kill mainstem does not occur until management unit #7. In total, 15 Japanese knotweed occurrences along an estimated length of 88 ft were documented in this management unit during the stream feature inventory.

*Japanese knotweed at Station 2150*

The best means for controlling knotweed is prevention of its spread, therefore, efforts should be made to ensure that all fill brought into the area is clean and does not have fragments of knotweed or other invasive plants. If Japanese knotweed sprouts or small stands are observed, they should be eradicated immediately to avoid further spread within this unit and downstream. Periodic monitoring for knotweed introductions in this unit is recommended.
