# Manor Kill Management Unit 1

Town of Conesville – Station 53,637 to Manor Creek Road (Station 45,598)

This management unit begins at a large NWI wetland complex, continuing approximately 8,039 ft to Manor Creek Road in the Town of Conesville.

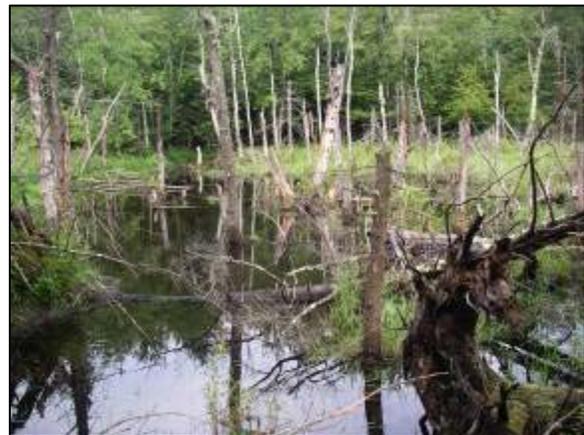
At the beginning of this management unit, there was a large open water wetland with a beaver dam, which was part of a federally designated wetland complex (near Station 53000) comprised of five wetland types, totaling approximately 10 acres. The wetland types include PEM1E, *palustrine, emergent, persistent, seasonally flooded/saturated*, PUBHh, *palustrine, unconsolidated bottom, permanently flooded, diked/impounded*, PSS1Eh, *palustrine, scrub-shrub, broad-leaved deciduous, seasonally flooded/saturated, diked/impounded*, PSS1E, *palustrine, scrub-shrub, broad-leaved deciduous, seasonally flooded/saturated*, and PSS1Eb, *palustrine, scrub-shrub, broad-leaved deciduous, seasonally flooded/saturated, beaver*.

*Wetland (near Station 53000)*

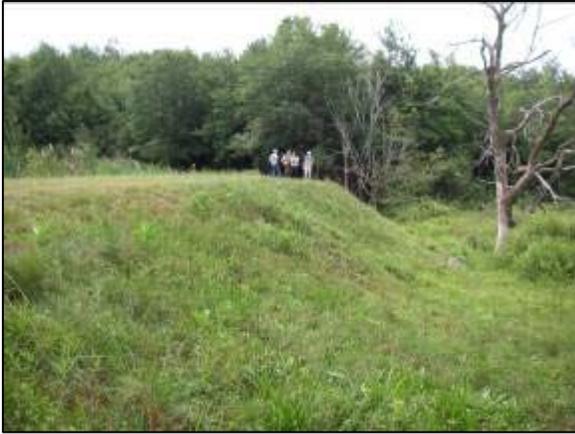
Continuing downstream, there was a private earth dam (NY00832, Station 52058) that was completed in 1977 to form a recreational pond (Figure 4.1.1, Inset D, looking downstream, Station 52800-52071). It measures 15 feet high and approximately 230 feet in

*Private dam, Station 52058)*

length. The drainage area of the dam is 0.05 mi<sup>2</sup>. The maximum storage space in the reservoir is 64 acre-feet and the maximum discharge that the dam was designed for is 62 cu ft/sec. According to the National Inventory of Dams, the downstream hazard potential is considered low, which is defined by the ACOEs as a dam “where failure or misoperation results in no probable loss of

human life and low economic and/or environmental losses. Losses are principally limited to the owner’s property.” Bedrock lined much of the left bank of the pond while the right bank was mowed to the edge. The bedrock provides lateral control along the left by limiting bank erosion. The right bank should be planted with trees and shrubs to increase bank stability and habitat. There was a dam spillway along the right bank lined with large rock and maintained herbaceous vegetation. Downstream of the dam, there was a wetland complex with herbaceous and shrubby vegetation and areas of open water with a beaver dam (Station 51344) at the downstream end.

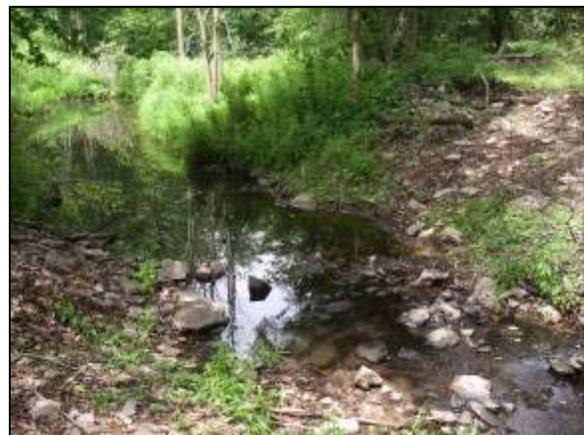
The rock wall provided lateral control and was further stabilized by herbaceous vegetation and vines that had grown through and along the stacked rock. Just downstream of the rock wall there was a stream channel crossing (Station 51040) that appeared to be maintained for recreational purposes.

*Channel Crossing at Station 51040*

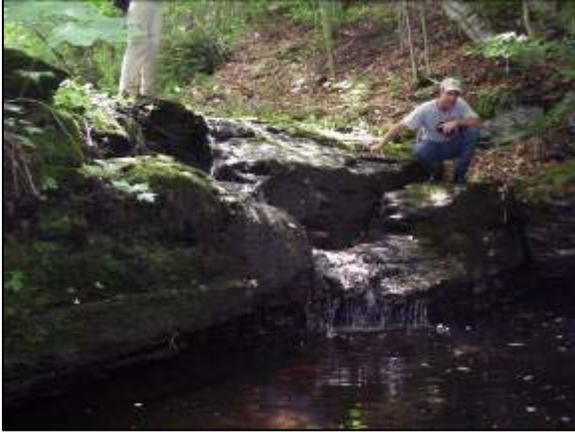
As the stream meandered to the right, there was bedrock (Station 50763) along the left stream bank and bed, gradually covering the full bed of the stream channel, for approximately 210 feet. The bedrock provides lateral control along the upstream portion of the bedrock by limiting stream bank erosion; and it

*Bedrock Stations 50763 - 50553*

provides grade control for the channel by preventing *degradation* or *downcutting* of the stream. This is the process by which streambeds and floodplains are lowered in elevation by eroding downward into the stream bed over time. The bedrock channel had multiple drops in elevation with a small waterfall entering a significant pool. At the time of the assessment, multiple trout were

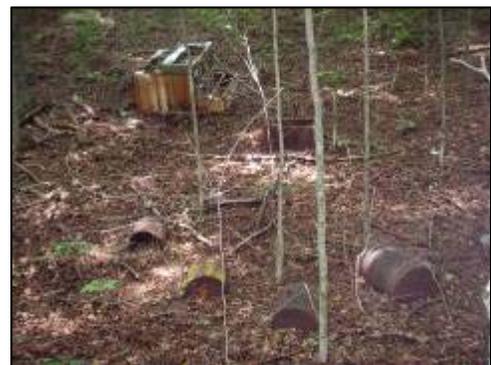
*Dump site at Station 49722*

during high flows. The second dump site (Station 49722) was located in the *floodplain* along the right bank and contained old farm equipment, refrigerators, metal scraps and some glass. The dump did not appear to be actively used or to pose an immediate hazard. During higher flows some of the material at the dump site may be mobilized and brought further downstream. It is recommended that both dump sites be removed to eliminate the potential safety and pollution hazards associated with the dumped material.

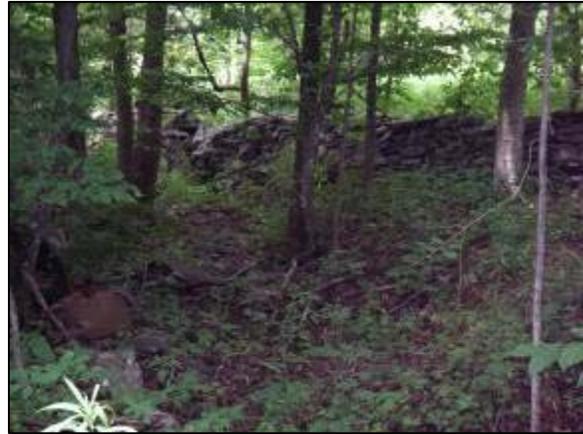
Further downstream, set back from the right stream bank, there was a stacked rock wall for approximately 100 feet (Stations 49481 – 49381). The wall appeared to be in good structural and functional condition. There was also a short section of bedrock (Station 49385) providing grade control in the bed of the stream and lateral control along the left bank for approximately five feet.

*Rock Wall, Stations 49481 - 49381*

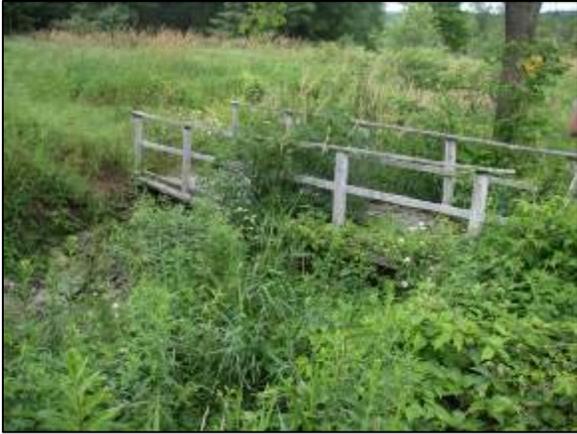
*Bridge at Station 48807*

As the stream gently meandered to the right, there was an old wooden foot bridge (Station 48807) in poor structural and functional condition. Starting approximately 400-500 feet upstream of the bridge, flow was subsurface at the time of the assessment. The bridge opening did appear to provide an adequate span for very low flows; however, the bridge may pose an obstruction during

higher flows. The bridge appeared to contribute to minor erosion just upstream.

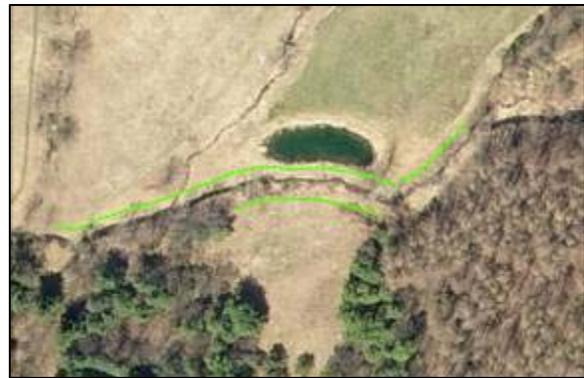
Along both sides of the stream, there were proposed planting sites. Land use changed from forested to maintained herbaceous vegetation. Recommendations for this site include

*Planting sites near Station 48700*

planting native trees and shrubs along the streambank and the upland area (Station 48700). Buffer width should be increased by the greatest amount agreeable to the landowners. Increasing the buffer width to at least 100 feet will increase the buffer functionality. A vigorous buffer with mature trees is important at these sites because it may also filter nutrients and pollutants, if any,

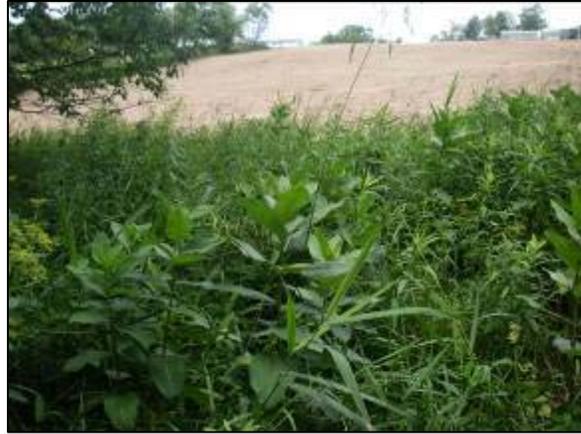
Continuing downstream, there was a proposed planting site (Stations 48413 – 48140) along the right streambank. This site was an active hayfield with a narrow area of unmowed herbaceous vegetation between the hayfield and the stream's edge. This narrow buffer had some shrubs and few trees. As with the previous planting sites, recommendations include planting native trees and shrubs along the streambank and the upland area. Buffer width should be increased by the greatest amount agreeable to the landowners. Enhancing the quality of the buffer with woody vegetation and increasing the overall buffer width will help to protect water quality through this reach by slowing stormwater runoff and filtering pollutants associated with nearby land use. This site may be eligible for the USDA's Conservation Reserve Enhancement Program.

*Planting site, Stations 48413 - 48140*

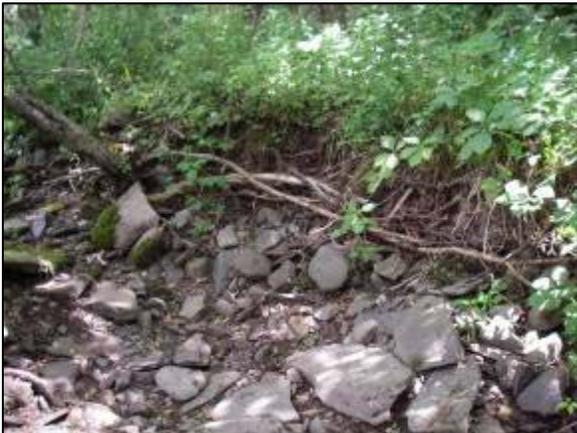
Opposite the planting site, there was minor erosion (Stations 48259 – 48181) along approximately 78 feet of the left streambank. The face of the bank had some exposed roots, with herbaceous vegetation, shrubs and trees at the top of the bank. The area was well vegetated with a forested floodplain.

*Eroding bank, Stations 48259 -48181*

Maintaining the forested cover along this bank is important, and may help the bank to recover naturally over time.

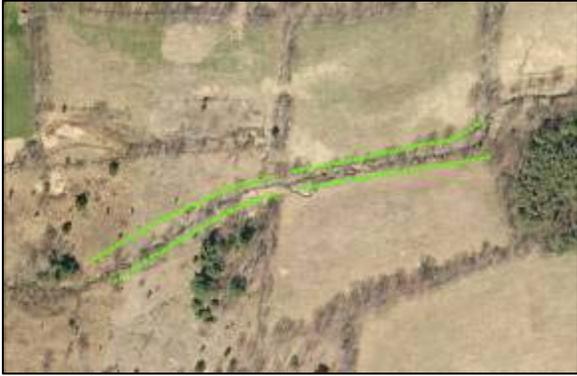
*Proposed Planting Sites, Stations 48082 - 47347*

As the stream meandered to the left, there was a stacked rock wall (Station 48082) that started along the right streambank and extended perpendicularly into the adjacent fields along a hedgerow. The rock wall was in good structural and functional condition. Just downstream of the rock wall, there were four additional proposed planting sites along approximately 735 feet of stream channel (between Stations 48082 and 47347). Each of

the planting sites had a narrow buffer of shrubs and trees. Along the right bank, the first planting site was a mowed field that did not appear to be in agricultural production. There was a stacked rock wall (Stations 47780 – 47685) in good structural and functional condition along the downstream portion of the first planting site. The other planting sites, one on the right bank and two on the left bank, were successional old fields that may be periodically mowed to maintain the open field. Through this stretch of stream, recommendations include augmentation and widening of the existing buffers by 100 feet or more through the planting of additional native trees and shrubs along the streambank and the upland area on both the right and left banks. Along the downstream planting sites, there was a private wooden bridge (Station 47585) that was in poor structural and functional condition. At the time of the assessment, flow continued to be subsurface. This bridge did not appear to be an adequate height or width for most levels of stream flow. If this bridge is replaced in the future, it is recommended that it be constructed with the appropriate bridge width that will provide the capacity to convey flood flows through the opening. Downstream of the bridge flow became surface at the time of the assessment.

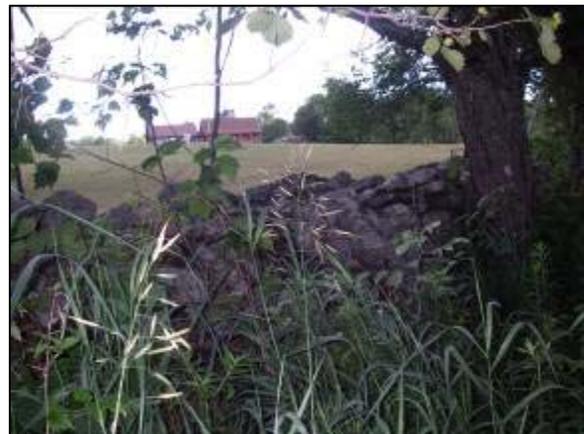
*Berm at Stations 46900 - 46760*

46987) with the main channel approximately 152 feet downstream. Continuing downstream, there was a stone berm (Stations 46900 – 46760) along approximately 140 feet of the right streambank. There was a thin line of trees between the berm and the stream's edge; beyond the berm there was a large mowed lawn. Berms tend to raise flood elevations and increase the erosive power of the stream.

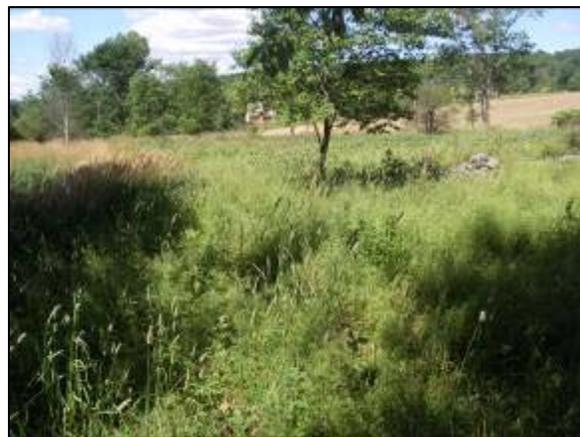
Both the left and right streambanks were experiencing minor erosion (Stations 46719 – 46540) for approximately 179 feet downstream of the bridge. There was also a proposed planting site (Stations 46719 – 46540) along the right bank. Increasing the buffer width to at least 100 feet will help to stabilize the stream bank and protect water quality. Recommendations for this site include planting native trees and shrubs along the streambank and the upland area. A tributary (Station 46454) entered along the right streambank. This tributary was classified C by the NYS DEC, indicating that the best uses for this stream are supporting fisheries and other recreational activities. Also along this stretch of stream multiple small channels were observed; the braided channel converged with the main channel (Station 46468) downstream of the planting sites.

*Planting Site, Stations 46719 -46540*

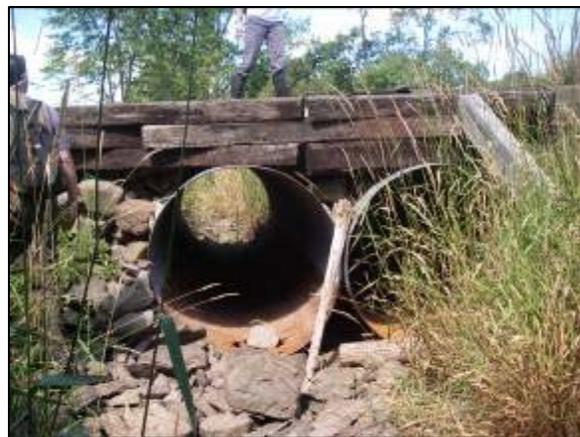
Further downstream, a private road crossed the Manor Kill. At this road crossing, there was a bridge with two metal culverts (Station 46395) that convey flow

*Bridge and Culverts at Station 46395*

under the bridge. The bridge and culverts appeared to be in fair structural and functional condition. Sediment deposition and accumulation of woody debris upstream of the bridge was noted. Deposits such as these are commonly caused by inadequate sizing of the bridge opening. An undersized bridge opening causes water to back up upstream of the bridge, reducing stream velocity, which results in sediment deposition. While low flows may flow freely through this bridge, higher flows may backwater, resulting in the upstream aggradation and woody debris accumulation. If this bridge is replaced in the future, it is recommended that a hydraulic analysis be conducted in order to determine the appropriate bridge width that will provide the capacity to convey flood flows through the opening.

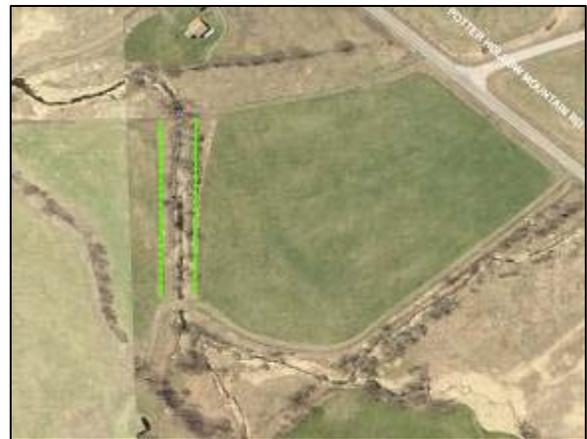
Continuing downstream, there was a proposed planting site along both the right and left streambanks (between Stations 46452 and 46035). Each site has a narrow buffer, with trees and shrubs along the right, and herbaceous and shrubby vegetation along the left bank; beyond the narrow buffers are hay fields. For each of these proposed planting sites, recommendations include augmentation and widening of existing buffer with the planting of additional native trees and shrubs along the streambank and the upland area. Buffer width should be increased by the greatest amount agreeable to the landowners.

*Planting Sites, Stations 46452 - 46035*

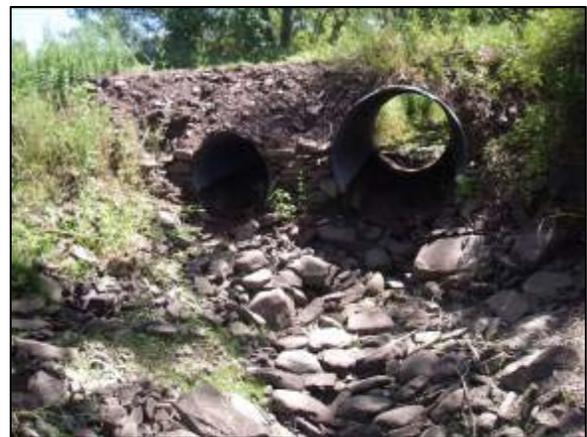
Downstream, there was a channel divergence followed by a bridge with two culverts (Station 46033) for conveying stream flow. The bridge was in fair structural and functional condition. On the upstream side of the bridge, there were stacked rock abutments and stacked rock between the culverts. The larger culvert conveys flow from the main channel, while the smaller culvert conveys flow

*Bridge and Culverts at Station 46033  
Photo looking upstream*

from a secondary channel. The two channels converged at the downstream end of the culverts. The culverts appeared to be in good structural and functional condition. While low flows may flow freely through this bridge, higher flows may be constricted, potentially contributing to backwater and excess sediment deposition. If this bridge is replaced in the future, it is recommended that it be constructed with the appropriate bridge width that will provide the capacity to convey flood flows through the opening.

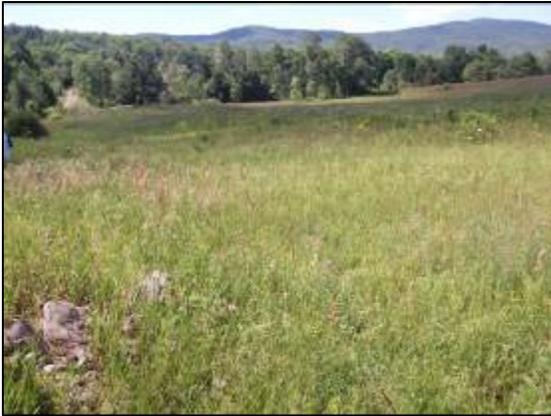
*Planting Site, Right Bank, Station 46375*

Downstream of the bridge, there were additional proposed planting sites on both the left and right streambanks. Both sides of the stream had herbaceous vegetation to the edge of the stream; primarily old field with some maintained herbaceous vegetation beyond the old field along the left bank. As with previous planting sites, recommendations include planting native trees and shrubs along the

streambank and the upland area to provide a buffer at least 100 feet wide, or the greatest width agreeable to the landowners.

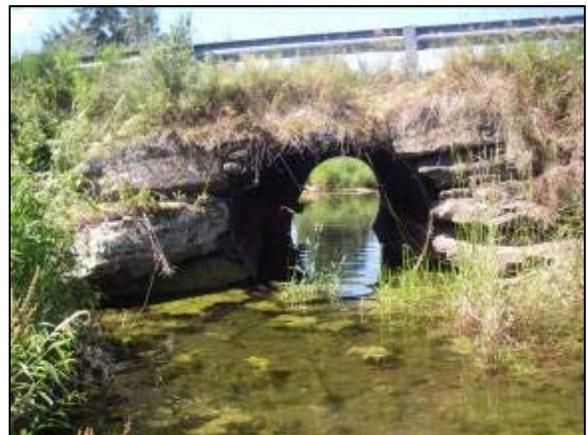
Management Unit 1 ended at the Manor Creek Road bridge (Station 45598). One large culvert conveyed flow under the private bridge; it was supported by boulder sized stack rock abutments. There was water ponding upstream and downstream of the bridge at the time of the assessment, with no flow beyond the downstream pond. The pond downstream of the bridge appeared to have been dredged and maintained. While most flows may flow freely through this bridge, flood flows may be constricted, potentially contributing to backwater. If this bridge is replaced in the future, it is recommended that it be constructed with the appropriate bridge width that will provide the capacity to convey flood flows through the opening.

*Culvert and Bridge at Station 45598*
