Manor Kill Management Unit 8

Town of Conesville – Station 9805 to Station 4523

This management unit began at Station 9805 and continued approximately 5,282 ft to Station 4523 in the Town of Conesville.

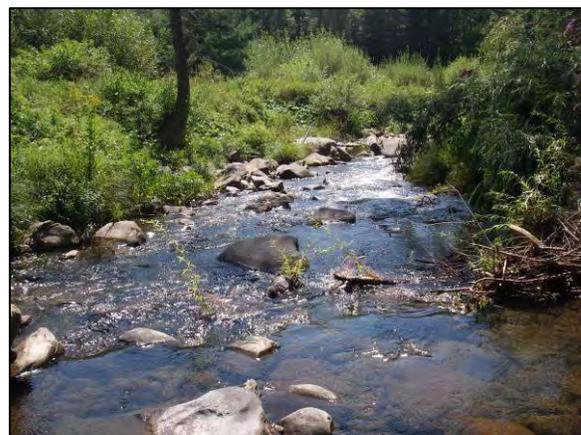
Head Cut at Station 9725

Downstream of the divergence, there was a *head cut* (Station 9725). A head cut is a marked change in stream bed slope that is unprotected, or of greater height than the stream can maintain (similar to a step). The stream was actively eroding the streambed downward to a new base level.

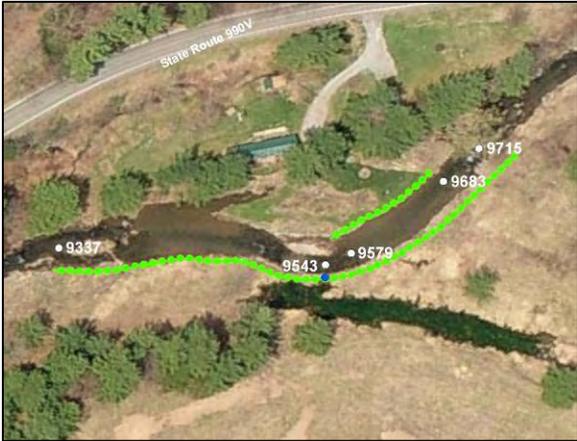
Riparian Planting Sites at Stations 9715-9337 and 9683-9579; Tributary at Station 9543

Continuing downstream, a proposed riparian planting site was identified along the left streambank. This site was a successional

old field with shrubs and a few trees. Recommendations for this site include planting native trees and shrubs along the streambank and the upland area. Enhancing the quality of the buffer with woody vegetation, and increasing the overall buffer width, will help to protect water quality through this reach by slowing stormwater runoff and filtering pollutants associated with nearby land use. Buffer width should be increased by the greatest amount agreeable to

the landowners. Increasing the buffer width to at least 100 feet will increase the buffer's functionality. About midway along the site, an unnamed tributary (Station 9543) entered from the left bank. This tributary appeared to receive its waters from upstream wetlands. Throughout this section of stream there were multiple areas of channel *aggradation*, the process by which streams are raised in elevation by the deposition of material eroded and transported from other areas. These areas include point, center and side bars that were vegetated with grasses and sedges.

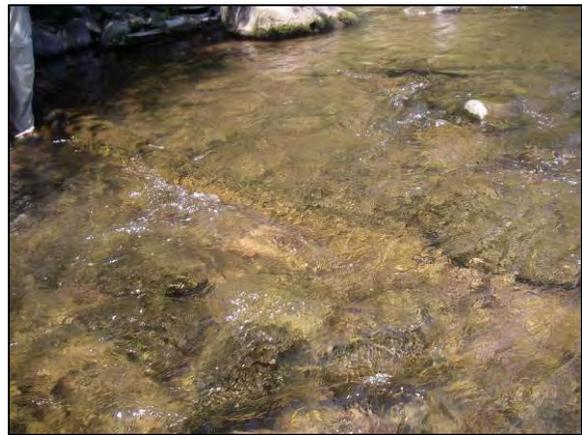
Habitat Structure at Station 9245

Further downstream it appeared that two logs had been placed perpendicular to the stream to serve as a habitat structure (Station 9245). Habitat structures are generally placed in an effort to create scour pools that offer deeper holding habitat as well as create spillways that raise the amount of dissolved oxygen in the water. In general, due to the channel spanning design, they cause water to back up on the upstream side of the structure which can increase sediment deposition. These logs were placed approximately 10 feet apart and spanned the width of the channel, however portions of both logs were buried and neither seemed to have a significant impact on the stream.

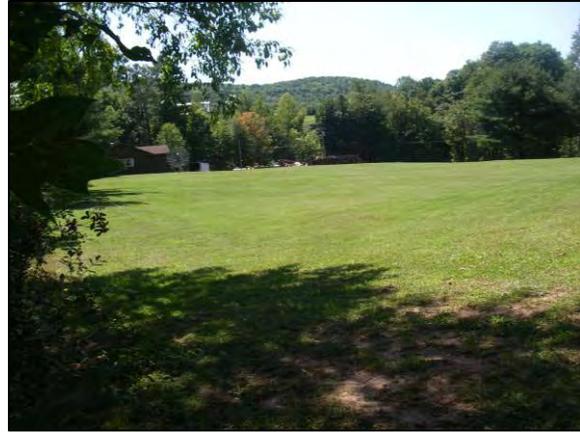
Planting Site at Stations 9036-8852

As the stream meandered to the left, a proposed riparian planting site was identified along the right bank. Lawn was mowed to the edge of the stream with shrubs and trees on the face of the bank. Recommendations for this site include planting native trees and shrubs along the streambank and the upland area. Buffer width should be increased by the greatest amount agreeable to the landowners.

Increasing the buffer width to at least 100 feet will increase the buffer's functionality and protect the stream from nearby land uses.

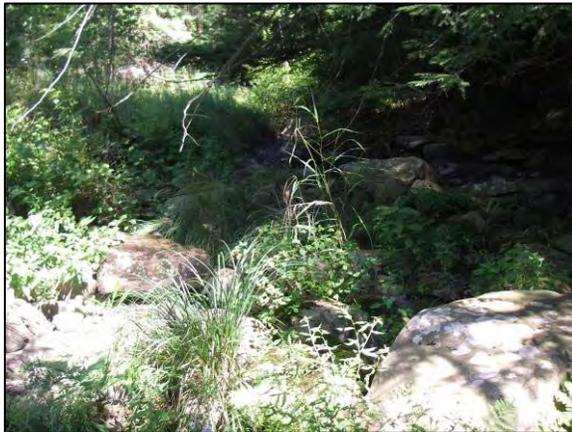
Flood Chute at Station 8426

At Station 8426 a flood chute converged with the main channel along the left streambank. The divergence of this flood chute was not observed during field assessment. This flood chute was lined with medium and large boulders; there was no flow at the time of the assessment. Additionally, this flood chute appeared to receive water from upland drainage.

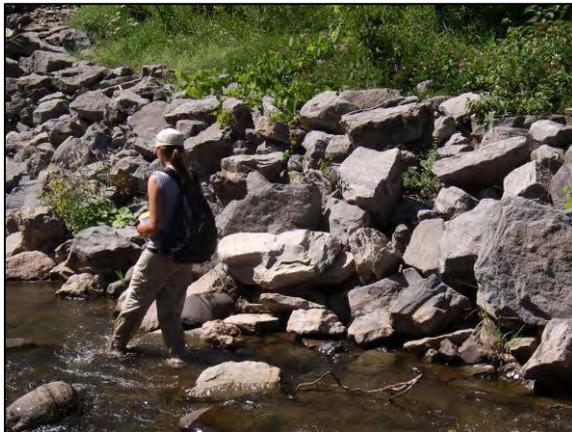
Revetment at Stations 8260-8165

Along the right streambank, rip rap had been installed for approximately 83 feet. This rip rap provided scour protection and appeared to be in good structural and functional condition. Interplanting native

shrub and sedge species through the rip rap and along the toe of this streambank is recommended. This planting will help to strengthen the revetment, while enhancing aquatic habitat.

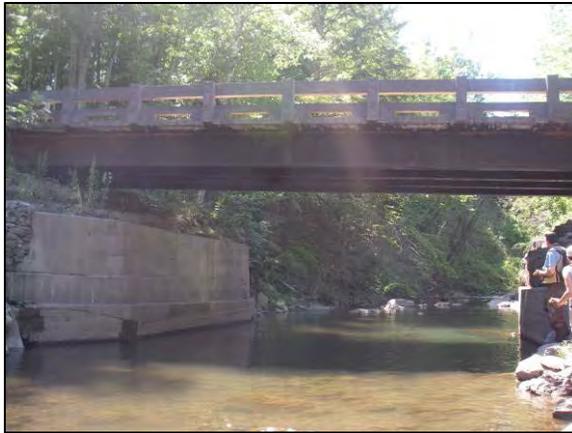
Bridge at Station 8167

Continuing downstream, the Manor Kill flowed under Pangman Road Bridge, ID 2228550 (Station 8167). In 1994 a permit was issued by the NYSDEC to Schoharie County for the replacement of this bridge. This bridge appeared to be in good structural and functional condition, conveying most flows freely; however some damage to the toe of the abutments was noted. Flood damage to bridges is typically caused by inadequate

hydraulic capacity of the bridge, misaligned piers and/or abutments, or accumulation of debris. As bridges are replaced over time these issues should be evaluated and adjusted if necessary to lessen the probability of flood damage by providing a more effective conveyance channel for water and sediment. Gabion baskets had been placed on and upstream of the bridge abutments to provide additional scour protection. Rock-filled gabions, or large wire-mesh baskets, are not generally a recommended management practice. They have a tendency to be unsightly, and when installed incorrectly they frequently blow out of the bank and scatter rocks and cages downstream, particularly following ice flows. Their correct use requires professional installation and maintenance.

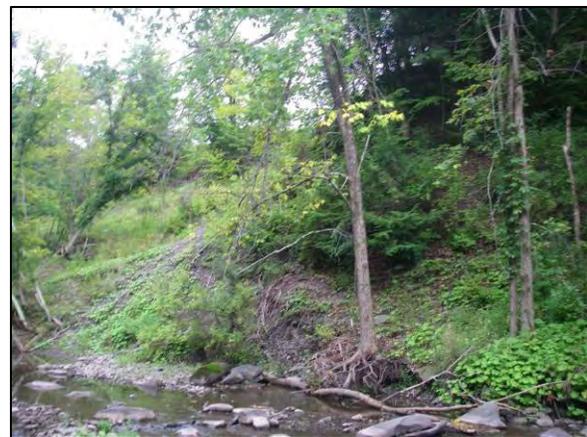
Mass Failure at Stations 8123-7800

Downstream of the bridge, the stream meandered to the right and the thalweg flowed up against the left streambank causing a second mass failure. The face of this erosion was vegetated with some grasses and trees while vegetation along the erosion was mowed to the edge. This mass failure resulted in an approximate erosion area of 9,215 ft² exposing roots and

compromising trees. Clay was exposed for the length of the erosion along the toe and into the bed of the stream. Opposite the mass failure a point bar had formed along the right streambank. Point bars commonly form on the inside of meander bends, where stream velocity is slower during high flows, allowing sediment to drop out of the water column and settle along the streambed.

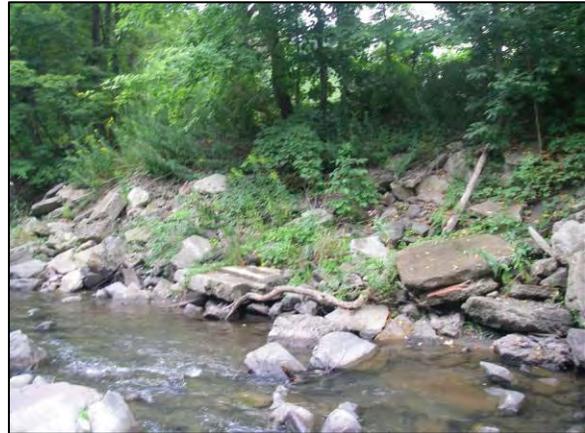
Revetment at Stations 7792-7657

Following the mass failure, rip rap (Stations 7792-7657) had been installed along the right streambank for approximately 135 feet. The upstream portion of this riprap consisted of cobble and some small boulders; continuing downstream large pieces of concrete had been placed with some smaller rock. This rip rap appeared to be in fair functional and structural condition, providing some scour protection.

A thin line of trees separated the revetment from Pangman Road. Interplanting native shrub and sedge species through the rip-rap and along the toe of this streambank is recommended to help to strengthen the revetment, while enhancing aquatic habitat. Continuing from the rip rap, there was erosion (Station 7657) for approximately 134 feet along the right streambank. The bank was overhanging along a portion of this site, exposing roots and compromising trees. Along this section of stream there were several aggradational features including side, transverse and point bars.

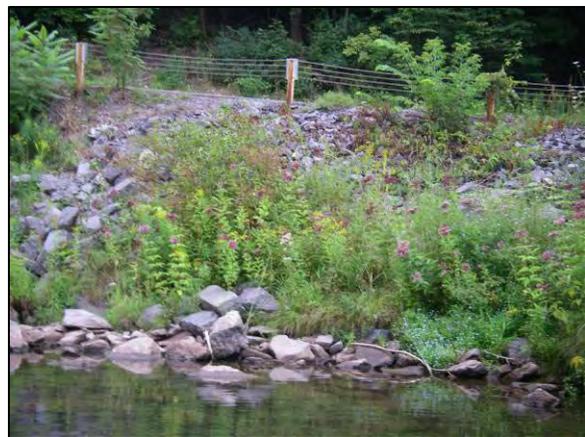
Revetment at Stations 7400-7367

As the stream flowed directly into State Route 990V, rip rap covered the bank and toe of the right streambank for approximately 33 feet. This revetment appeared to provide scour protection and be in good structural and functional condition. Some herbaceous vegetation had grown along the rip rap, and it is recommended that additional native shrub and sedge species be

interplanted into the rip rap. As the stream turned sharply to the left, bedrock (Figure 4.8.1, Inset B, Stations 7368-6336) extended from the top of the bank along State Route 990V into the channel of the right streambank and bed for approximately 1,032 feet. This bedrock at times covered the full bed of the stream channel. The bedrock provides lateral control along the right bank by limiting stream bank erosion; it provides grade control for the channel by preventing degradation or downcutting of the stream, the process by which streambeds and floodplains are lowered in elevation by eroding downward into the stream bed over time.

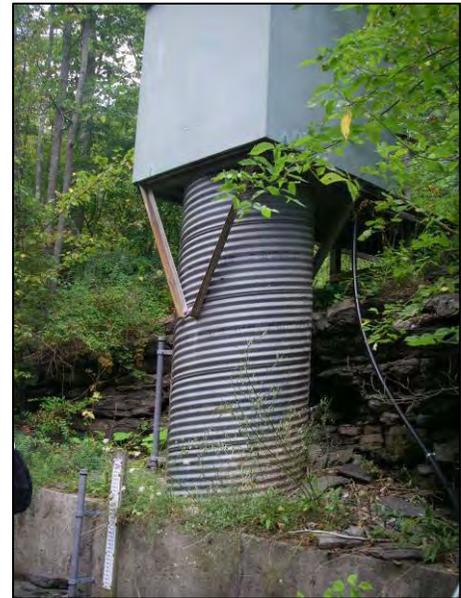
Gage at Station 7191

At Station 7191 there was a water-stage recorder and crest-stage gage on the right bank. This gage is operated by the United States Geological Survey (USGS) in cooperation with the New York Power Authority. The gage (#01350080) has a drainage area of 32.4 mi² and has been collecting continuous data from July of 1986 to the present. All gage information including real time discharge and gage height is available online at the USGS website:

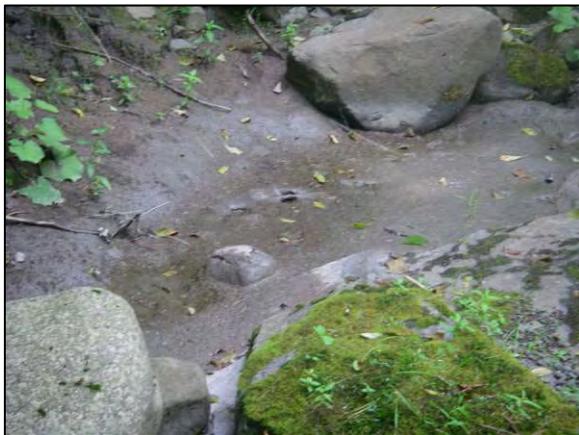
Clay Exposure at Station 6475

6821) along the bank for approximately 316 feet. This bank was undercut and slumping in areas exposing roots and compromising some trees. Clay was also exposed along the length of the erosion. It appears that during high flows water flows behind the side bar contributing to the erosion. Approximately 287 feet downstream of the erosion there was an additional 8 foot clay exposure along the left bank.

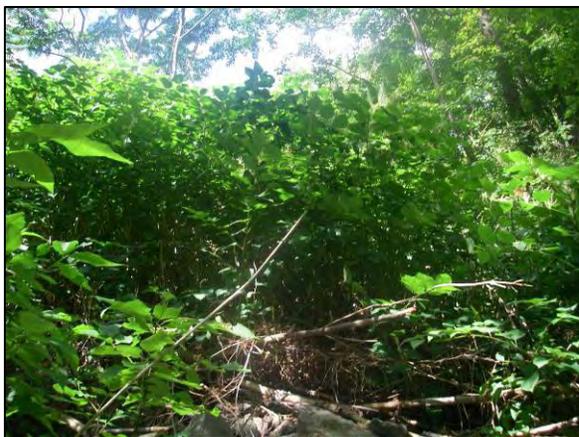
Japanese Knotweed at Station 4555

Along the right bank the first stand of Japanese knotweed was observed in this management unit. Japanese knotweed is an invasive non-native species which does not provide adequate erosion protection due to its very shallow rooting system; knotweed also grows rapidly and tends to crowd out more beneficial streamside vegetation. The best means for controlling knotweed is prevention of its spread. Therefore, efforts should be taken to

ensure that existing stands are not fragmented via unnatural processes (i.e. mowing without removal of all mowed material) and transported into downstream areas. Small stands should be eradicated immediately to avoid further spread within this unit and to downstream management units. There are removal methods that may be used for larger stands (see Section 2.7), but these methods

should be used with caution and carefully executed to avoid further spread of Japanese knotweed. Downstream a flood chute flowed behind a well-vegetated side bar along the right streambank for approximately 200 feet.

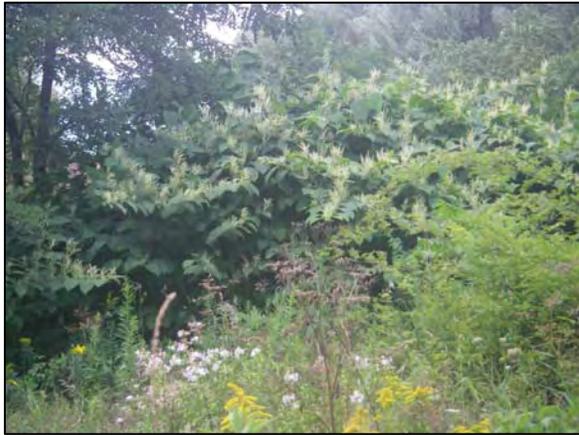
Japanese knotweed at Station 4567

Some plant species that are not native can create difficulties for stream management, particularly if they are invasive. Japanese knotweed (*Fallopia japonica*), for example, has become a widespread problem in recent years. Knotweed shades out other species with its dense canopy structure (many large, overlapping leaves), but stands are sparse at ground level, with much bare space between narrow stems, and without adequate root

structure to hold the soil of streambanks. The result can include rapid streambank erosion and increased surface runoff leading to a loss of valuable topsoil. Japanese knotweed locations were documented as part of the stream feature inventory conducted during the summer of 2008 (Riparian Vegetation Mapping, Section 2.7). In total, two Japanese knotweed occurrences, covering an estimated length of 55 feet, were documented during the stream feature inventory. The best means for controlling knotweed is prevention of its spread, therefore, efforts should be made to ensure that all fill brought into the area is clean and does not have fragments of knotweed or other invasive plants. If Japanese knotweed sprouts or small stands are observed, they should be eradicated immediately to avoid further spread within this unit and to downstream management units.
